Deep excavations for Amsterdam Metro North-South line: An update and lessons learned

A.F. van Tol

M. Korff

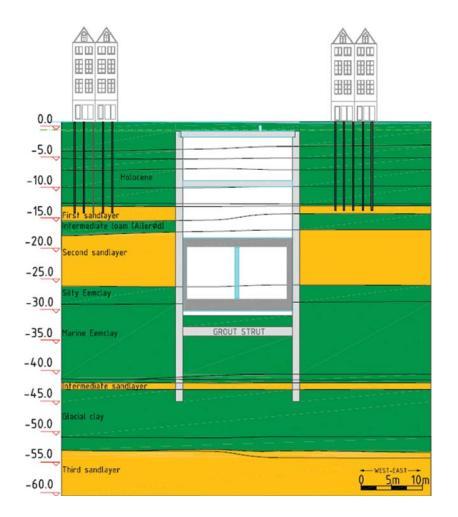
Figure 1. Cross-section of Vijzelgracht Station.

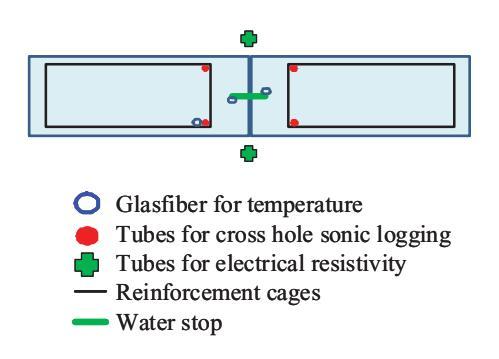
Figure 9. The position of monitoring systems (Spruit, 2011).

Figure 9 shows the layout of different monitoring systems at the joint between two D-wall panels as recently applied in a test in a D-wall project in Rotterdam and on a regular base at a D-wall project in Delft, Netherlands. The cross-hole seismic logging method was validated using a D-wall test block with a height of 2 m with a known inclusion. The measurements, see Figure 10, showed a clear increase of arrival time and of attenuation of the sonic waves (Spruit, 2011).
