Detection of imperfections in diaphragm walls with geophysical measurements

R. Spruit

V. Hopman

A.F. van Tol

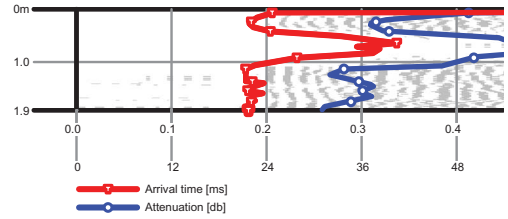
Figure 7. Typical CHST profile of the laboratory block, straight across the joint.

A typical CHUM graph from the test blocks is shown in Figure 7. The known anomaly is present from 0.1 m to 1 m and varies in thickness from 0 to 0.3 m.

The average (from two test blocks) extra arrival time for a joint contaminated with 0.3 m bentonite is straight across the joint 0.23 ms and 0.35 ms diagonally across the joint. Because the ‘straight’ signal can partly bypass the inclusion, the expected extra travel time will be around 0.1 ms per 0.1 m bentonite inclusion.

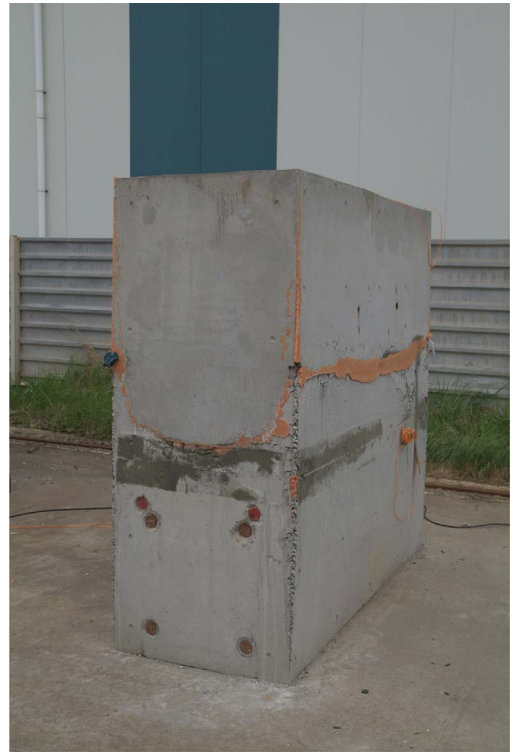
Figure 8. Laboratory block.

From the laboratory tests (Fig. 8) a first indication of the anomaly size can be deduced. The test blocks were poured in a normal formwork with a steel joint profile as the lower boundary of the formwork. After curing of the first half, the block was inverted, an anomaly was sculptured in the joint area, the formwork was attached again and the upper block was poured. Instrumentation was set up similar to the in-situ tests.
