Case history of a ruptured multi tied-back retaining wall

C.E.M. Maffei

ABSTRACT: Excavation of a São Paulo Metro Station was performed in residual soil. During excavation a tied-back retaining wall broke off. The rupture is analyzed from a soil-structure point of view. As a consequence of the failure, the construction method was changed to allow catching up with the lost time due to the accident. Reconstruction details are presented as well as re-calculations.

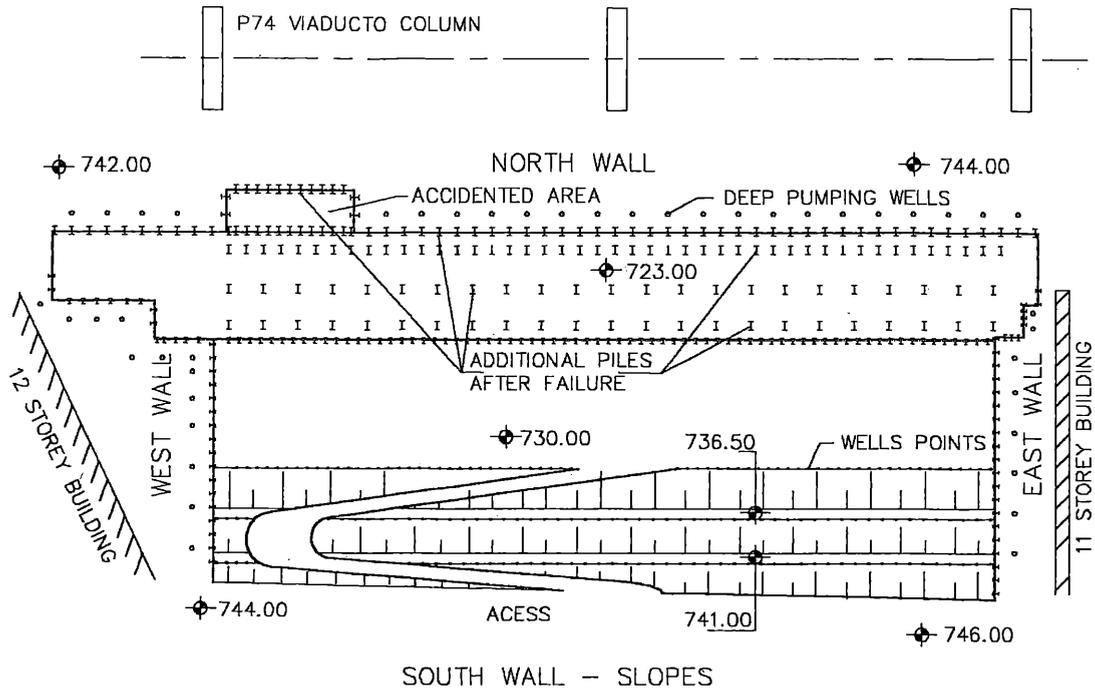
FIG. 1 - EXCAVATION PLAN

The Marechal Deodoro station, in the city of São Paulo, was built by "cut-and-cover" method. Due to the great width and geometry of the underground structure, the temporary works were executed with retaining walls constituted by soldier piles, wood lagging and tie-backs (North, East and West Walls), and with slopes (South Wall), as may be observed in figure 1 and the following figures. It is important to emphasize the proximity of a viaduct.

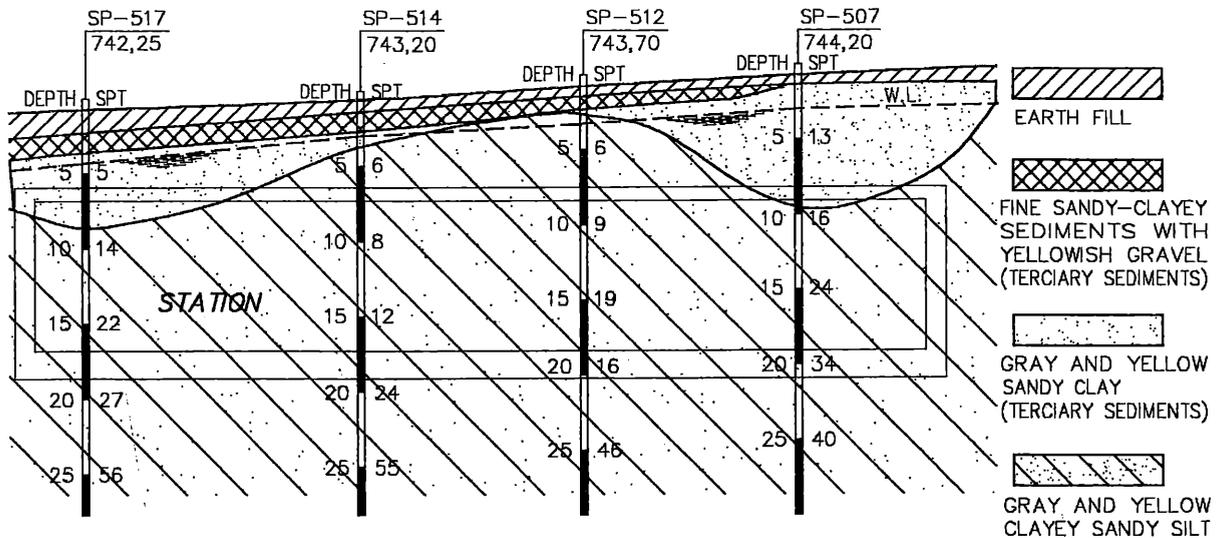
FIG. 2 GEOLOGICAL PROFILE

The Tertiary sediments are deposited on saprolitic soils constituted of gray and yellow, hard to stiff clayey-sandy silt, originally from Pré-Cambrian granite-gneissic rocks in alteration. Figure 2 shows the subsoil geological profile. For depth greater than 20 m, the SPT value increases significantly, demonstrating stiffer and higher cohesive material, transition from saprolitic to decomposed rock.
