Building collapse and ground subsidence in northern section of Calcutta Metro Construction

N.N.Som

ABSTRACT : The paper presents the case history of a building collapse in contract section 7 of Calcutta metro construction. A 5-storey building adjacent to a braced cut with R.C.C. diaphragm walls and struts collapsed after a 600 mm dia unfiltered water main gave way and water began to flow into the excavation under high pressure with consequent soil loss through openings in diaphragm walls. Extensive soil stabilization was done by cement / cement sand grouting before work could be resumed and the underground construction completed in the affected area.

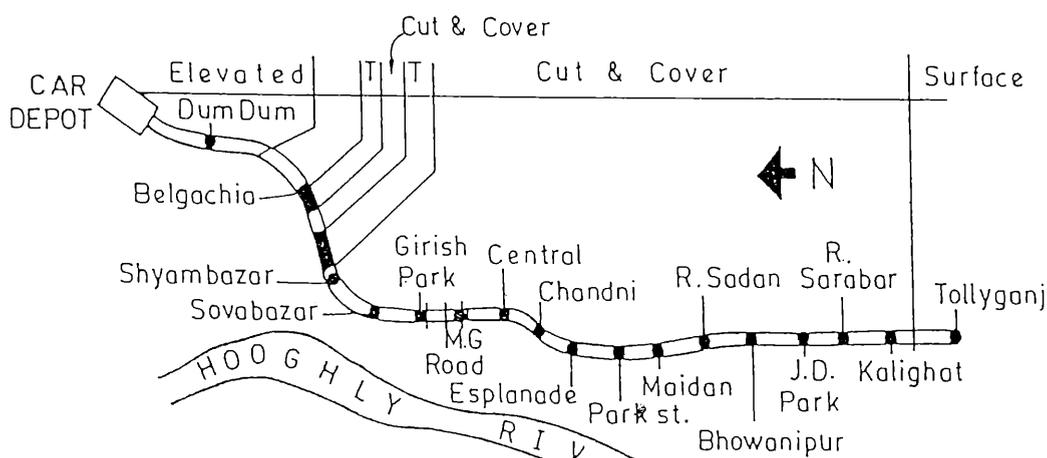
Fig. 1 Calcutta Metro alignment and location of collapsed section

Fig.1 shows the Calcutta Metro alignment and the subsidence area in front of the collapsed building. The location of diaphragm walls and struts, major water mains and buildings in the vicinity of the affected area are shown in Fig.2.

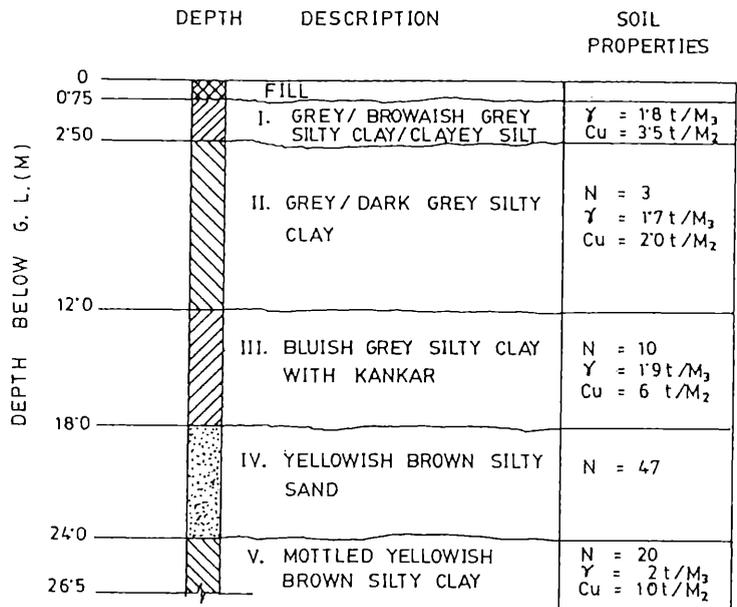
Fig. 2 Soil profile

Fig. 3 shows the subsoil condition in the collapse area as determined from detailed soil investigation prior to Metro construction. The subsoil consists of typical Normal Calcutta deposit with successive layers of silty clay / clayey silt and sand. The soil strata are particularly weak in the top 12 m as evidenced by low shear strength ($C_u = 20 \text{ kN/m}^2$). Thereafter, subsoil characteristics improve. The ground water table is high during rainy season.

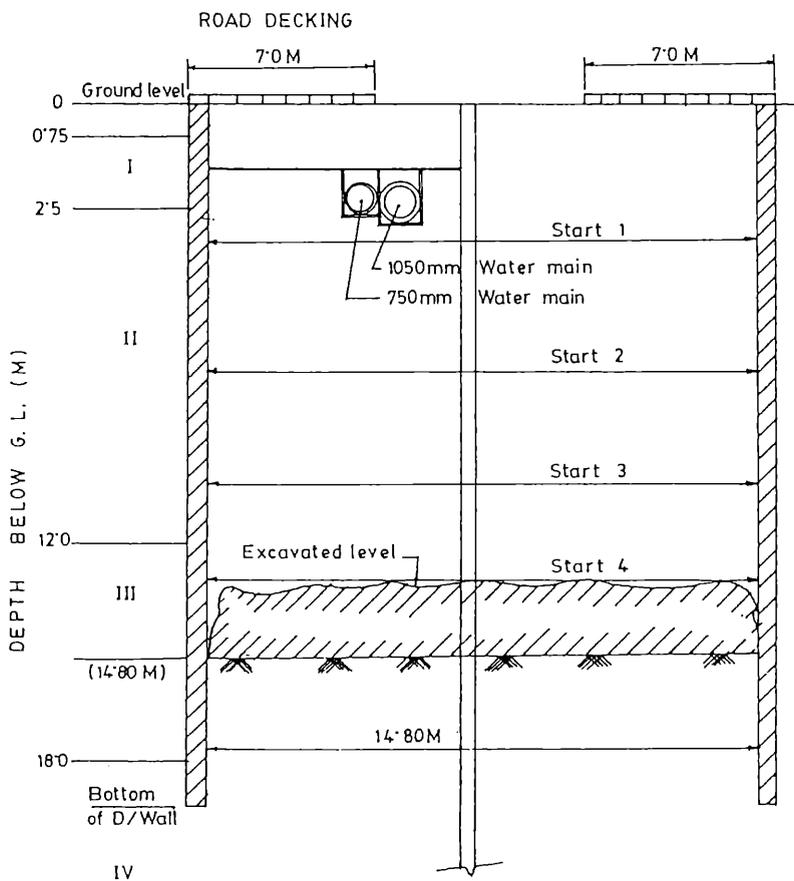
Fig. 3 Excavation profile near collapsed section

Fig. 4 shows the excavation profile for Metro construction in the subsidence area. 600 mm diaphragm walls were taken 4-5 M below the final cut depth i.e. into the dense silty sand stratum. The walls were propped against each other by 4 Nos. steel struts. While the depth of diaphragm wall ensured stability against bottom heave and clay bursting the struts and diaphragm wall were designed to resist the lateral earth pressure during excavation. That the design had been adequate from stability considerations is borne by the fact that the diaphragm wall and struts had remained stable even after the collapse. Also, more than 13 KM of Metro construction had been done without any failure of the support system.

At the time of subsidence the excavation had been done to 12 m depth with three struts. Work had been going on at this section for some months. Excavation was in progress at the 4th strut level. Subsidence of earth took place a number of times during the construction. On 15th June, 1994, a portion of earth subsided on the eastern side of the road opposite the collapsed building near the petrol pump.

Close inspection of the Metro trench showed visible gaps and openings in the diaphragm wall at the junction of adjacent panels near the collapsed area. Diaphragm walls were built in 3 m panels. In the whole of Metro construction by the cut-and-cover method (13.4 KM) about 8000 such panels had been built. Gaps in a few adjacent panels would not be unlikely in such construction. Attempts were made to close these gaps near the affected area by welding lagging plates to diaphragm wall reinforcements. Even then some cavities and voids could be detected behind the lagging plates. Water was coming through the gap in diaphragm wall with some force and sand bags were dumped on the floor of the excavation by

- (b) There was still some water coming into the excavation through the gaps in diaphragm walls. This was a source of potential danger as the water continued to wash away the fine soils and cause further ground subsidence. The most immediate task, therefore, was to stabilize the soil outside the diaphragm wall and to reduce the flow of water into the cut. This would be done by grouting on both sides of the cut near the collapsed zone. Cement or cement-sand grouting would be done to close the voids within the soil and strengthen any zone of weakness that still existed in the soil. The grouting would be done between the diaphragm wall and the building lines from outside the wall or by drilling holes from inside the diaphragm wall down to a depth of about 20 m below ground level. During grouting cement / cement-sand would be plumped into the soil and the grout would spread into the soil through the void space and finally set in the soil to give it greater strength. Difficulties would occur in grouting under flowing water condition because of the chances of the cement being washed out. In such cases quick-setting additives would be added to the grout. Grouting would be continued at each place till refusal to accept cement and sufficient pressure was built up to indicate closure of voids / cavities.
