The influence of unsaturated phenomena in the failure of an ancient (upstream raised) tailings dam

Luciano A. Oldecop¹, Rubén D. Rodari¹, Lucas Garino¹, Gustavo Navarta¹

¹*Instituto de Investigaciones Antisísmicas "Ing. Aldo Bruschi", Facultad de Ingeniería, Universidad Nacional de San Juan, Argentina.*

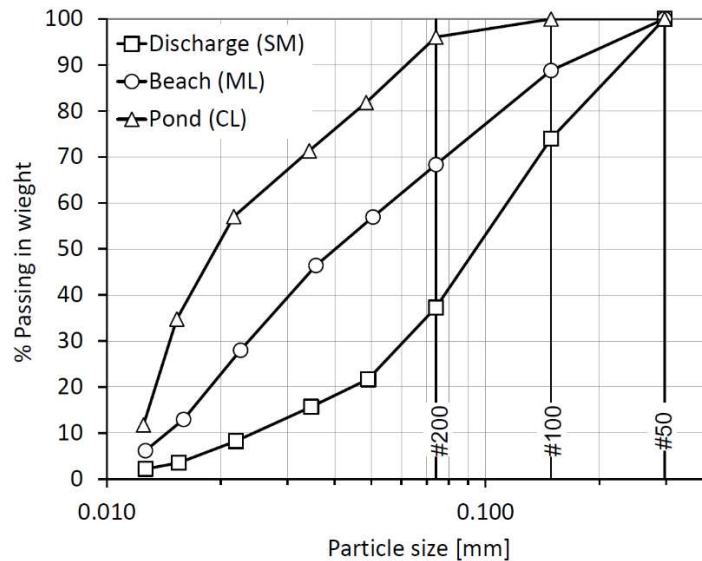
The grain size distribution (GSD) varies within the deposit because of the hydraulic filling method used. The material becomes finer as the sampling point moves away from the discharge points, which in this case were located along the dam crest. Strong vertical variations in grain size are also common, owing to the stratified structure of the deposit. A simplified distribution of materials is adopted for modelling purposes. Three distinct types of tailings are considered, each type pertaining to a zone within the deposit: (1) the discharge zone, (2) the beach zone, and (3) the decant pond zone. The index properties are summarized in Table 1. Figure 6 shows the average grain size distribution for each zone.

Figure 6: Mean grain size distribution curves from samples collected in the three zones of the deposit: discharge zone, beach zone and decant pond zone.

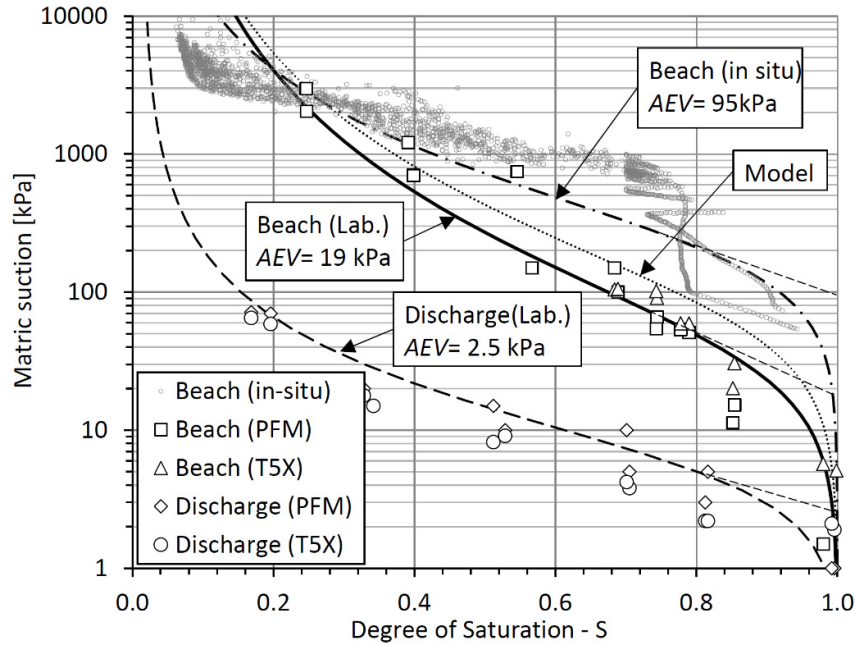
where θ_r is the residual volumetric water content, p_g and p_l are the gas phase and liquid phase pressures, respectively, and α , n , and m are fitting parameters whose values are given in Table 3. In addition to laboratory data, Figure 8 includes a series of points obtained from field measurements [15]. These data (over 30,000 points) were collected in an instrumented plot at one of the Castaño Viejo tailings dams (different from the study case). The measurements correspond to a silt layer in the beach zone, located 7 cm below the surface. The instrumentation consisted of a Decagon MPS-2 suction sensor and a Decagon 5TE volumetric moisture sensor. The dry unit weight of the layer was also measured, converting volumetric moisture readings to degree of saturation for inclusion in Figure 8. The retention curve derived from field data shows higher suction values than laboratory samples for the same degree of saturation. This suggests that the field material is finer. One possible explanation for this discrepancy is again the strong heterogeneity of hydraulically deposited tailings.

Figure 8. Retention curves of Castaño Viejo Tailings (data after [14, 15]). Laboratory specimens were prepared at a dry unit weight of 14.5 kN/m³. van Genuchten (1980) [19] curves fitted to the experimental data with the parameters indicated in Table 3.

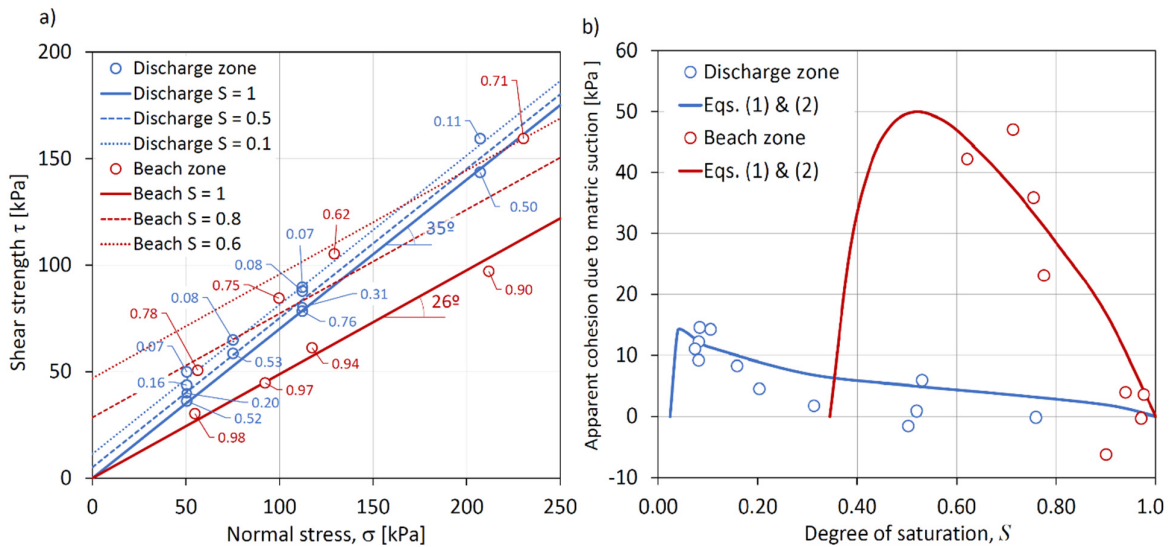
Eq. (2) shall be used with eq. (1) since the matric suction ($p_g - p_l$) is determined by the retention curve for each value of θ . Figure 9.a displays, along with the experimental results, the Mohr-Coulomb (M-C) envelopes arising from eqs. (1) and (2) with the corresponding values of the parameters indicated in Tables 2 (last column for the beach material) and 4, respectively. Figure 9.b displays the variation of the apparent cohesion due to capillary forces with the degree of saturation. Apparent cohesion is computed as the y-intercept of an M-C envelope passing through each data point, assuming a fixed slope ($= \tan \phi'$) for each material. The data are compared to the plot of third addend of eq (2), computed with the corresponding set of parameters. The model predicts a vanishing apparent cohesion for very dry states, which is physically expected to occur, although it is not evidenced by the available set of data.

Figure 9. Shear strength determined in direct shear tests conducted under constant water content for the discharge zone sand and the beach silt (data after [14]). Laboratory specimens were prepared at a dry unit weight of 14.5 kN/m^3 . a) Experimental results obtained in direct shear tests with constant water content (initial degree of saturation indicated for each datapoint) and Mohr-Coulomb envelopes for given values of initial degree of saturation resulting from the application of eqs. (1) and (2) along with the parameters given in Tables 2 and 4. b) Measured apparent cohesion as a function of the initial degree of saturation compared to eq. (2) plot.

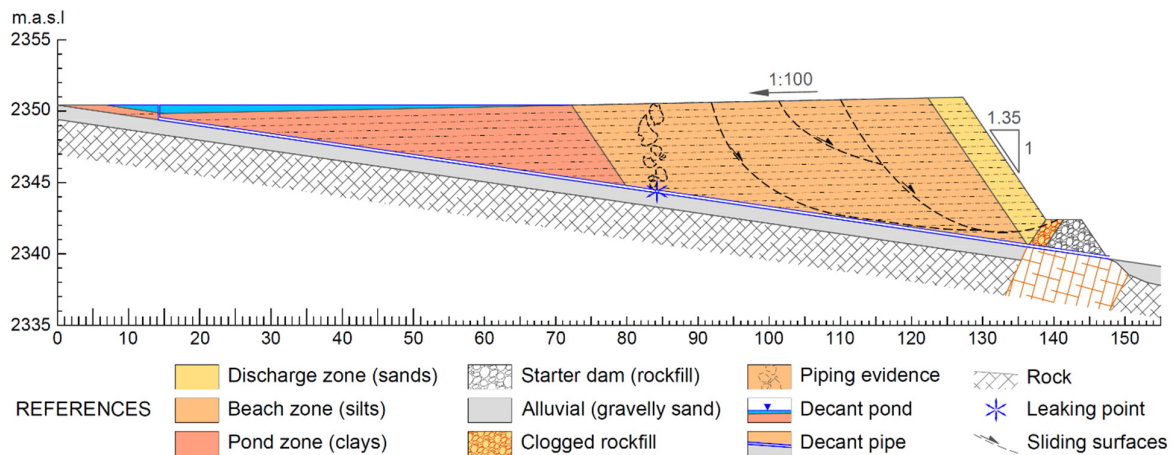
Analyses were conducted in two dimensions. The analysis section is shown in Figure 10 (its trace is indicated in Figure 2. b). The material zonation was adopted according to the restored deposit geometry and field observations. The materials considered are the three types of tailings already discussed in the previous sections, plus an alluvial fill in the valley bottom, the rockfill making up the starter dam and a zone of rockfill clogged with tailings in the upstream part of the starter dam. The tailings beach is assumed to have a uniform slope of 1% upstream. Otherwise, the slope of the valley bottom is 7.3%. The position and level of the decant pond was identified in the field by the marks in the tailings relicts. The section in Figure 10 includes the indication of the position of the decant pipe, the karstified tailings zone and the approximate geometry of the sliding surfaces interpreted from the field observations. The rock outcrops in the nearby of the deposit in both margins and in the stream bed at the position of the starter dam (igneous dike). Hence the alluvium is inferred to be shallow. A depth of 1 metre is assumed.

Figure 10. Analysis section for the base case. Vertical scale exaggerated by 2.

Explaining failure turned to be not straightforward. In fact, no failure was predicted with the Base Case model which uses the geometry of Figure 10 and the parameters of Table 5. The minimum factor of safety after running the steady-state stage was 1.6. After running the transient stage during a six-month period injecting water from the leaking pipe, a minimum safety factor of 1.3 was attained with the model approaching a new steady state flow condition. Hence a series of additional factors were tested to understand the failure mechanism. Those factors are discussed in the following sections and incorporated into a new model, termed the Failure Case. The goal was to weight out their relative importance in the failure process.

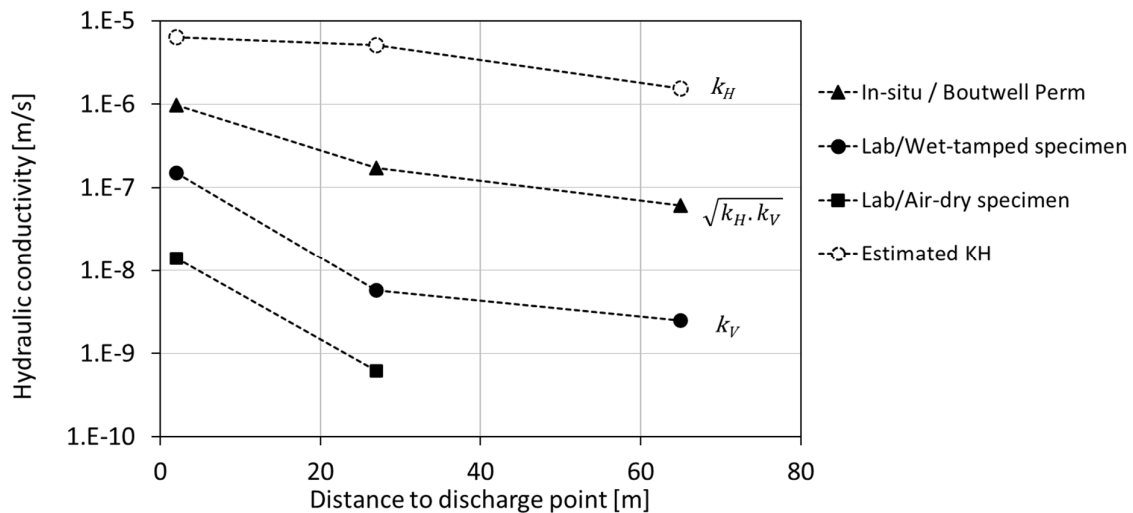
The Failure Case model considers higher-than-normal anisotropy ratios for the tailings permeability. It is assumed that lab tests on reconstituted specimens (wet tamped) yield values roughly close to the vertical permeability, k_V . This is a reasonable hypothesis since the permeability is controlled by the finer fraction, i.e., the tailings arising from the fine-grained strata. Moreover, as in the Base Case, the field measurements (Boutwell permeameter) are considered the geometric mean of k_H and k_V [21]. Thus, the corresponding k_H values can be inferred from these two assumptions. All permeability values are depicted in Figure 11 as a function of the distance between the dam crest and the sampling point. The resulting ratio k_V/k_H is in the order of 10^{-2} for the sand of the discharge zone and of 10^{-3} for the beach and the pond zones. It is interesting to note that the permeability data collected for the analysis of the Correo de Feijao accident [11] support such a three-orders-of-magnitude variability range in any vertical within the beach zone.

Figure 11. Hydraulic conductivity measurements as a function of the distance from the discharge point (dam crest) were the sample or measurement was taken (values indicated in Table 2). Horizontal permeability estimated according to the hypotheses made in the Failure Case Model.
