Construction failure of X Dam: the importance of field monitoring

Andhika SAHADEWA^{1,3}, Haris SETYAWAN¹, Mahdi TANJUNG¹, Astyka PAMUMPUNI^{1,3}, Abi HAKIM², Jagad LANGIT³, Pebri HERRY^{1,4}, Aris WIBOWO^{1,4}

X Dam, located in Jawa, Indonesia, experienced catastrophic failure during its construction in 2021. This manuscript describes failure incident, investigation, and post-failure mitigation of the dam. Disordering field monitoring execution was one reasons of the collapse. Authors believe that investigation report of such failures can contribute to advances in design, construction, operational and monitoring of dams.

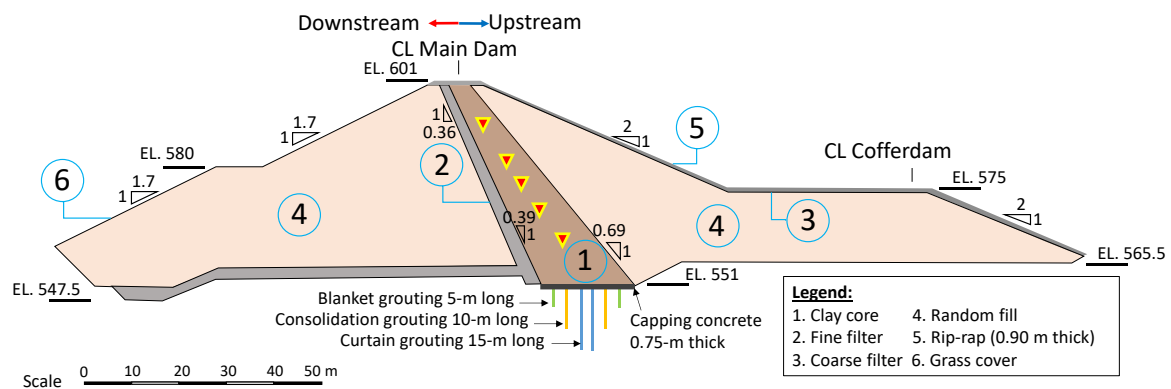
Figure 1: Cross-section of X Dam at STA 0 + 235.

The idea of building X Dam, designed mainly for flood control, has been initiated since 1990s. But the construction was not commenced until 2017. Prior to the failure incident, this dam was originally designed to be approximately 50-m high, 170-m long, and 10-m wide with an inclined-core fill (Figure 1). Having capacity exceeding 1.5 million m³ and inundation area of more than 5 Ha, this dam is expected to reduce flood debit over 10 m³/second.

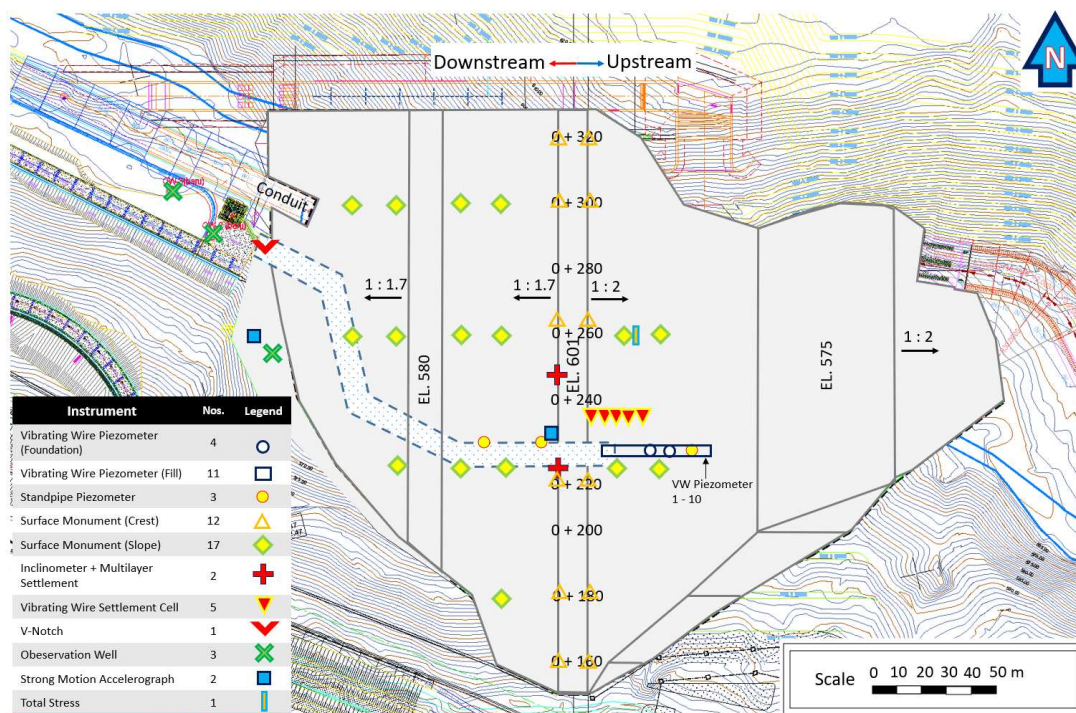
Figure 2: Plan view of X Dam.

X Dam in fact is equipped with a series of dam instrumentation, including standpipe piezometers, surface monuments, and inclinometers with multilayer settlement. Instrumentation locations are presented in Figure 1, Figure 2, and Figure 3.
