The paper was published in the proceedings of the 11th International Symposium on Field Monitoring in Geomechanics and was edited by Dr. Andrew M. Ridley. The symposium was held in London, United Kingdom, 4-7 September 2022.

Utilization of Instrumentation Data for Averting a Potential Support Failure in a Deep Excavation Project

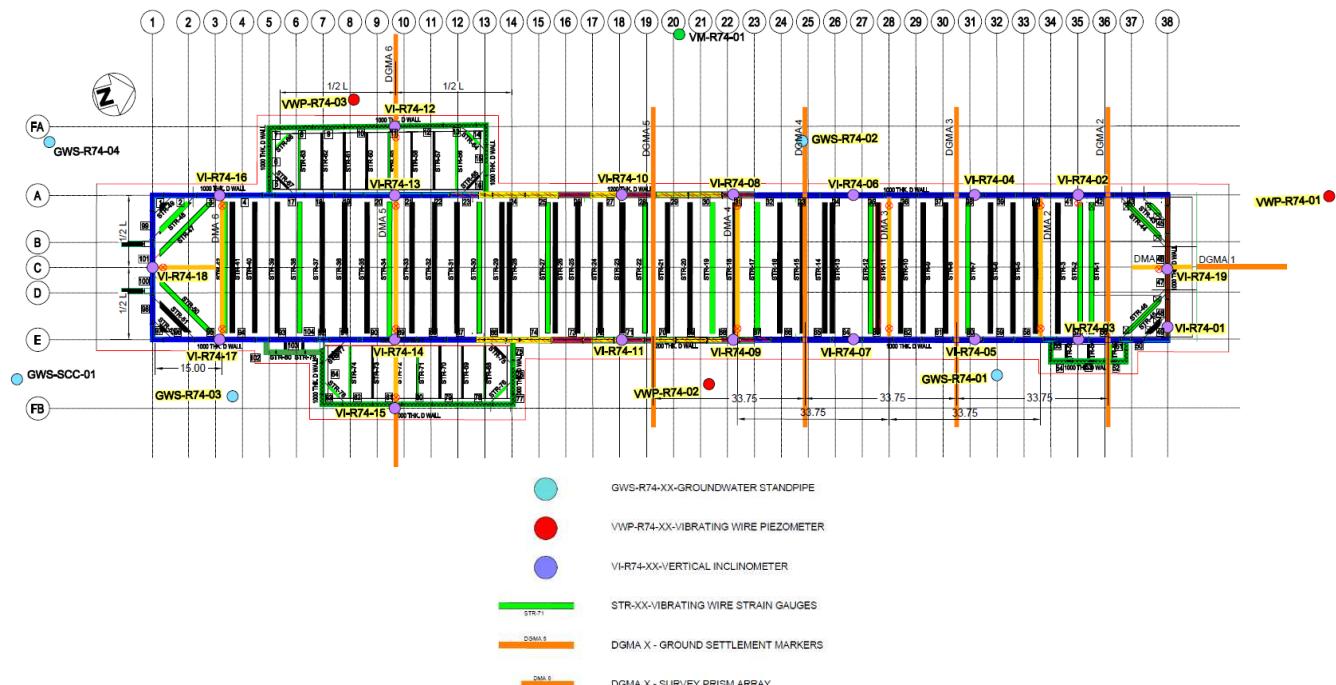
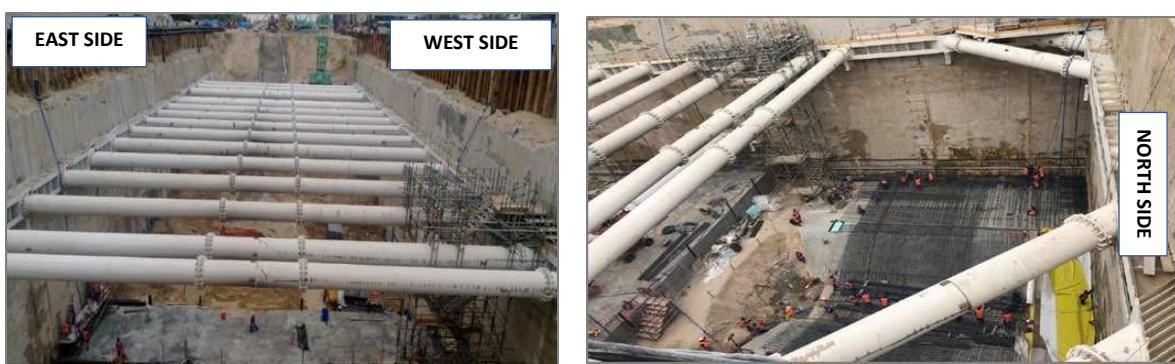
Figure 1: Instrumentation layout plan (above) and site pictures (below).

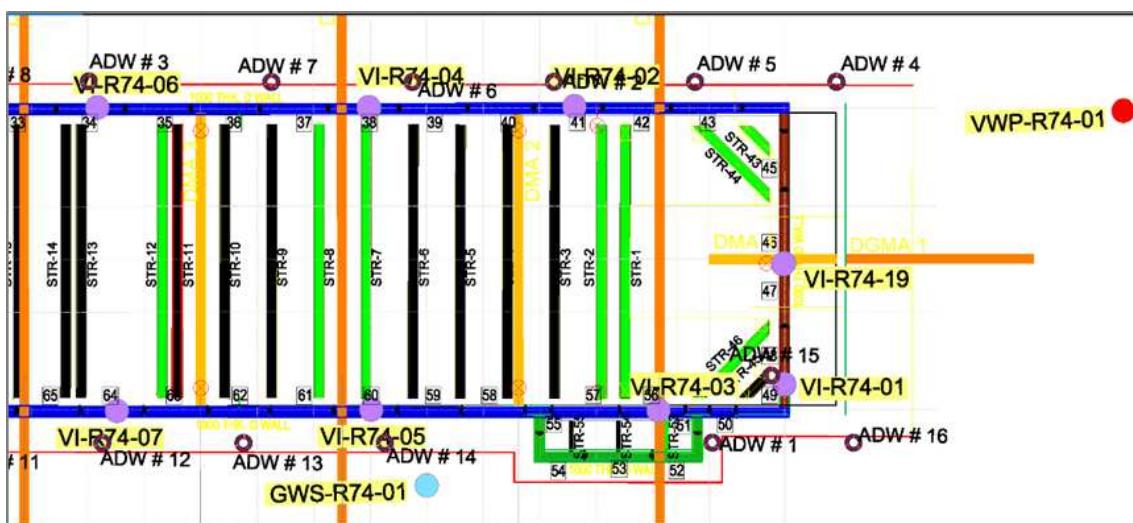
From the monitoring results, it was observed that the diaphragm wall was sensitive to any excavation below -11 m DMD. It reacted with a sudden increase in deflections when excavation was carried out below this depth. The movements were also observed with an increase in water level in that zone. Data from inclinometers, water level, prism targets, and strain gages were all correlated and confirmed the movement of the diaphragm wall. A close view of the location where the incidence took place is shown in Figure 2, with all the instruments marked.

Figure 2: Close up view of instrument layout for East side diaphragm wall, showing inclinometers VI-03, VI-05 (incidence 1), VI-19 (incidence 2), VI-02 (incidence 3); dewatering well ADW # 01; water standpipe GSW-01 (automated later); Strut STR-1 with strain gages.

On May 1, 2018, the dewatering well ADW # 01 (location shown in Figure 2 above) was damaged by the nearby works and it was out of order for a few hours. During that time a rise in the ground water level of 2 m was recorded on the East side which caused the wall to deflect further. Inclinometers VI-03 and VI-05 recorded an increase of deflection of approximately 19 mm and 16 mm respectively as the water level reduced to the previous level after almost 24 hours. Refer to Figure 4 and Figure 5.

April 19, 2018, onwards the inclinometer VI-19 installed at the North headwall, started to show a rapid deflection while the excavation was at -9 m DMD. Refer to Figure 2 for the location of inclinometer VI-19 and Figure 12 for the data showing the movement.

During the site inspection, it was found that the dewatering well was not constructed on this side of the diaphragm wall. After studying the inclinometer data, the civil contractor decided to construct and install the dewatering system behind the North wall on an urgent basis. The readings reached up to 25 mm before the dewatering system was functional. The readings got stable subsequently.
