# Landslide During Construction Of A Rockfill Breakwater In The Coast Of Sergipe, Brazil

**SUMMARY:** On October 12<sup>th</sup>, 1989, a rockfill breakwater under construction in Sergipe state, Brazil, situated some 2,4 km from the beach, suffered a foundation slide failure. The breakwater had a total height of 16 meters, with 6 meters above sea. The soil profile, from sea bottom down, was 4 meters of sand, 7 meters of soft clay and below the soft clay, sandy layers to great depth. During the construction period that anteceded failure there was monitoring of displacements and pore pressures. A modified design has been conceived and construction was completed in October, 1992. Geotechnical instrumentation has been used to monitor the construction of the breakwater before and after failure. This work reviews the sequence of events, briefly presents the geotechnical characteristics of the foundation, including the fact that there was artesian pressure of unsalted water at the base of the soft clay, describes the instrumentation results before and after the failure, discusses its possible causes and, at the end, presents the criteria used to ascertain acceptable safety.

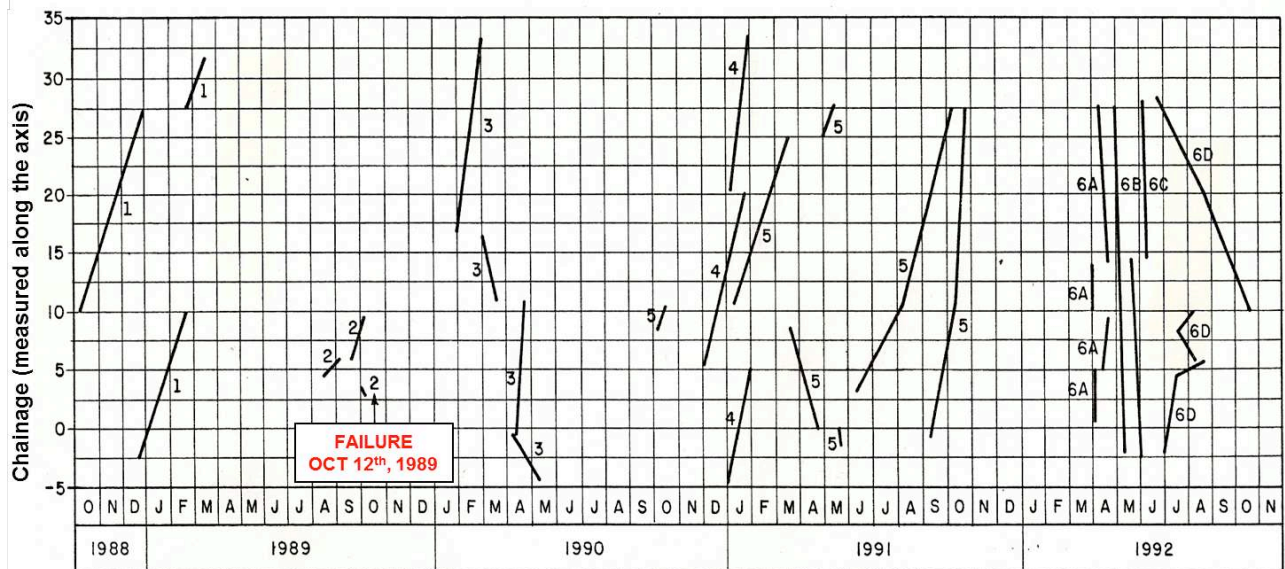
- Failure took place on October 12<sup>th</sup>, 1989 when about 100 meters of the terrestrial phase had been built (see figures 3 and 4);
- Before failure, the (initial) design was developed by a Design Firm and checked by consultants hired by the Contractor;

Figure 3. Time-path diagram of the construction stages: initial design (before failure, stages 1 and 2) and final design (after failure, stages 3 to 6). See Figure 5a for a plan view of the chainage.

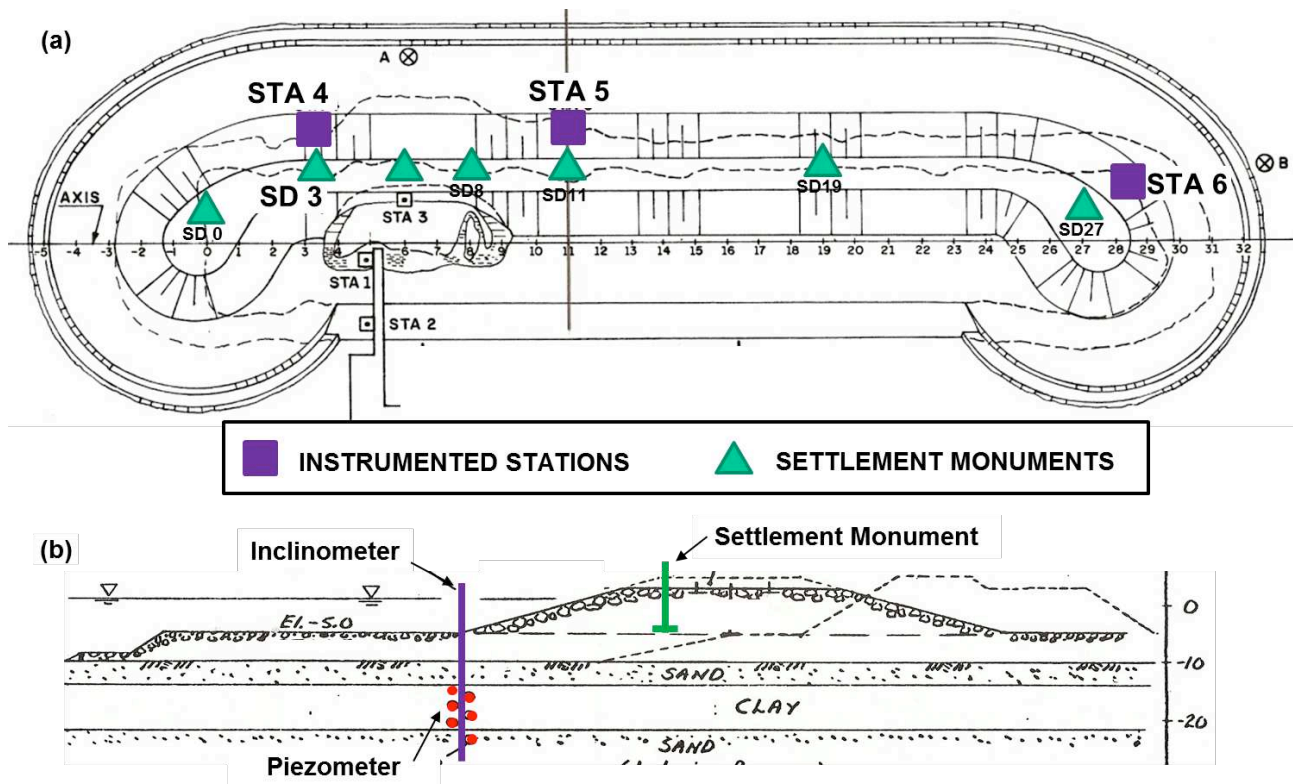
Figure 5. Layout of instrumentation: (a) plan view; (b) typical section.

Three monitoring stations, STA4, STA5 and STA6, with piezometers and inclinometers, have been installed as shown in figure 5. Seven settlement monuments with base at the top of the geotechnical berm have been placed in the positions shown in the same figure. All instruments were continuously measured by a full time technical team.

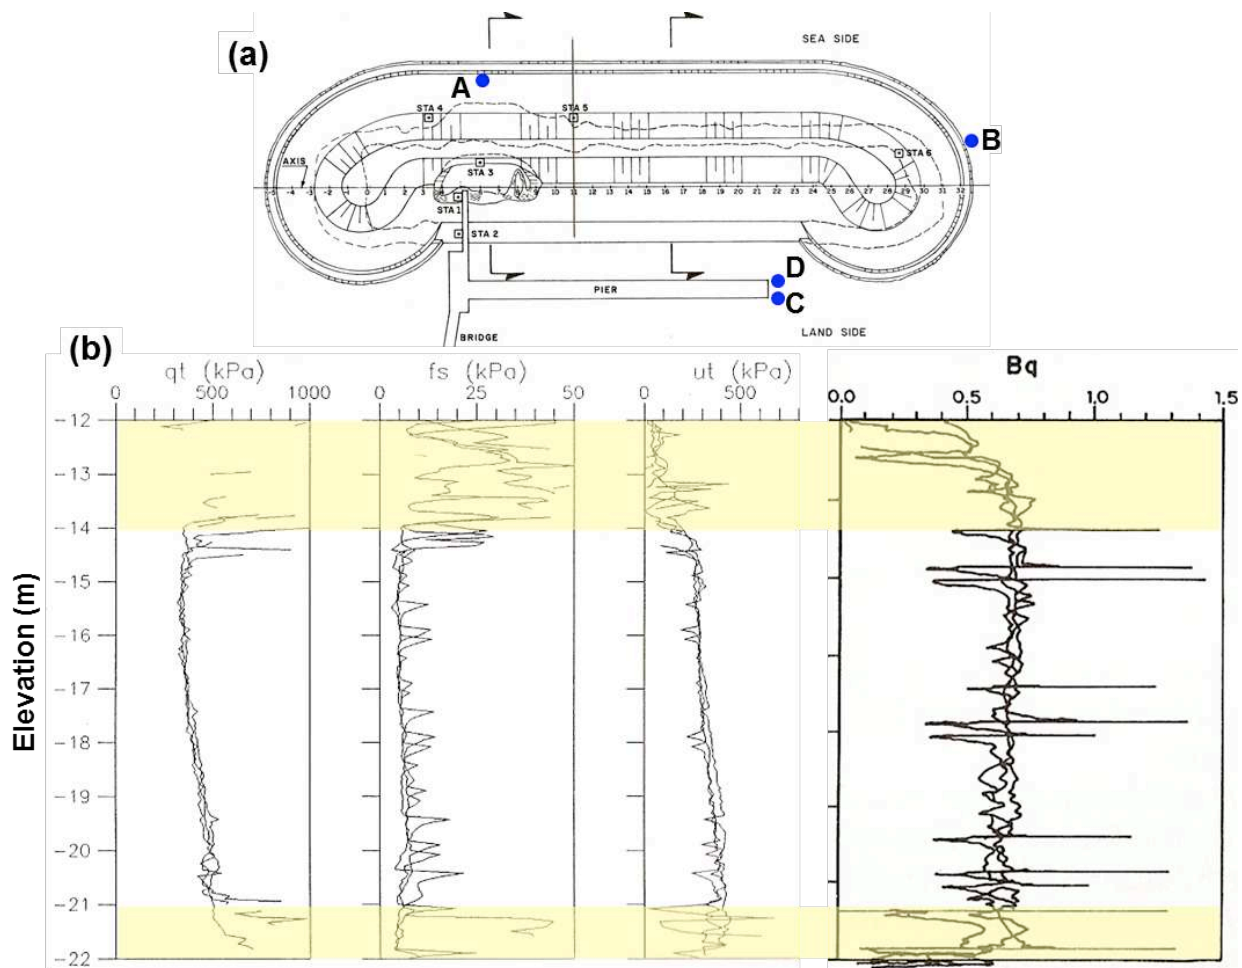
Thin tube piston sampling and field tests have been carried out at points A, B, C and D (see figure 6a). The results of piezocone tests (driving velocity 20 mm/sec, area of point 10 cm<sup>2</sup>) are summarily reproduced in this figure. It is worth noting that the results are remarkably uniform (values of  $q_T$ ,  $f_s$  and  $B_q$  in very narrow intervals, in spite of the distance of hundreds of meters between the points).

Figure 6. (a) Position of sampling and field tests (Dotted line in plan is the foot of the initial geotechnical berm); (b) Piezocone results at points A, B and C/D plotted together.

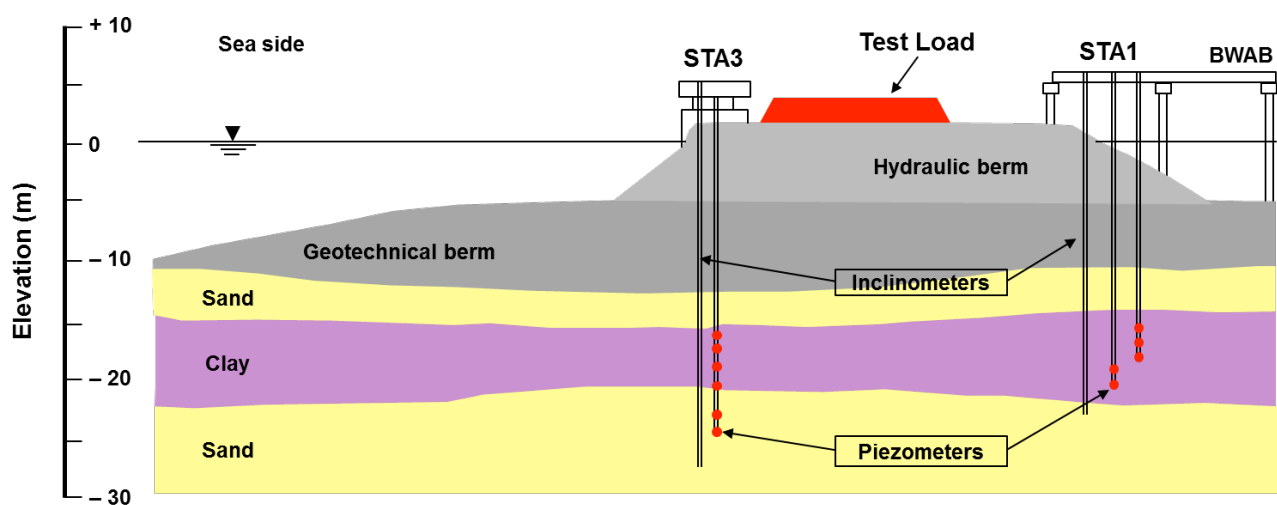
Soon after failure, in March, 1990, station STA3 with one inclinometer and six VW piezometers (see figures 4 and 10) has been installed to verify if the failed mass had stopped moving and also to observe the position of the failure surface.

To induce additional movement, a 2,5 meters thick, 25 meters long and 50 meters wide fill was placed over the part of the failed mass that remained above water, as sketched in figure 10.

Figure 10. Load test after failure and details about STA3.

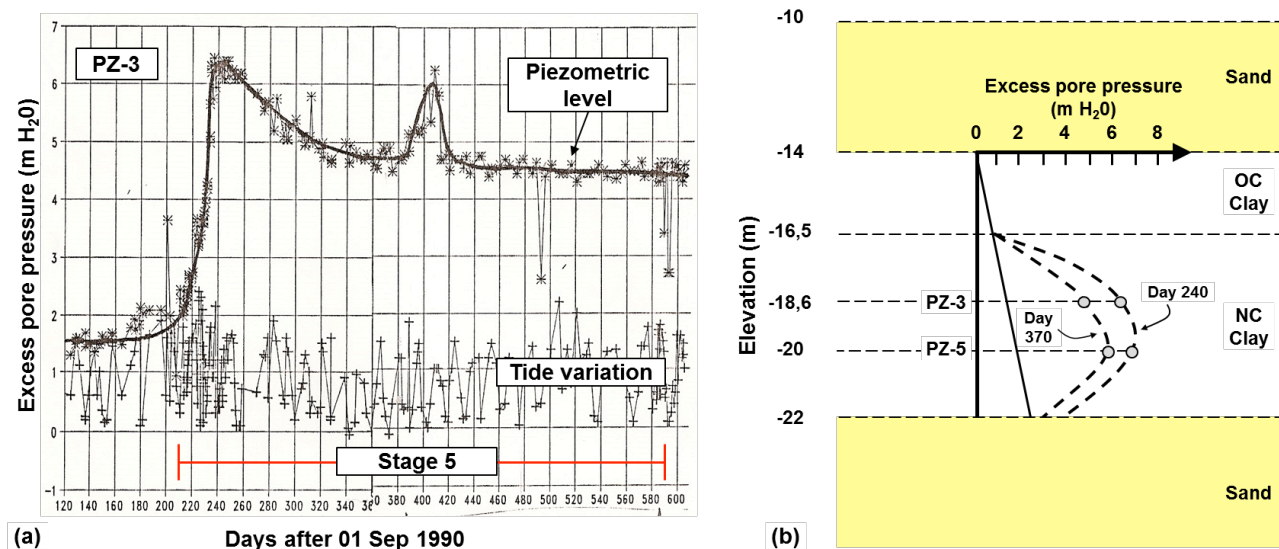
Figure 13a presents the monitoring of pore pressures in piezometer PZ-3 at STA4, installed at elevation -18,6 m. Figure 13b shows that the excess pore pressure varied in the expected way through Stage 5, decreasing as the consolidation progressed considering the existence of the aforementioned artesianism. Figure 13b also shows the result provided by the piezometer PZ-5, installed at elevation -20,0 m.

Figure 13. Monitoring of pore pressures at STA4 during Stage 5: (a) at PZ-3; (b) section showing PZ-3 and PZ-5 at different moments (estimated isochrones in dotted lines).

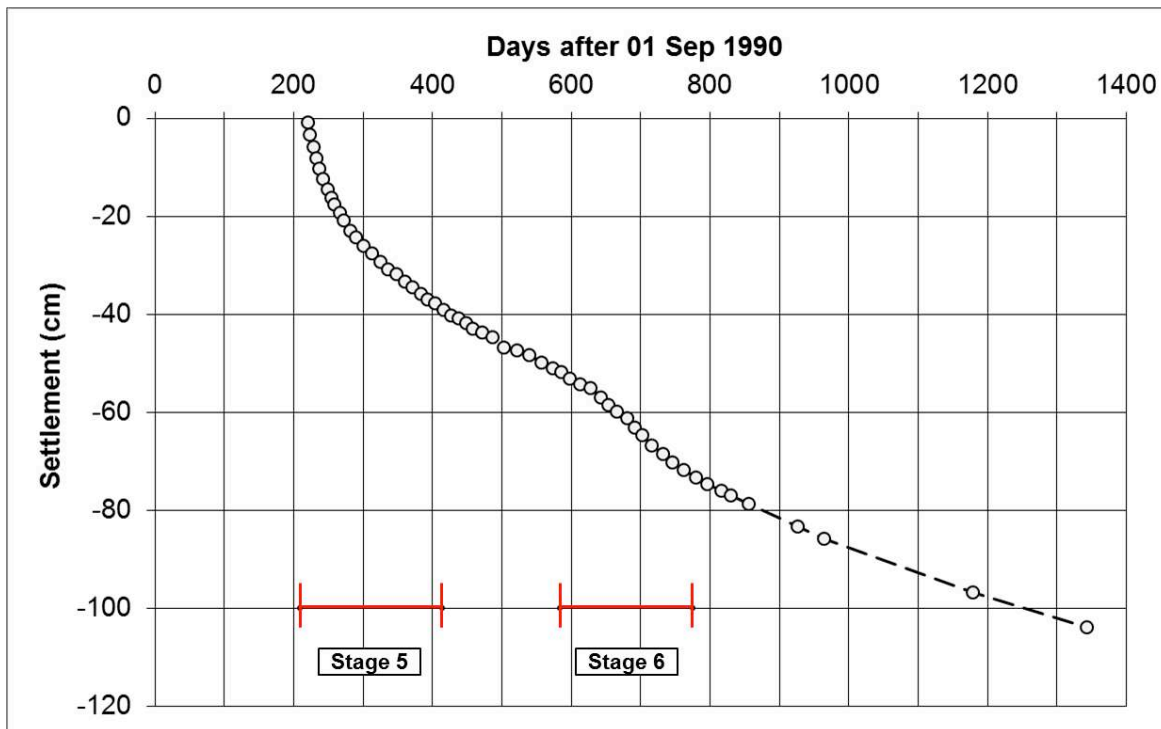
Settlements in excess of 1,0 meter have been measured in all the SD towers, from the beginning of Stage 5 to the end of construction. Settlements after the end of construction were lower than 75 cm, therefore guaranteeing that the crest elevation would remain above elevation +4,25, as desired. The monitoring of the monument SD3, measured from the beginning of Stage 5 until 19 months after the completion of Stage 6D is presented in figure 15.

Figure 15. Settlement measured at SD3TA4 since before Stage 5 until after conclusion of Stage 6.
