# Highway cut made in a rock formation with precarious stability

Herrera, S., Schmitter, J.J. & Colonia, J.  
*Free-Lance Consultancy, ICA & CONNET, Mexico City, D.F., Mexico*  
Macedo, V.H. & Reynoso, E.A.  
*CONNET & ICA, Mexico City, D.F., México*

The paper describes the peculiar deformational behavior observed in the vicinity of a 60 m tall highway cut, where the natural slope of the surrounding ground is of about 33% (18°). A description of the observed behavior and comments about its stabilization are included.

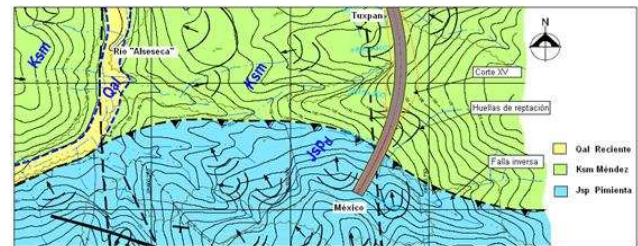
Figure 1. Topographic location of Cut XV

At the zone of Cut XV (Figure 1) rocks of the Méndez formation are found being in contact with Jurassic rocks of the Pimienta formation due to the inverse regional fault that lies immediately to the south.
