Stability slopes study of dams of Necaxa Hydroelectric System

Nicolás Melchor-García & Roberto Ruedas-Medina
Instituto de Investigaciones Eléctricas, Cuernavaca Morelos, México
Oliver Nava-Tristán
Comisión Federal de Electricidad, México.

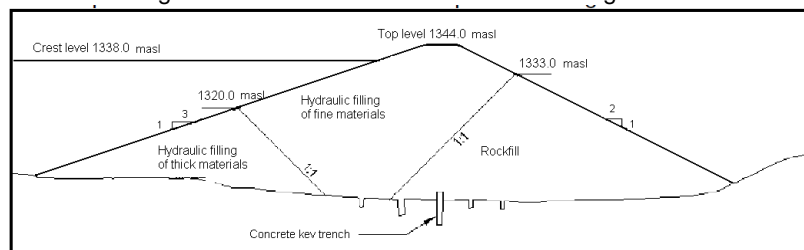
Figure 4 Maximum cross section of Necaxa Dam

Necaxa Dam is also composed of three materials (Fig. 4). Downstream is a rockfill of triangular section with a maximum height of 1333 masl. Upstream are placed heavy earth materials, with a maximum triangular section to 1320 masl. Among these materials is deposited hydraulic filling of fine grain size, with maximum elevation on the crest of 1344 masl. At the base of the curtain, along its axis and embedded in the foundation rock (basalt) there is one concrete key trench with variable depth, with a maximum of 15 m, and four trenches run parallel to the concrete key trench; two are located upstream and two downstream.

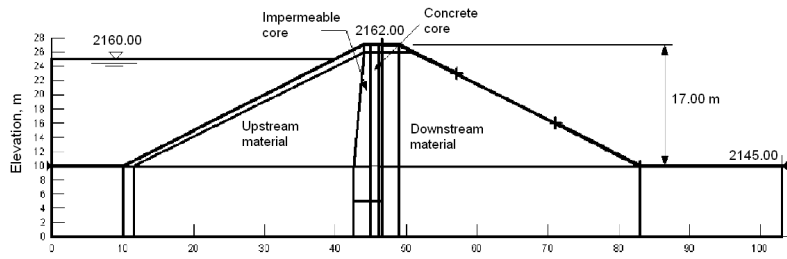
Figure 5 Maximum cross section of La Laguna Dam

La Laguna Dam, (Fig 5), is of earth core and concrete wall type. In the central part of the core, the concrete wall is one meter thick, and penetrates the dam foundation. In the area where failure occurred in the year of 1969, a cement-bentonite wall with a maximum depth of 26 m was built. The body of the dam is composed for three different types of earth materials. The upstream slope has impermeable material with very soft consistency (clay-sand). The downstream slope is composed of coarse materials (gravel and boulders) in a silt-clay matrix; they are very permeable. The core was made of gravel hand packed in fine material, with an intermediate degree of permeability.

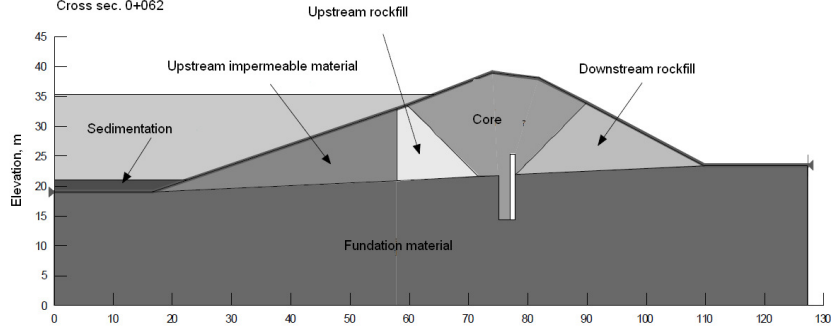
Figure 6 Maximum cross section of Los Reyes Dam

Los Reyes dam (Fig 6) consists of an upstream cofferdam and diaphragm of waterproof timber (built in a first stage) and a backup of earth and rockfill downstream. Between the two previous materials there is a space with trapezoidal section filled with material hydraulically deposited. The crest of the curtain was built with layers of clay compacted by hand. At the base of the curtain, along its axis and embedded in the foundation soil there is one concrete key trench with variable depth, with a maximum of 7 m. The downstream slope is composed of coarse material (gravel, boulders and blocks), packaged in silty-clay with low plasticity.

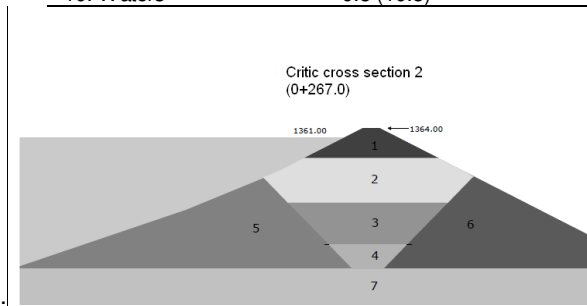
Figure 10. Critical section 2, Los Reyes Dam

The materials found in all the drillings on in the core of the curtain of Los Reyes dam have a heterogeneous composition, ranging from clay particles to sand and gravel. Therefore, an average value of resistance may be considered. The downstream slope is composed of plastic material overlying boulders and rocks packaged in fine materials. In this section of the dam, the Le Franc test showed high permeability.

One of the critical sections for analysis was selected where the body of the dam is founded on a natural slope which contains fine soil (silty-clay).

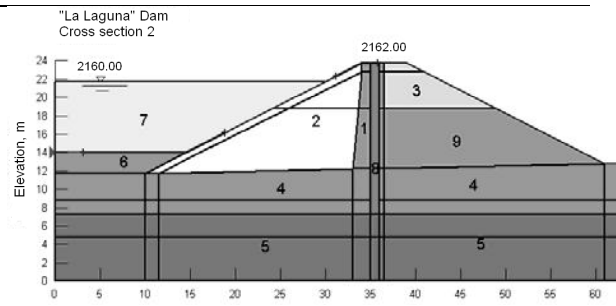
Figure 11. Critical section 2, La Laguna Dam

At La Laguna Dam, 4 borings were made in the core (9, 17, 20 and 21 m deep) and 6 boreholes on the slopes of the curtain to detect the thickness of rockfill that covers the fine earth materials (15 m deep). Permeability tests were conducted at different depths, both on the material of the curtain as on the natural support soil. The materials found in the upstream slope, in general show a soft, low resistance, with a high degree of uniformity in the longitudinal direction. The core material shows a large variability in permeability and resistance. In the most superficial zone there is low permeability silty material, which is followed by very permeable boulders and gravel. The foundation of the curtain is made up of cracked basalt rock with signs of injections in some places and disturbed basalt of varying thickness, also reported by Marsal and Resendiz (1975). Table 5 and Figure 11 present a summary of the material properties of the La Laguna dam.
