# Retrofit of a pile-supported bridge in soft clay damaged by failure of adjacent soil stockpile

Sy, A., Thavaraj, T. & Hamersley, B.  
*Klohn Crippen Berger Ltd., Vancouver, BC, Canada*  
Gillespie, D.  
*Ministry of Transportation and Infrastructure, Victoria, BC, Canada*

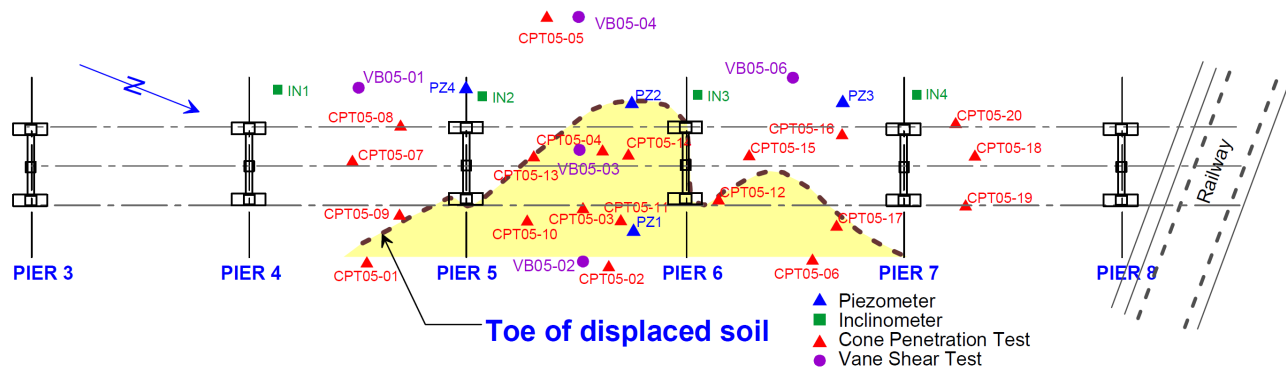
Figure 11. Locations of test holes and instrumentation, and toe of displaced soil

Site investigations consisting of cone penetration tests (CPT) and in-situ field vane shear tests were carried out in and around the significantly displaced piers and soil failure area. Inclinoimeters and piezometers were also installed to monitor lateral ground movement and pore pressures, respectively. Figure 11 shows the locations of the test holes and instrumentation, as well as the approximate outline of the displaced or heaved soil around Piers 5 to 7. Note the soil stockpile was on the east side (bottom of figure) of the bridge.

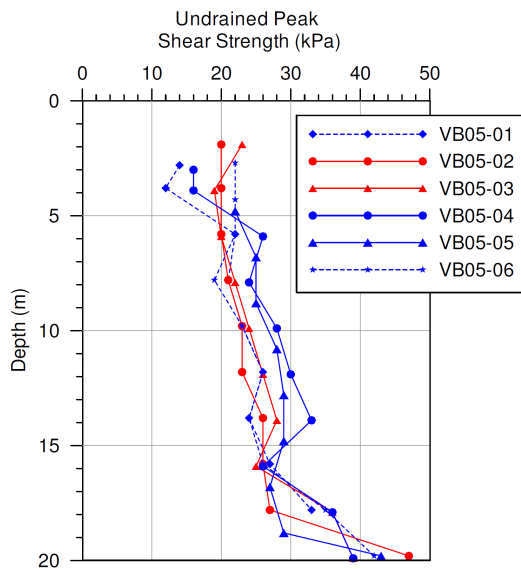
Figure 12. Undrained peak shear strength profiles from field vane shear tests

Figure 12 shows the peak undrained shear strength profiles obtained from field vane shear tests carried out inside (red lines) and outside (blue lines) the failure area. The vane shear test results were not able to definitively differentiate between the disturbed clay in the failure area and the undisturbed clay outside the failure area.

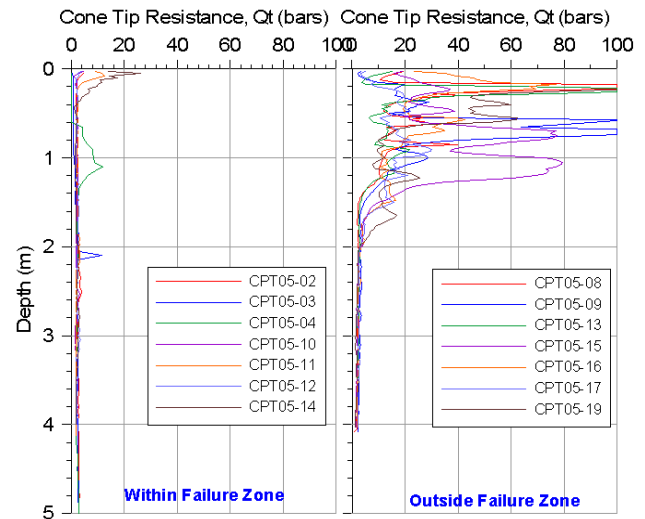
Figure 13. CPT tip resistance profiles

Figure 13 shows cone tip resistance profiles of the CPTs separated into two groups or plots: within failure area (left plot) and outside failure area (right plot). Note the CPTs within the failure area clearly show absence of the typical 2 m thick clay crust that is evident in the CPTs performed outside the failure area.

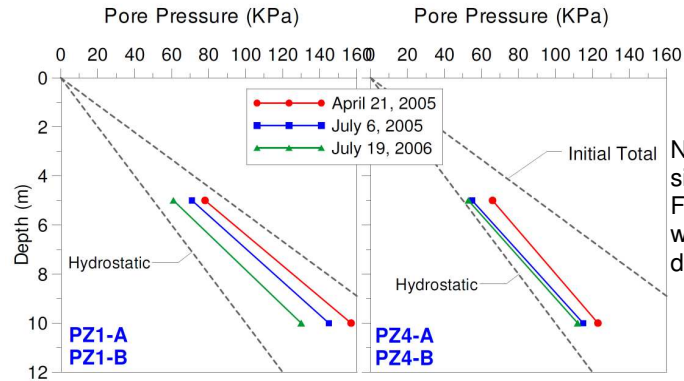
Figure 14. Measured pore pressures in piezometers PZ1 and PZ4

The piezometer data indicated high excess pore pressures existed in the ground, even one and a half years after the soil failure, particularly on the east side of the bridge. There was very slight dissipation during that period (see Fig. 14).

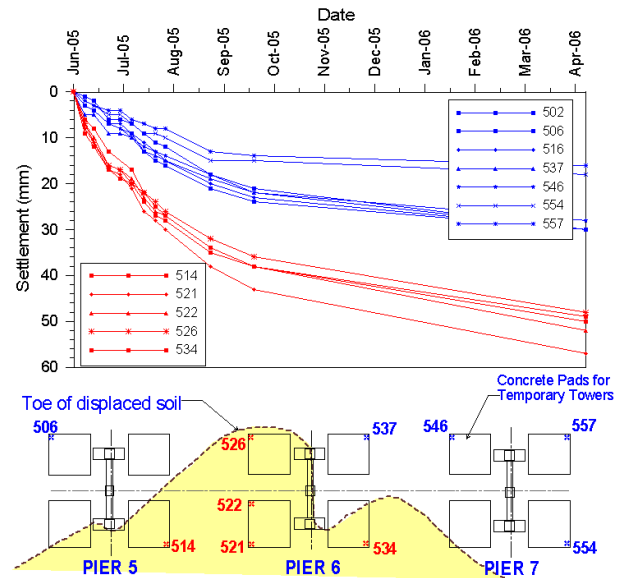
Figure 18. Time vs. settlement plots of the temporary tower concrete pads, and location plan

Figure 18 shows typical time-settlement plots of the temporary tower concrete pads, as well as a location plan. Note the significantly higher settlements recorded on pads within the failure area (red curves), compared to those outside the failure area (blue curves).
