Foundation Drainage Performance at Gordon Dam

S. GIUDICI

Section Engineer, Structures Section, Hydro-Electric Commission, Tasmania

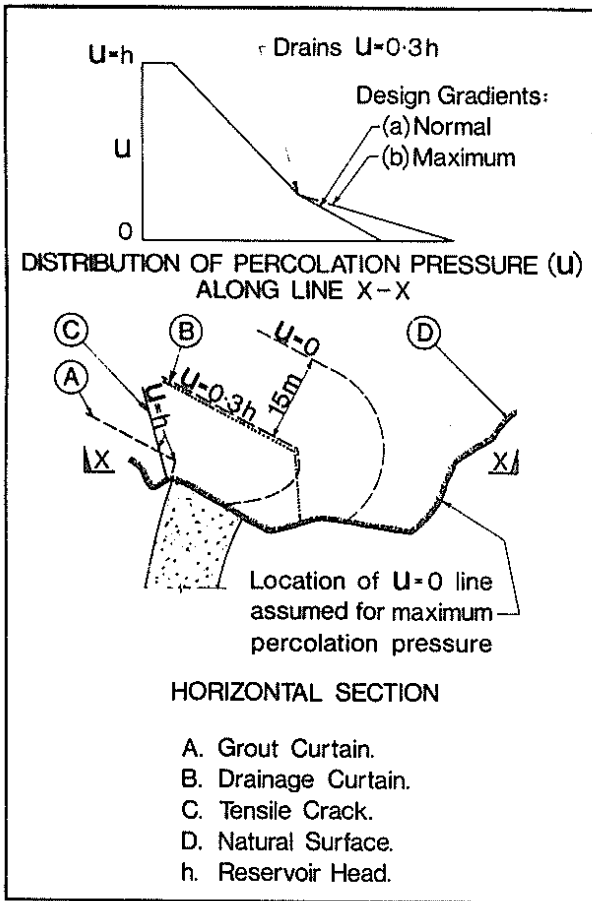
Figure 1 Design pore pressures (after Allen (1971))

Allen (1971) discusses the philosophy of drainage and grouting curtain location, and indicates the percolation pressure distributions which were used in the stability analysis. The positions of the drain and grout curtains are shown on Fig. 1, which also shows in diagrammatic form the distributions of pressure used for the stability analyses.

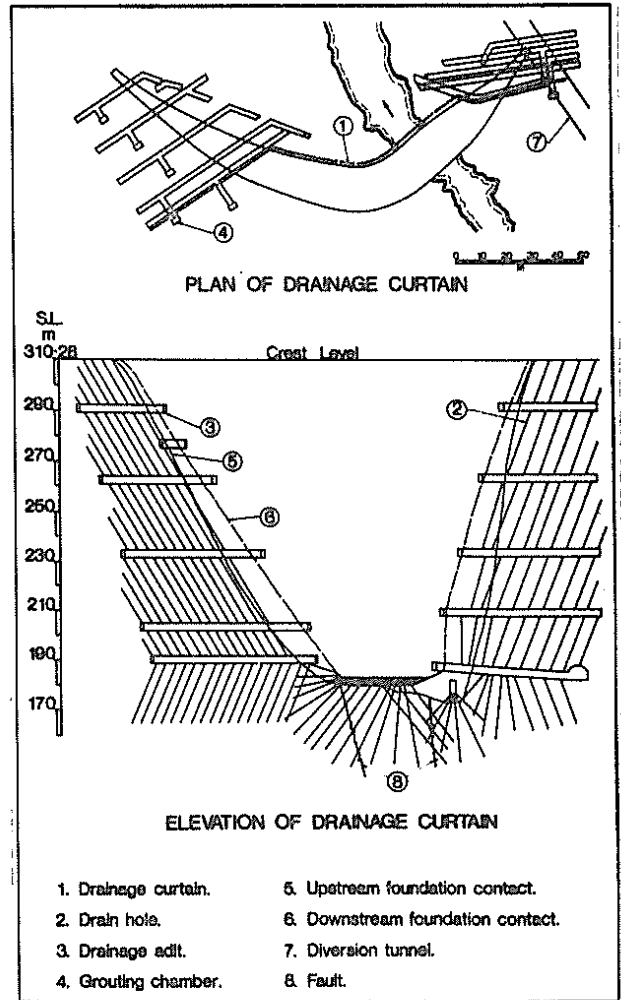
Figure 2 Drainage curtain layout

Drainage for the dam abutments was achieved by a series of adits about 30 m apart in elevation, oriented in the general direction implied in Fig. 1. Fig. 2 shows the layout, with a series of 75 mm holes at 4 m spacing on the left abutment and 6 m on the right, drilled from one adit to the next below. In the area between the top-most adit and the crest of the dam, holes were drilled upwards in the same general plane as the holes below. Similarly, in the lowest adits, holes were drilled from the invert to levels below the dam. Around the base of the dam, a network of about 34 holes collared near the downstream toe was sunk to intersect known faults and joints. Advantage was taken of a second stage diversion opening in the dam, at foundation level near the right abutment, to drill a fan of holes underneath the dam. Water from these was piped to the downstream side when the opening was backfilled.

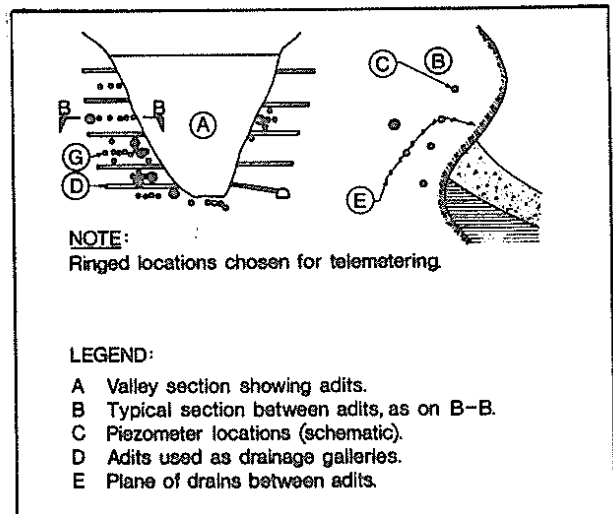
Figure 3 Piezometer location

Seven piezometer locations (six on the left, one on the right, shown ringed in Fig. 3) were chosen for remote monitoring, via a telemetry system, which also monitors twenty other instruments in the dam. It has been possible to telemeter for monitoring at very little cost, as a by-product of the remote control system for the nearby power station.
