Copeton Dam Spillway -- Geological Investigations and Performance

SUMMARY The geological investigations undertaken in connection with the design and construction of Copeton Dam spillway are described, together with the factors influencing the spillway location and type of structure finally constructed. Following two minor discharges through the spillway extensive scour occurred in the discharge area, which necessitated additional geological and engineering investigations including stress measurements and resulted in remedial and additional construction work being performed at a total cost of \$1.3M. The fundamental cause of the problem was found to be the occurrence of high horizontal stresses of up to 20 MPa in the rock over this area. The mechanism of spillway scour here encountered is thought to be unique.

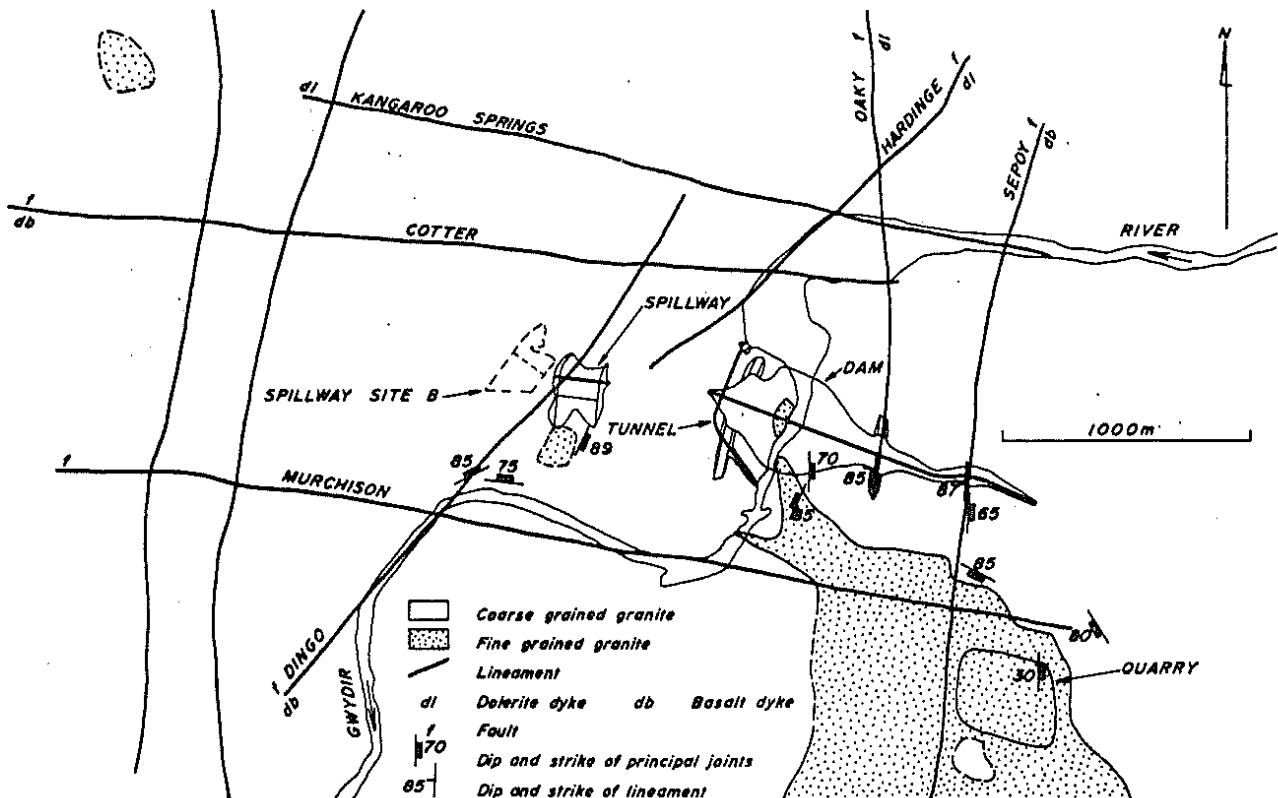
Figure 1 Regional Geology of Copeton Dam

Copeton Dam is located in an area of coarse grained porphyritic granite of Permian age which has been intruded by one main mass of fine grained granite and a number of smaller such bodies. Later intrusion by a series of dykes of basaltic composition of probable Tertiary age has occurred along a number of well defined orientations to produce a series of lineaments easily observable in aerial photographs, Fig. 1. The spillway is located in a saddle about 500 metres from the dam along the right hand ridge in predominantly coarse grained granite intersected by the Dingo lineament which crosses the saddle. The granite in the saddle is more deeply weathered than is generally the case in this area and these poorer foundation conditions for the structure were realised early in the investigations.
