Stabilisation of a Mudstone Derived Colluvium Slope

G. RAMSAY

Design Engineer, Ministry of Works and Development, Wellington, N.Z.

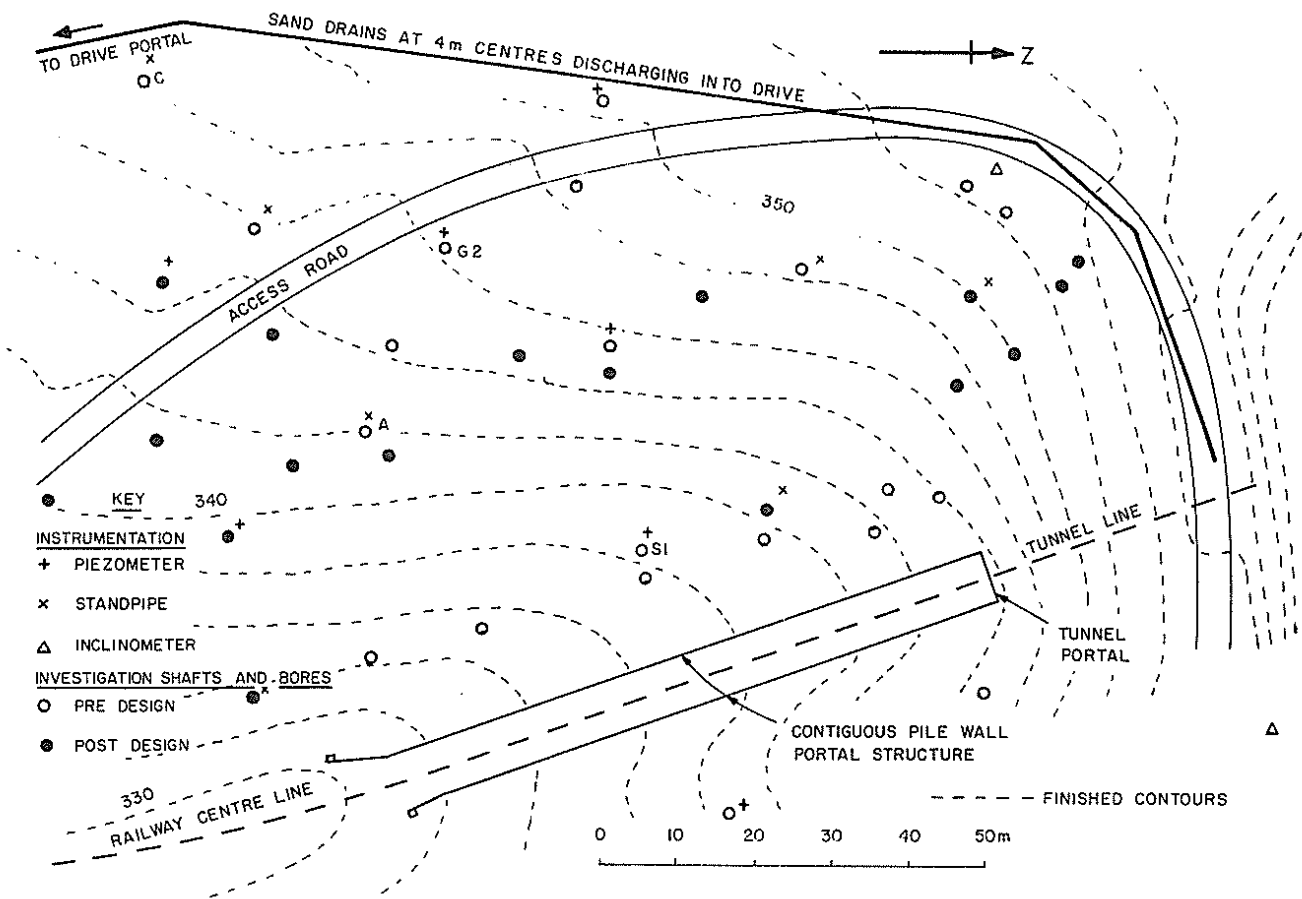
FIG. 1 LAYOUT OF SOUTH PORTAL PORO-O-TARAO TUNNEL

Locations of the drainage drive, sand drains and portal structure are shown on Figure 1.

The locations of the instrumentation stations are shown in Figure 1.
