Stress Induced Roof Collapses During Construction of the Sydney LPG Storage Cavern

Summary: This paper discusses the experience of the authors with two large failures that occurred in the roof strata of a storage facility for LPG which was being constructed deep below the ground surface in Hawkesbury Sandstone in the Sydney Basin, NSW, Australia.

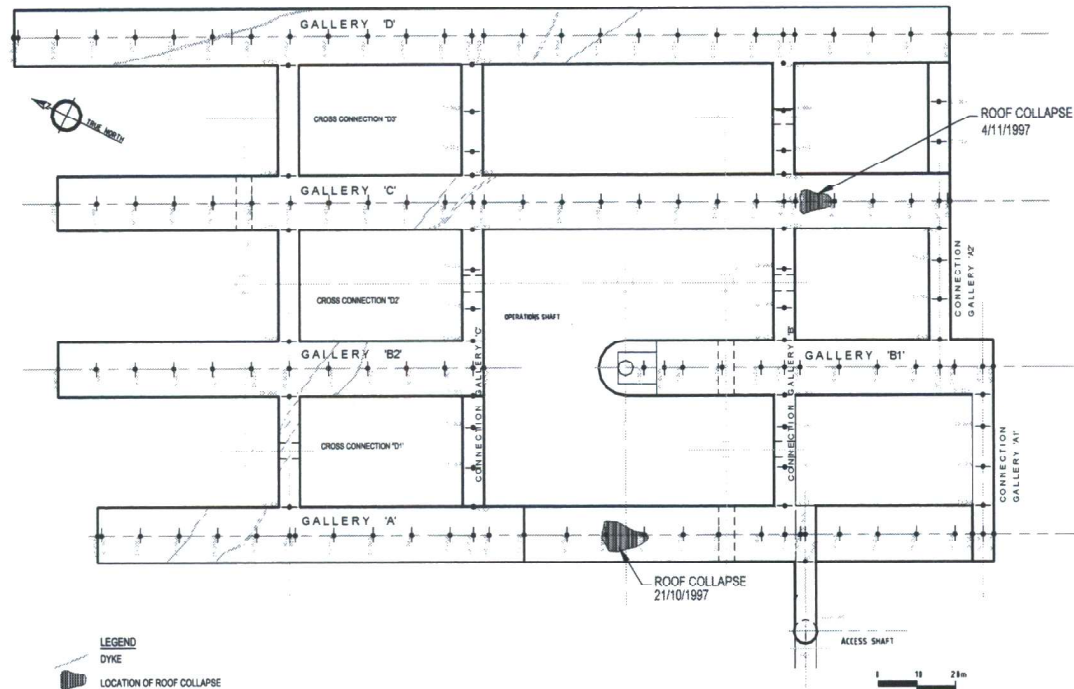
Figure 2. Plan of Storage Facility

The collapse occurred either during or immediately after the perimeter blast of the western strip at chainage 096m, when the pilot heading was at face chainage 104m. The collapse occurred from chainage 089m to 102m and over a roof span width of up to 7m (refer to Fig 2). The failed material ranged in thickness from 1m to 1.5m into the roof in sheet facies sandstone strata. At the time of the failure none of the rock bolts had been grouted.
