# Monitoring and Remediation of a Slow Moving Landslide

**Summary:** An area in the township of Clifton Springs called The Dell is a prominent coastal amphitheatre feature of the Bellarine Peninsula in southern Victoria. The local community and visitors to the area have used The Dell as a safe access point to Corio Bay and for its recreational facilities.

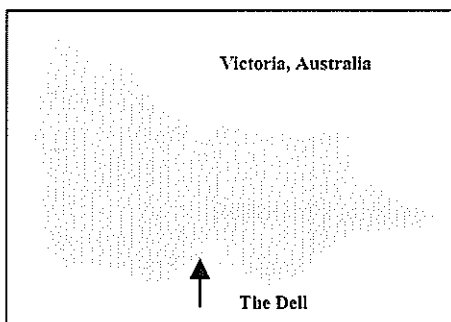
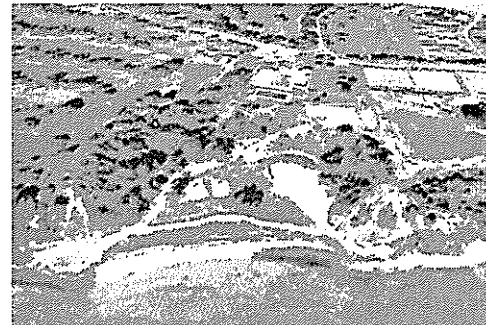
Figure 1. Location Plan and Aerial Photograph

The Dell (Figure 1) is located on the foreshore of Clifton Springs on Bellarine Peninsula, Victoria. The springs have been known for a long time dating back to the early 1800's. Development of the springs commenced in the 1870's with a hotel and resort being constructed by 1880. The hotel was destroyed by fire in the mid 1920's and the wells and pipework associated with the springs have since fallen into disrepair. Since this time, the Dell has provided an easy access point to the bay and foreshore and has been only recently redeveloped by the City of Greater Geelong through the installation of children's playground and barbeque facilities. The site is about 150m long and 100m in width. The lowest levels on the site are at sea level (RL0m) and the crest of the steep slopes is at a level of around RL 30m.
