Large Debris Flows in the Townsville Urban Area and Associated Remedial Works.

Summary: Landslides and Debris Flows have occurred in Townsville, Queensland, during intense tropical rainfall events. This paper describes two recent debris flow events, their effects on infrastructure and the remedial works undertaken.

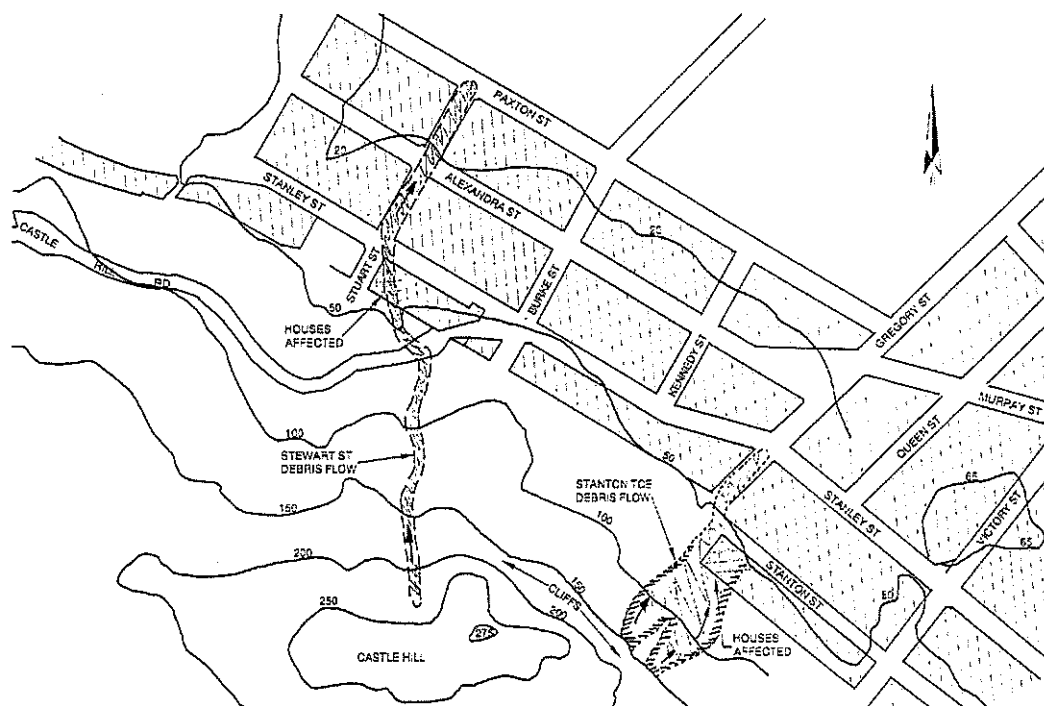
Figure 1, Location of debris flows from Castle Hill

On the evening of 3 April 2000, two debris flows initiated high up on the slopes of Castle Hill, and debris flowed rapidly down gullies and hill slopes until deposited behind, in and around five houses at Stanton Terrace and along Stuart Street. Locations are shown in Figure 1, and an overall view of the Stanton Terrace debris flow is presented in Figure 2.
