# Remediation of a Major Urban Rock Slope - Howard Smith Wharves, Brisbane

C.B. Thorley<sup>1</sup>, B.E. MIE(Aus), RPEQ and T. Weingarth<sup>2</sup>, B.E.

Howard Smith Wharves on the Brisbane River near the Central Business District (CBD) are currently being redeveloped as open space parkland. Overlooking the parklands is a 25m high, 500m long, vertical cliff face formed progressively by quarrying over the last 150 years. The cliff face consists of two dominant rock types, the Brisbane Tuff and phyllites of the Neranleigh Fernvale Beds. Between the two rock types and exposed in the face is probably the best example of a Triassic age unconformity in the Brisbane region. Prior to parkland construction, the first stage of redevelopment consisted of the design and construction work necessary to stabilise the cliff face. For architectural and space reasons, the adoption of rock fall fences or rock fall zones was not possible, hence the stabilisation works had to ensure the cliffs were remediated to a standard where the risk to park users was as low as possible. Potential future uses of the park also included recreational rock climbing on the cliffs, requiring minimal artificial chang

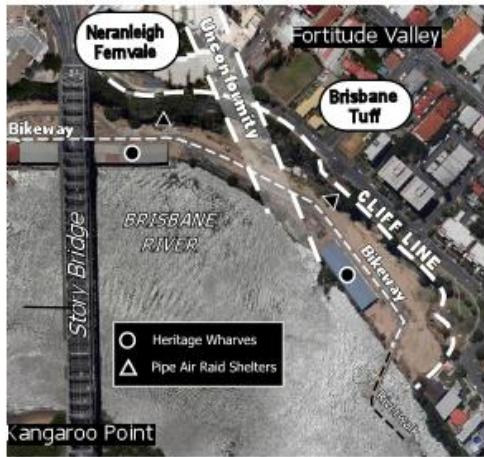
Figure 1 - Aerial view and main site features

Brisbane City Council procured the land in the 1990s however it remained unused apart from a fenced off strip through the middle used as a pedestrian path and bikeway connecting the Floating Riverwalk at New Farm with the Riverside bikeways through the CBD. An aerial view of the site is shown as Figure 1. Forming the northern edge of the site is a 500m long vertical cliff, generally 20m high but up to 25m high in places. These cliffs were partly formed during wharf construction in the late 1930s, but historical photographs show quarrying operations on the site as early as the 1880s (National Library of Australia, 2012). The cliffs have not been stabilised or maintained over their lifetime and were prone to frequent rock falls and small collapses. For this reason a 20m to 30m wide zone along the base of the cliffs had been fenced off to prevent public access.

The cliff face and the wharf site occur on the boundary of two distinct geological formations. These are the Mesozoic age Brisbane Tuff and the Palaeozoic age Neranleigh-Fernvale Beds, as shown on Figure 1. The Brisbane Tuff is a porphyritic rhyolite tuff and typically occurs as a massive widely jointed rock of high to very high strength. The Neranleigh-Fernvale Beds are comprised of phyllite, a slightly metamorphosed and foliated fine grained marine sediment. The Tuff is thought to be about 40 million years younger than the underlying Neranleigh-Fernvale Beds, and the contact between the two forms a geological unconformity. This overlying Tuff forming the unconformity is generally considered to be 220 million years old and deposited as a result of one or at most several massive pyroclastic ash flows.
