# Identification, Management and Reduction of Slope Instability Hazards within the Wellington Regional Metro Railway, New Zealand

R. Justice<sup>1</sup>, MSc, TMIPENZ and G. A. Cassidy<sup>2</sup>, MSc, CEng (UK), MIMMM, FGS.

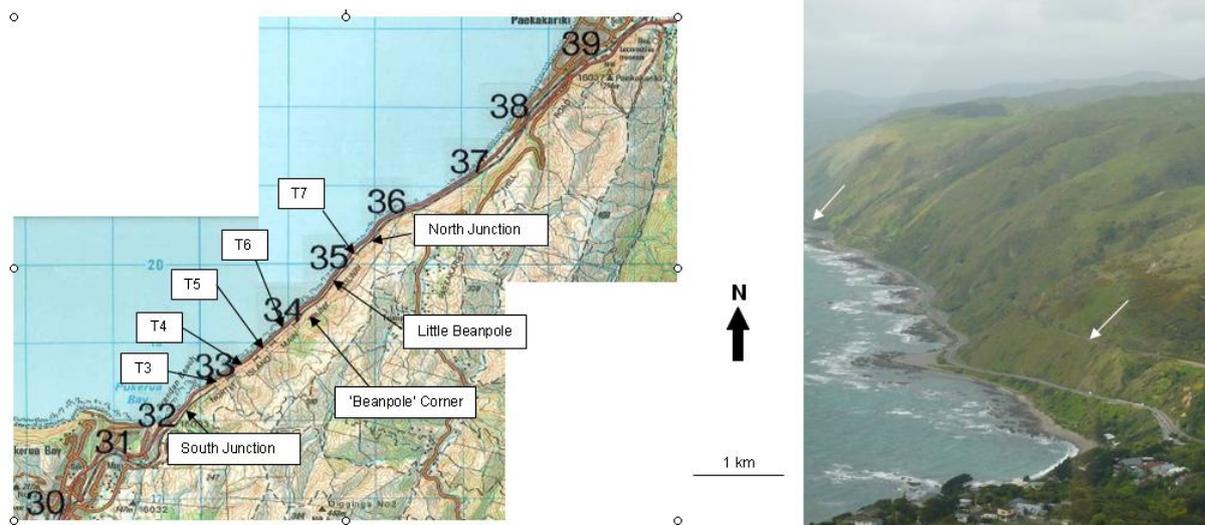
NSJ is located at the foot of a steep, high coastal escarpment, which has an average slope of between 35° to 50° and rises to just over 300m above sea level (Figures 5 and 6). The escarpment is an old wave-cut platform and is now covered in grass and regenerating bush. The railway is constructed on a cut bench which rises from approximately 6m above sea level at the northern end of the section to about 60m near South Junction.

Figure 5 & 6: Location of North –South Junction of the NIMT and Key features (T – Tunnel). Location of track indicated by white arrows.
