# Evaluation of Full Scale Levee Stability Tests at Booneschans and Corresponding Centrifuge Tests

The IJkdijk project is an international test site for inspection and monitoring techniques for levees. The objectives are two-fold: firstly, to develop and validate new sensor techniques and secondly to perform full-scale failure experiments on levees to understand fundamental behaviour in order to be able to increase the quality of the inspection process and safety assessment of levees. The final goal is to be able to respond timely with appropriate measures. The experiment that will be focused on in this paper is a stability test. In the beginning of 2008, a preliminary full-scale test has been performed to determine the characteristics of the subsoil in the area. The results of this test are needed to optimize the full-scale, heavily monitored levee stability failure test, which is executed in the end of 2008. The full-scale tests also have been simulated on a much smaller scale in centrifuge tests. The paper illustrates the applicability and benefits of modern sensor technology by one of the measured parameters, the horizontal deformations. They seem to indicate trends, already h

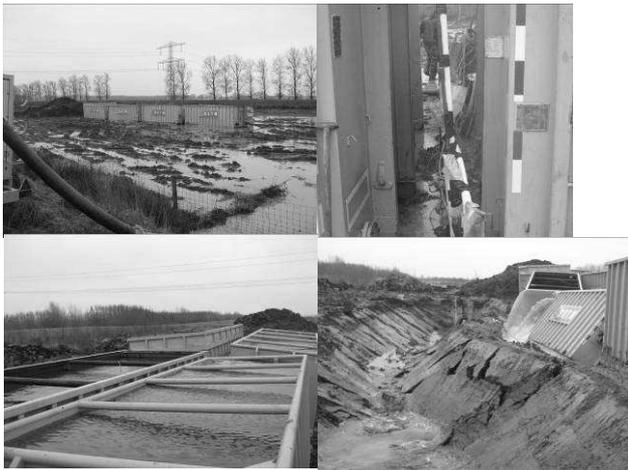
In this test two rows of four containers each represented an embankment. By filling the containers with water a load could be activated almost instantaneously. During a period of a week the decrease in excess pore pressure is measured. Next, the containers were emptied and at a distance of one metre from the front container row a ditch is excavated. During excavation the ditch was filled with water. After draining the ditch, the containers were filled again. For the first 25 minutes, no deformation could be observed visually. Then, horizontal displacement of the slope of the ditch was observed, leading to progressive failure of the subsoil 2 to 3 minutes later. Figure 4 shows an impression of the stages of the preliminary test.

Figure 4. a) Overview preliminary test b) Measurement row at the centre of the container row c) Filling of the containers d) Failure

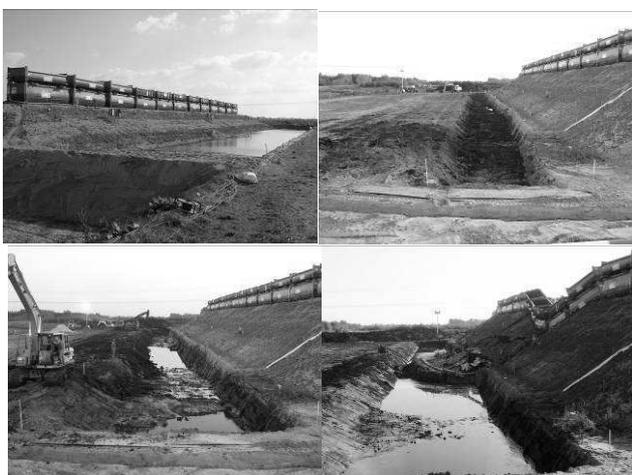
The construction phase of the test embankment started on August 13<sup>th</sup> 2008 and was finished on September 19<sup>th</sup> 2008. The test started on September 25<sup>th</sup> by filling the bathtub in front of the dike, see Figure 8a. Later that day the top clay layer was excavated, see Figure 8b, at the toe of the dike. On September 26<sup>th</sup> the ditch was fully excavated, on to the top of the sand layer, see Figure 8c. On September 27<sup>th</sup> the sand core was filled with water. The filling started at 12:07h, at 16:00h deformation could be observed visually, failure was found at 16:02h, see Figure 8d.

Figure 8. a) River side of the dike, b) Inner side of the dike during excavation of the ditch, c) Inner side of the dike after excavation of the ditch, d) Failure
