## Prediction versus performance of Land Reclamation Bund

C.F. Leung, S.A. Tan & R.F. Shen

*Centre for Soft Ground Engineering, Department of Civil Engineering, National University of Singapore*

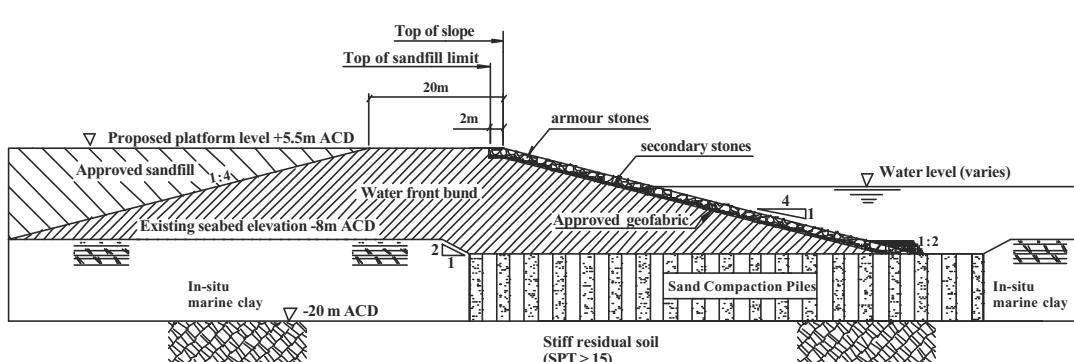
Figure 1 Typical water front bund design scheme

Prior to the placement of landfill in a reclamation project, a perimeter bund which may stretch tens of kilometers in length needs to be constructed. Fig. 1 shows a typical design scheme of a water front bund in Singapore with the seabed located at -8 m ACD (Admiralty Chart Datum). The deep deposit of the underlying soft marine clay extends to approximately -20 m ACD. To prevent potential slope failure, the underlying soft marine clay is reinforced with sand compaction piles (SCP) with a replacement ratio ranging from 30% to 50%. The lateral extent of the SCP is 5 m behind the crest of the slope and 10 m beyond the toe of the seaward slope. The SCPs are installed through the entire depth of marine clay and rest on the underlying stiff residual soil. The desired factor of safety for the bund against global slope failure is at least 1.5. How ever, it has been reported occasionally bund failures have occurred during bund construction despite adopting a high safety factor value. The causes of slope failure are often unknown and there are many possible factors involved such as overfilling, uncontrolled bund slope gradient, unforeseen underlying soil profiles and strengths, as well as deviation of alignment of bund from designed positions. In this paper, parametric studies are performed to examine various factors to evaluate the peformance of water front bund and to identify the degree of risks these factors pose to the bund stability.

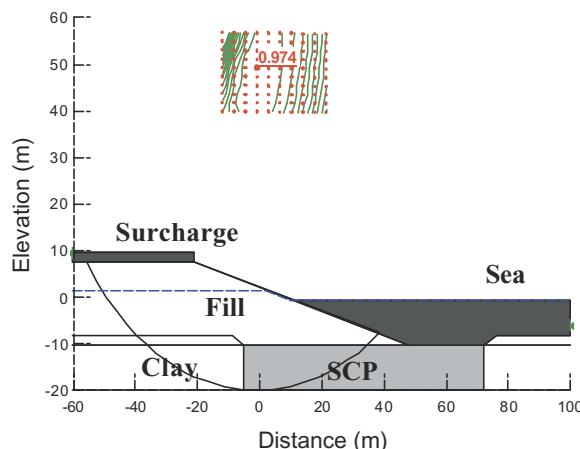
Figure 2 Failure of bund slope under a combination of adverse conditions

It should be noted that none of the single factors alone listed in Table 1 can trigger the bund failure. However, when several adverse conditions happen simultaneously at the same location, bund slope failure may become imminent. For example, if factors 2, 3 and 5 in Table 1 occur simultaneously at the same location, namely the underlying soft marine clay is weaker than typical value, the bund alignment deviates landward for say 13 m relative to the SCP, and the bund has been overfilled too fast to +7.5 m ACD without proper control, the bund slope will fail with the factor of safety dropping below unity, as shown in figure 2. It is likely that localized concurrence of several adverse conditions will trigger local failure of the bund slope and propagates progressively to larger areas leading to catastrophic effects.

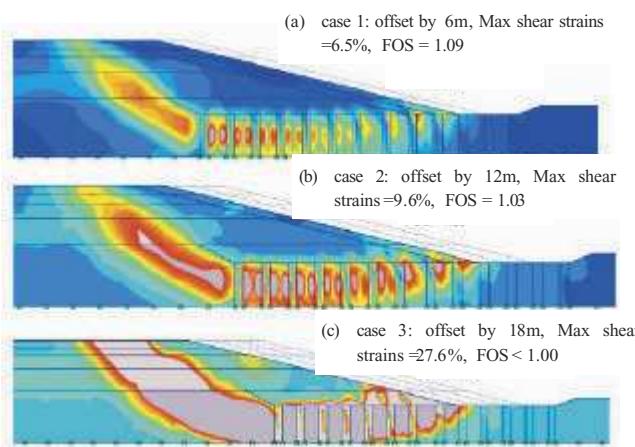
Figure 3 Shear strains for 7.5m bund with bund alignment offsets by (a) 6m (b) 12m and (c) 18m

clearly shows the significant impact of the offset of bund alignment on the slope stability. As shown in Fig. 3, with the bund offset increases from 6m (case 1) to 12m (case 2), the FOS reduces from 1.09 to 1.03. When the offset reaches 18m (case 3), the FOS drops below unity, indicating a slope failure. The maximum shear strains also increase from 6.6% to 27.6% from case 1 to case 3 as shown in the figure.
