Building response to tunnel step-plate junction construction - the former Lloyds Bank Building, St James's, London

ABSTRACT: The former Lloyds Bank building, located in the St James's area of London, was affected by the construction of the step-plate junction that connects the southbound tunnel of the existing Jubilee Line and the eastbound tunnel of its new extension. The step-plate junction is located directly below the building footprint. As a protective measure, compensation grouting within the underlying London Clay was implemented from a shaft sunk adjacent to the building, to control the tunnelling-induced ground movements and building deformations. The response of the building to the construction activities was monitored by various methods, including precise levelling in the basement and total station surveying of the facades. The results of this monitoring together with contours of grout injection intensity are presented in this paper together with a discussion of the observed response of the building. The maximum building settlements resulting from the construction works of about 20 mm increased by about 10 mm in the following two years. Horizontal strains and displaceme

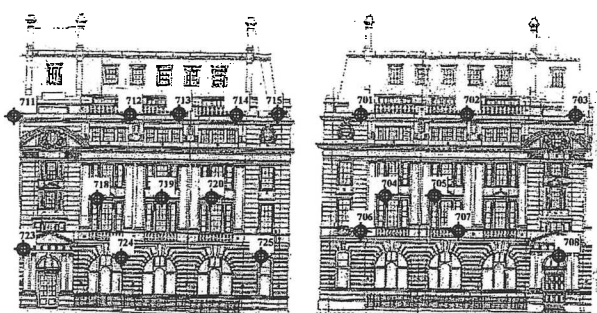
Figure 4. Layout of facade monitoring targets.

Monitoring of the St James's Street and King Street building facades was undertaken using a high precision, Leica TC2002, total station. Measurements were made to retro-reflective prisms fixed to the two facades at roughly three levels. The layout of targets is shown in Figure 4.

measurements. It should be noted that the retro-reflective targets used for the total station measurements extended beyond the Lloyds Bank part of the St James's Street facade (i.e. points 721 and 722). In the following figures 723 roughly corresponds to the position of precise levelling point 35 and the enlargement of the existing Jubilee Line tunnel was roughly beneath point 724 (see Figures 3 and 4).

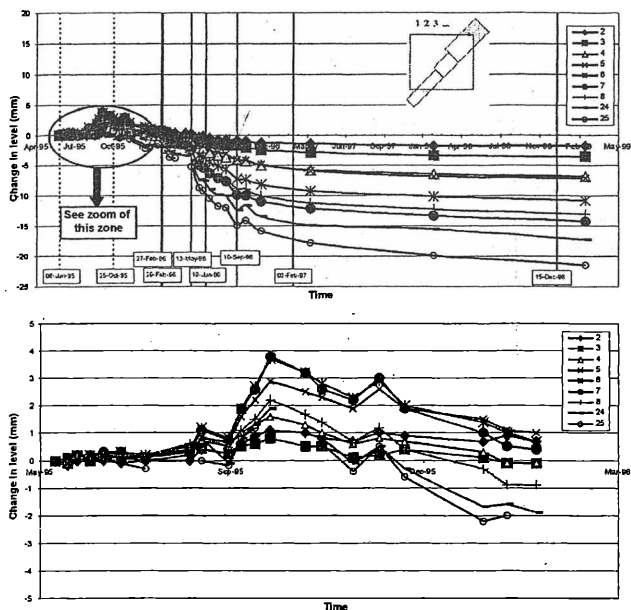
Figure 5. Precise levelling data from points along the rear wall of Lloyds Bank (see insert) plotted against time.

Precise levelling data from points installed in the rear wall parallel to St James's Street are plotted against time in Figure 5. Data for the entire monitoring period are shown along with an enlargement relating to the initial period. The dates marked on the first plot relate to dates of total station surveys.

Data from the overall monitoring period indicate that during the construction of the pilot tunnel and enlargements (starting at the end of February 1996, i.e. roughly corresponding to the first total station surveys, and finishing 25 September 1996) there was a progressive settlement increasing towards the step-plate junction. The greatest settlement was about 15 mm, immediately over the largest section (i.e. point 25, see Figure 3). The small reversal in settlements just after this time, clearly visible for points 24 and 25 (see change just after total station survey of 10 September 1995), resulted from the final phase of compensation grouting. The influence of grouting prior to that time is barely discernible, although concurrent grouting took place during the course of the step-plate enlargement, as discussed in the next section. The maximum long-term consolidation settlements are about 8 mm, again directly above the largest opening, the rate of settlements can be seen to be reducing.

The enlarged section of data is shown to illustrate the effects of TAM installation and give an indication of the accuracy of the readings. The heave of points 4 to 8 is a consequence of the spacing of the TAMs and their sequence of installation. At the lo-

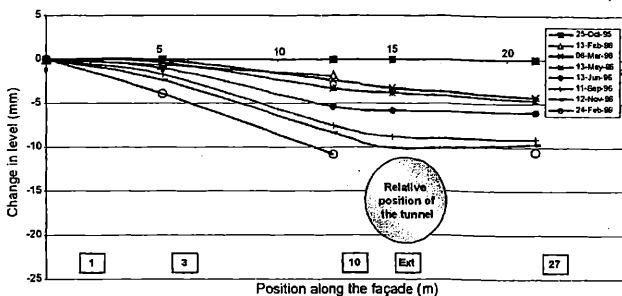
Figure 7. Precise levelling data transverse to the 6.5 m section of the step-plate junction plotted against distance.

Precise levelling data plotted against distance along lines transverse to the 6.5 m step-plate section and longitudinal to its four sections are given in Figures 7 and 8. The data are discussed in terms of three general periods. The first, from the start of monitoring to May 1996, corresponds to the sinking of the ground treatment shaft, subsequent TAM installation and conditioning, and eastbound running and pilot tunnel excavation. Observed movements were small,

The second period, from June until October 1996, when the excavation of the step-plate enlargements and concurrent grouting took place, resulted in more significant movements. Differential settlements of up to about 10 mm occurred along the rear wall of the building and along the line of the step-plate itself (Fig. 8). By this time there was a maximum settlement of about 15 mm above the 10 m section of the step-plate. The maximum resulting deflection ratio was compressive and less than 0.02 %. Other settlement profiles plotted along different lines within the building show smaller differential movements. The overall pattern of movement suggests that the building responded in a relatively rigid manner to the underground construction works with a maximum slope, in the transverse sense of about 1:1700. Most settlement occurred directly above the 8 and 10 m sections of the step-plate with a small rotation that caused an apparent heave at the opposite corner (apparent because the movement is relative to point 1).

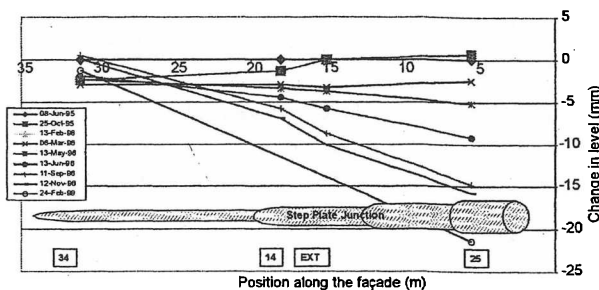
Figure 8. Precise levelling data roughly parallel to the step-plate junction plotted against distance.

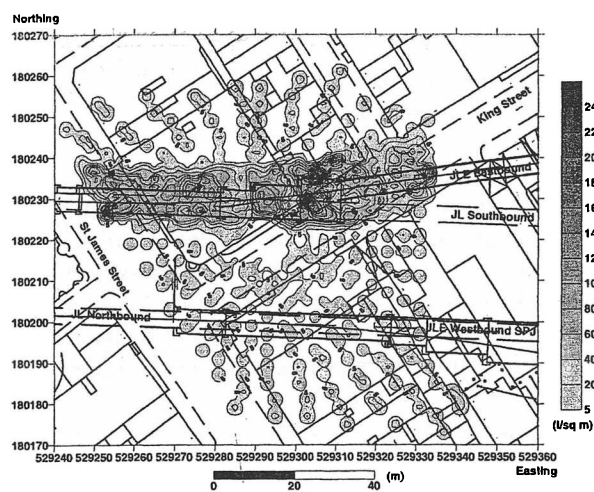
Figure 9. Grout density contours for entire period of grouting.

The total volume of grout injected beneath the Lloyds bank building during eastbound SPJ construction is presented in Figure 9.

the excavation works and the concurrent compensation grouting (see Fig. 9). At the end of the monitoring period, the maximum settlement was just over 30 mm. The effect of using an internal point as datum for the precise levelling measurements is evident when comparing respective survey points 25 and 708 (see Figures 8 and 11). There is a difference of about 8 mm between their apparent vertical displacements, but the points are only a short distance apart. This indicates that point 1 also underwent settlement. It is possible that the point used as a datum for the total station measurements was also affected by tunnelling settlements, but these were probably negligible at that location.

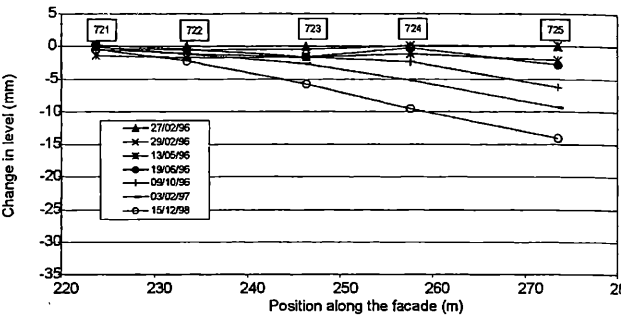
Figure 10. Vertical displacements from total station measurements to lower level of targets along St James's Street facade.

Vertical movements from measurements to the lower level of targets on the St James's and King Street facades are presented in Figures 14 and 15 respectively. Along the St James's Street facade, there are negligible movements at points 721 and 722 and even beneath the Lloyds building itself, settlements are very small at the end of construction (represented by the 9 October 1996 survey), being just over 6 mm towards the corner of the building. The greater movements at point 725 compared with 724, which was closer to the works, probably result from a small overall rotation of the building caused by the excavations for the larger sections of the SPJ on the opposite side. In the longer term, settlements increased uniformly to a maximum of about 14 mm, diminishing away from the construction works.

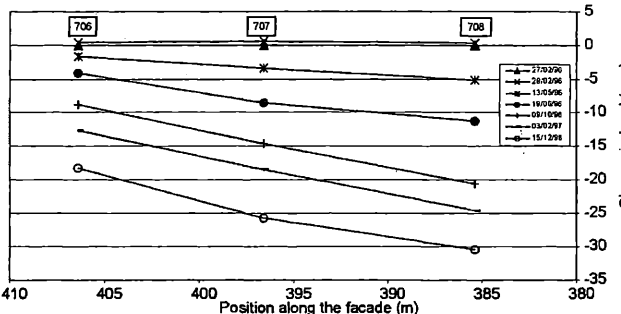
Figure 11. Vertical displacements from total station measurements to lower level of targets along the King Street facade.

Along King Street, the settlements towards the western end (i.e. point 706) were slightly greater than point 725 on St James's Street, i.e. being about 9 mm on 9 October 1996 compared with 6 mm. This is consistent with the excavation being mostly on that side of the building. The magnitude of settlement increases uniformly towards the larger excavation works, reaching a maximum of just over 20 mm. These settlements reflect the combined effect of

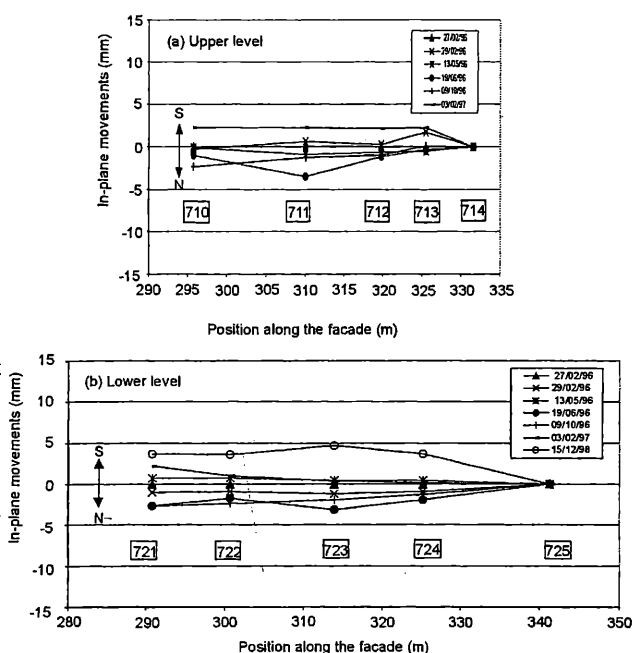
Figure 12. Relative horizontal in-plane displacements from total station measurements to (a) upper and (b) lower levels of targets along the St James's Street facade.

The in-plane horizontal displacements along the two building facades at the upper and lower levels of targets are shown in Figures 12 and 13. The data have been expressed relative to end points (725 and 706) in each case, roughly corresponding to corners of the building because datum points tend not to be as stable in the horizontal sense as vertically (see Standing *et al.*, 2002b for a similar example).

The north-south relative horizontal displacements deduced from the total station measurements to the upper and lower levels of targets on the St James's Street facade are shown in Figure 12a and b (i.e. Lloyds bank and the buildings adjacent to it). Displacements are small, being within ± 5 mm. Where the lines are generally flat (i.e. between points 710 and 712 and points 721 and 723 at the upper and lower levels respectively) there are negligible strains. The strains that do develop occur are within the Lloyds Bank building and are very small.

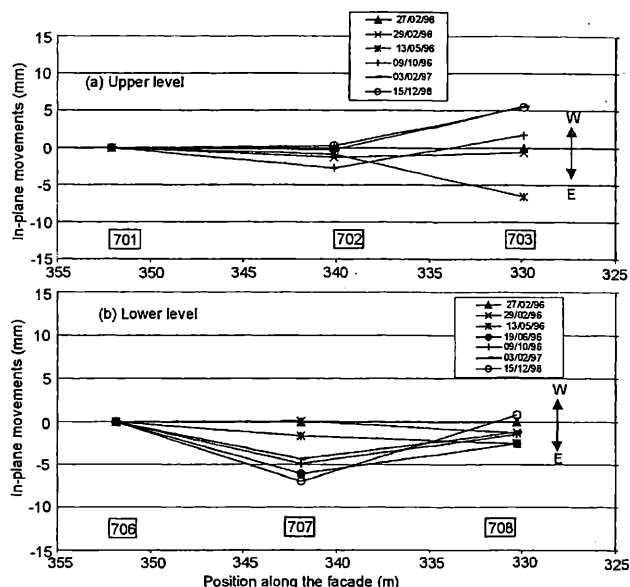
Figure 13. Relative horizontal in-plane displacements from total station measurements to (a) upper and (b) lower levels of targets along the King Street facade.

There are greater horizontal in-plane displacements and strains indicated along the King Street facade, particularly at the upper level (see Figs. 13a and b). As it is the westernmost point that is taken as fixed, movements to the west and east are compressive and tensile respectively. The two parts of Figure 13 indicate that strains occur at different positions along the facade at the upper and lower levels. At the upper level they develop towards the eastern end of the building while they are within the central part of the facade at the lower level. At the upper level a small tensile displacement is indicated from the survey 13 May 1996 (see Fig. 13a) when the SPJ construction took place in the absence of concurrent grouting operations. Horizontal displacements at the lower level at that time were also tensile but much smaller. The magnitudes of these tensile horizontal strains were about 0.07% and 0.01% at the upper and lower levels respectively and relate to damage categories of negligible and slight (Burland, 1997). Strains were generally compressive after this time, as construction proceeded with concurrent grouting and in the longer term. At the lower level, tensile and compressive strains are indicated, with negligible net strains. The settlement profiles shown in Figure 11 are generally sagging and so would be associated with compressive strains, as reflected particularly by the compressive displacements measured on the final two surveys. The maximum compressive strains at both levels are between about 0.05% and 0.07%.

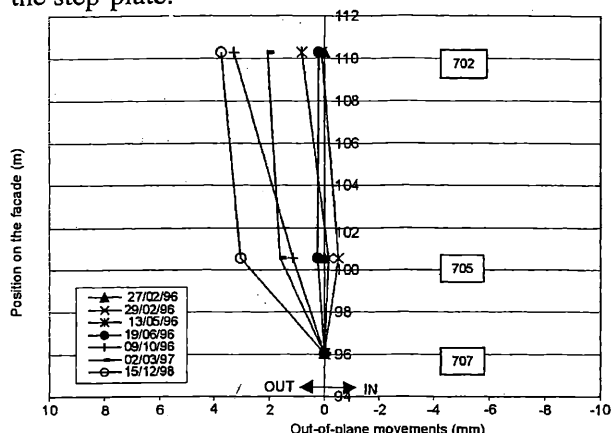
Figure 14. Relative horizontal out-of-plane displacements from total station measurements to a vertical section on the King Street facade.

Out-of-plane relative horizontal movements for one section of the King Street facade are shown in Figure 14. The displacements are plotted relative to the lower level target. A progressive outward development of displacement with height and time is indicated with maximum movements of about 4 mm. This is consistent with a downward and southward

rotation of the facade caused by the excavation of the step-plate.
