Mechanical behaviour of an experimental embankment dam during initial impoundment

Jasmina Toromanovic, Hans Mattsson, Sven Knutsson & Jan Laue

ABSTRACT: Sweden's largest dam owner, Vattenfall AB, together with several teams of researchers, built an experimental embankment dam. The purpose was to study the mechanical behaviour as well as to detect built-in damages. The dam is a small scale conventional earth- and rockfill dam. In this paper, the mechanical behaviour of the dam in terms of development of saturation and pore pressure, deformations and strains during impoundment is presented. Pore pressure measurements have shown a slightly slower development of the pore pressure than what was expected from numerical predictions. The horizontal deformations are increasing in magnitude from the upstream side to downstream side, with quite well agreement with the locations of higher strains in the dam.

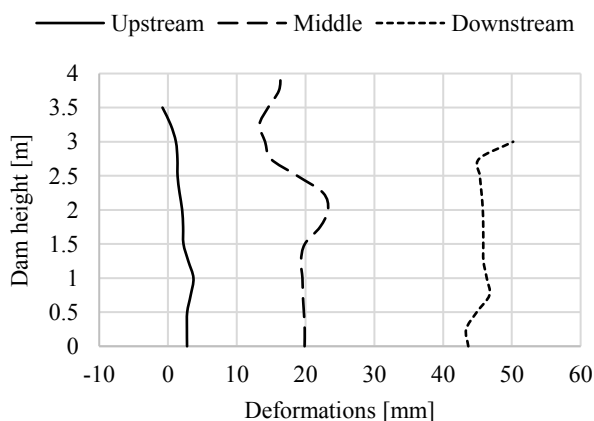
Figure 9. Horizontal deformations in the dam.

Since the bottom points of the inclinometers were not fully fixed to the concrete slab during construction the top point of the device is used as a reference point. The tops of the inclinometers were measured after finalized construction in November 2019 and next time in November 2020. The deformations of the dam presented in Figure 9 are over a period of one year, including impoundment. Only the horizontal components of the deformations are presented, being positive in the downstream direction.

As the deformations are overall positive in Figure 9 for each inclinometer, there is an indication of movement in the downstream direction. The deformations are increasing in magnitude from the upstream side of the dam to downstream side of the dam.

For the middle inclinometer, there is an indication of 20 mm movement in the bottom, the deformations are at the same magnitude up until the middle of the dam. Here the “bulge” deformation is larger than in the upstream part. From the field data, there is an indication of a slightly lower density of the till material of the core around this level. Further up, the deformations are lower. The field data is indicating lower densities, and thereby lower stiffnesses, in this part of the dam. A lower stiffness could be an explanation for the uneven deformations caused by the water load. Deformations at the very top in the middle inclinometer could also be affected by activity on the dam (i.e.).

In the downstream part, there are indications of almost 44 mm of deformations in the bottom. Further up, the “bulge” is visible as discussed above. The deformations in the dam are quite constant up to the very top of the downstream inclinometer. The deviating deformation of the upper 30 cm of support fill is very likely to be caused when measuring the reference point of the inclinometer.

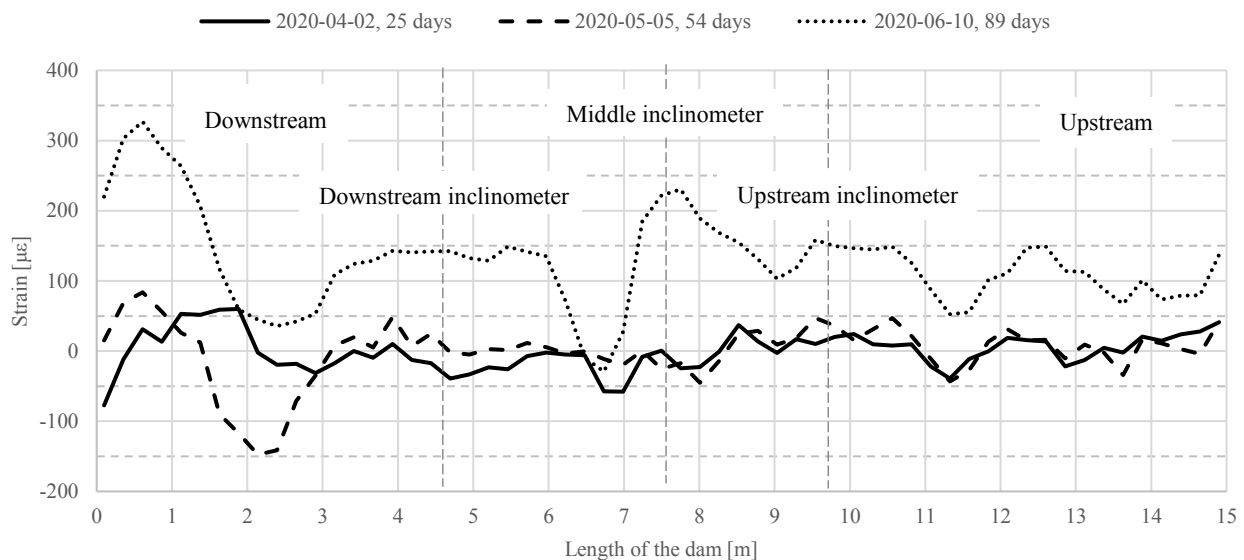
Figure 10. Strain measurements in one section of the dam

The results of the strain measurements are presented in Figure 10, at the end of this paper. The results are presented for the side S1, which is found in a top view in Figure 4. In Figure 10, the upstream side is to the right and the downstream side to the left. Positive values are tension and negative values are compression. The strains are presented as average values for 1 metre of cable. The strains have been corrected for the influence of temperature. These measurements are zeroed at the 9th of March, before the impoundment started.

In Figure 10, the solid line representing 25 days of impoundment shows the strains. The strains are overall quite even, but there are larger strains towards the end of the downstream side. At the 5th of May, represented by the broken curve, at the start of the second part of impoundment, no significant changes in strain have occurred on the upstream side. On the downstream side, more compression strains have developed.

The line representing 89 days of impoundment in Figure 10, shows the strains in the dam after the second time of impoundment. There are more strains at the core in the middle of the dam. Considering the upstream side of the core, the strains are approximately in the same range in that side. On the downstream side of the dam there are some significantly larger strains, which are partially caused by the cables being exposed to air. In general, more strains are occurring in the downstream side than in the upstream side.
