## Geosynthetic reinforced column supported embankments with defective columns

**ABSTRACT:** Geosynthetic reinforced columns supported embankments generally require the installation of a large number of ground improvement columns, such as drilled displacement columns. Defects within such ground improvement columns can arise due to several reasons during construction, which may compromise the load-settlement response of the columns, and as a result, may adversely affect the performance of the embankment. The load transfer platform overlying ground improvement columns distributes embankment loads towards column heads through soil arching and membrane actions. Small scale model tests were conducted to understand how soil arching develops above a defective column. Imaging of the small-scale models indicated that for tall embankments, a plane of equal settlement may still develop above a defective column. However, the defective column was shown to increase the height at which a plane of equal settlement formed, and as such, shallow embankments may be susceptible to differential settlements if columns with defects are installed.

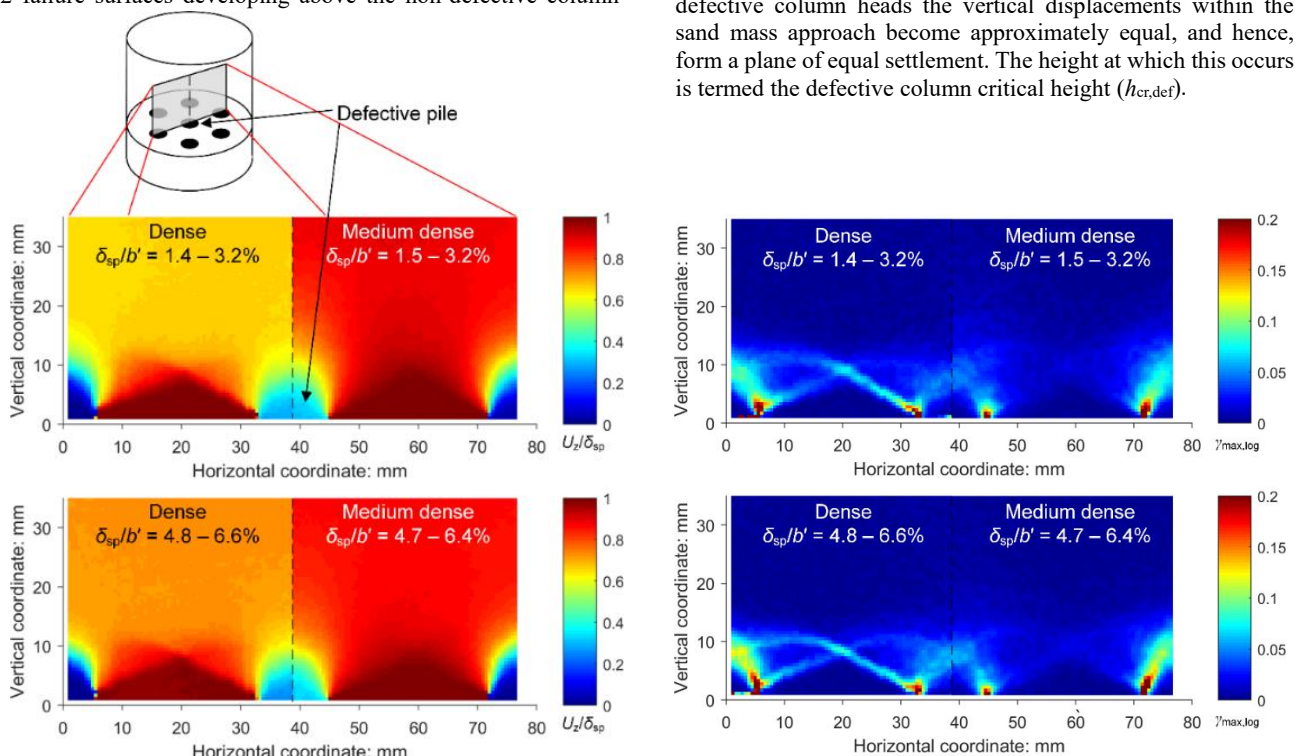
The incremental normalised vertical displacements are presented in Figure 2 for model tests comprising a central defective column at two increments of normalised settlement

plate displacement for both dense and medium dense sand. The symmetrical nature of the slices means that slices can be divided in two about a central line of symmetry, with the model tests comprising dense and medium dense sand displayed in the left and right half of each slice, respectively. The normalised displacements in Figure 2 show the additional settlement that the soil directly above the central column underwent compared to the surrounding non-defective columns. However, even with this additional settlement experienced by the defective column at the base of the embankment sand, differential settlements reduced with height above the column heads, such that a plane of equal settlement developed. Thus, for the arrangement modelled, a critical height still formed in the presence of the central defective column. Again, it is also evident that with increasing settlement plate displacement, greater amounts of settlement propagated to the sand/embankment surface above the critical height for samples of dense sand, while medium dense samples did not experience much of a change.

As shown in Figure 2, a plane of equal settlement still developed within the sand mass when a defective column was present. This is further demonstrated in Figure 4 where the incremental normalised vertical displacements taken throughout the height of the sand mass are presented for three locations, amid columns, above the non-defective columns and above the central defective column. It is evident from the incremental displacements in Figure 4 that at some height above the non-defective column heads the vertical displacements within the sand mass approach become approximately equal, and hence, form a plane of equal settlement. The height at which this occurs is termed the defective column critical height ( $h_{cr,def}$ ).

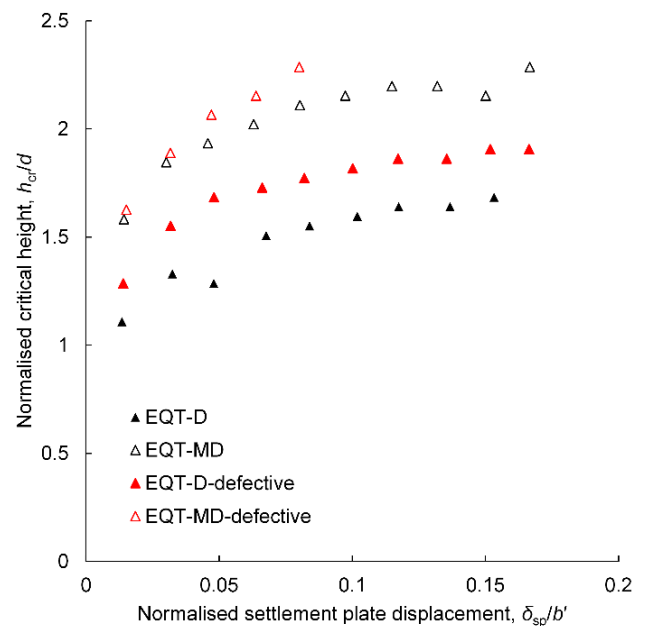
Figure 5: Normalised critical height plotted against normalised settlement plate displacement for model tests comprising columns on a triangular grid both with and without a central defective column.

The critical height, defined as the height above the column heads where displacement amid columns and above columns becomes equal, is presented in Figure 5 for model tests comprising columns on an equilateral triangular arrangement both with and without a defective column. Unfortunately, the worm drive controlling the displacement of the central defective column failed during the test comprising a defective column and medium dense sand after a normalised settlement displacement of 8%, which meant that the test did not extend to displacements that allowed the final critical height to be determined. It is evident from Figure 5 that the defective column caused an increase in critical height for both dense and medium dense model tests.

increased the height at which the plane of equal settlement developed. As such, if a relatively shallow embankment was constructed where  $h_e \approx h_{cr}$ , then the presence of a defective column would likely result in differential settlements being experienced at the embankment surface.

There is a greater level of redundancy in taller GRCSEs, and there may be an ability for columns to exhibit differential stiffness while not affecting the performance of the embankment. This was shown in Figures 4 and 5. However, if the granular material is placed only up to a height of  $h_{cr}$  with predominantly fine-grained materials used in the embankment fill above this height, these fine-grained materials will not reduce differential settlements as efficiently as coarse-grained materials. Thus, for tall GRCSEs where a defective column is installed, it is likely to be beneficial to increase the thickness of the LTP granular material to allow for an increase in the critical height.
