Durability of hydraulic structures reinforced with lime: a French onsite experience

Federica Bertola, Marcello Mutti, Jorrit Gillijns
Lhoist Research and Development, Belgium, federica.bertola@lhoist.com

Lucile Saussaye
Cerema, ENDSUM research team, Blois, France

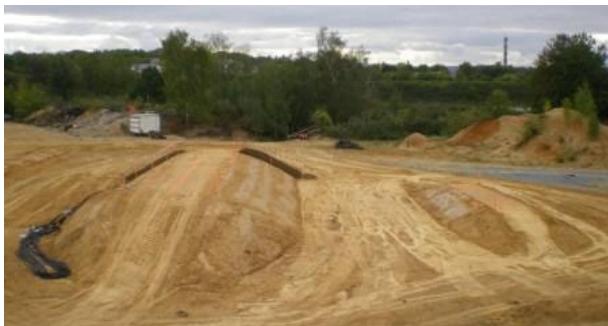
Figure 2. Global view of the two embankments soon after their construction (lime-treated on the left and untreated on the right).

The lime-treated embankment featured an asymmetrical cross-section, with slopes of 3H/2V (facing southeast) and 2H/1V (facing northwest). It measured 21 m in length at the crest and 28.20 m at the base, with widths of 4 m and 10.30 m respectively, and a total height of 1.80 m (comprising six layers of 30 cm). The untreated embankment was smaller, measuring 10 m in length, 2 m in width, and 0.9 m in height (three layers), but shared the same asymmetrical geometry and the same slope coefficients. Figure 1 shows the geometry of the two embankments, while Figure 2 the global view after their construction.

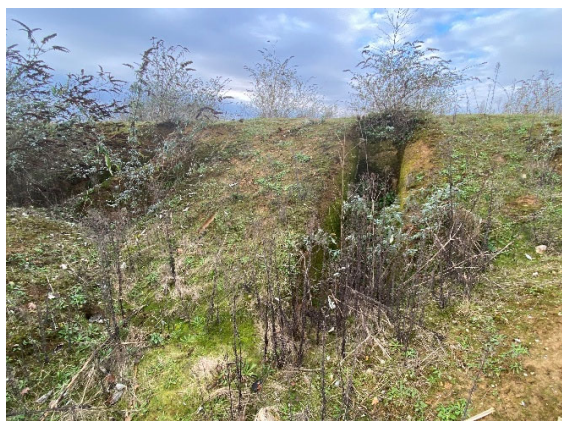
Figure 3. View of the treated embankment in lime-treated soil after 14 years from its construction.

At the beginning of 2025, an additional monitoring campaign was conducted to continue gathering information on the evolution of the performance of the lime-treated embankment under study, which had been exposed to environmental conditions for approximately 14 years (Figure 3).

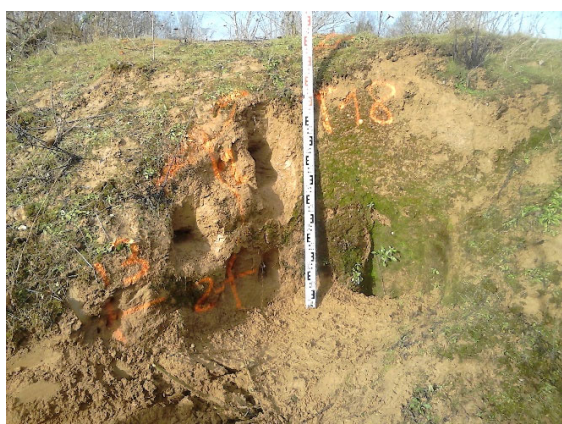
Figure 5. Example of the sampling of loose material.

Samples were extracted on both slopes of the dike, from 6 different locations, always within a trench opened between 2018 and 2020 (Figure 4). For each location, several sampling points were chosen, with depth reaching 35 cm in the direction perpendicular to the trench wall (Figure 5). The moisture content of every collected sample was determined by drying part of it at 105°C for 24h. After drying, the samples were used

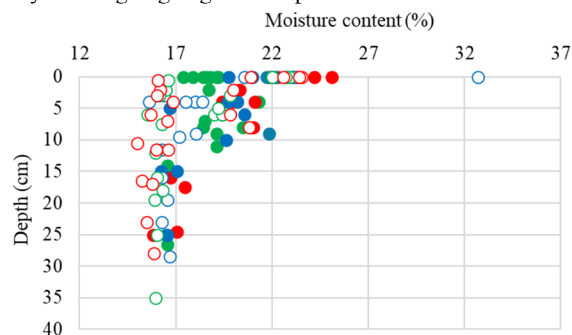
Figure 6. Evolution of the moisture content with the sampling depth. The colors of the scatterers refer to those of the trenches in Figure 4. Open circles correspond to samples taken from the northwest slope, while full ones to those taken from the southeast slope.

Figure 6 shows a wide distribution of moisture content in the superficial layer of the dike, ranging from 17% to 32% in the very external layer (i.e. first few cm), regardless the date of trench opening (and the soil-atmosphere exposure of 5 to 7 years). As the sampling depth increases the moisture content becomes less variable and stabilizes around 15-17% once below 10 cm, compared to 12 cm in 7 years (Das et al., 2021). A similar trend is observed in Figure 7, which displays the soil pH as function of depth. In the first 5 cm, the pH ranges between 8.5 and 11 while it quickly stabilizes around 11.5 at greater depths.

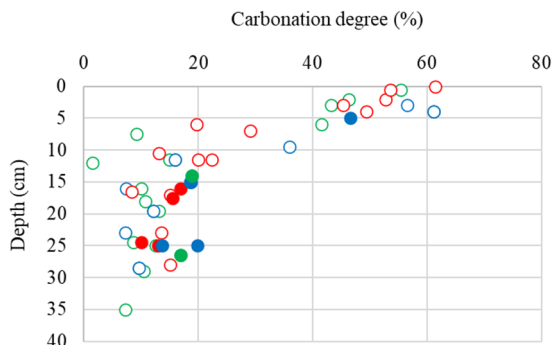
Figure 9. Carbonation degree as a function of the sampling depth.

Lastly, the carbonation degree of CaO, with the assumption that none is lost due to leaching, is shown in Figure 9. Whereas up to 60% of the added lime appears to be carbonated in the superficial layer, this proportion rapidly decreases to below 20% at depth greater than 10 cm. Although these results are consistent with the pH measurements shown in Figure 7, the carbonation of lime observed in deeper layer cannot be associated univocally with that occurring after compaction of the soil. In fact, it is not possible to experimentally distinguish between carbonation that occurred during the construction of the embankment, i.e. mixing of lime and soil and mellowing period, and carbonation that occurred at later stages (Kleib et al., 2024) if the first was not measured at the time of compaction. Moreover, the determination of carbonates via TGA does not allow to determine whether the uncarbonated part of the lime is still available for pozzolanic reaction, and in which quantity.
