Investigating Railway Ballast Instability Under Flooding Conditions: A Physical Modeling Approach

ABSTRACT: Flooding poses a significant threat to railway infrastructure, often leading to ballast instability that compromises track safety and serviceability. When floodwater overtops and seeps through the ballast layer, concentrated flow between sleeper gaps can accelerate erosion and breach formation. This study investigates the failure mechanisms of sleeper-installed railway ballast under flooding using reduced-scale physical model tests in an open-channel flume at discharge rates of 30 m³/h and 40 m³/h. The results show that higher discharge rates reduce the time to overtopping and significantly intensify ballast displacement. At 30 m³/h, failure progressed through a multi-phase retrogressive collapse, while at 40 m³/h, rapid headcut erosion dominated. Particle Image Velocimetry (PIV) analysis revealed that the higher discharge produced earlier, more widespread, and higher-magnitude particle movement, whereas the lower discharge allowed a slower progression with localized displacement concentrated between sleeper gaps. These findings provide experimental evidence of how hydraulic

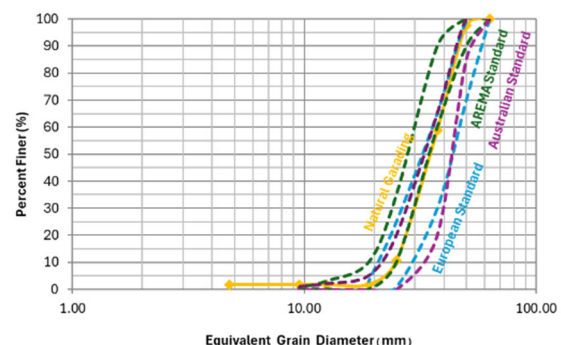
Figure 1 Particle size distribution of the tested railway ballast

The railway ballast used in this study was sourced from a quarry in northern Thailand. Its particle size distribution (PSD) was determined through laboratory testing. The results indicated that the ballast met the relevant standards and specifications, as illustrated in Figure 1. The measured bulk density of the ballast was 1,650 kg/m³. Following the PSD verification, the ballast was scaled down to a 1:2 ratio for the purpose of constructing the physical model, taking into account both laboratory conditions and prototype characteristics. The PSD of the scaled-down 1:2 ballast is presented in Figure 2.

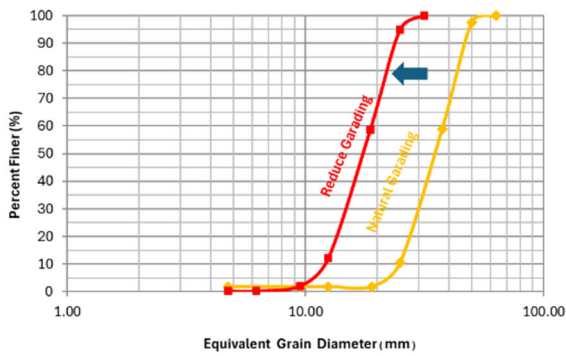
Figure 2 Particle size distribution of the 1:2 scaled railway ballast

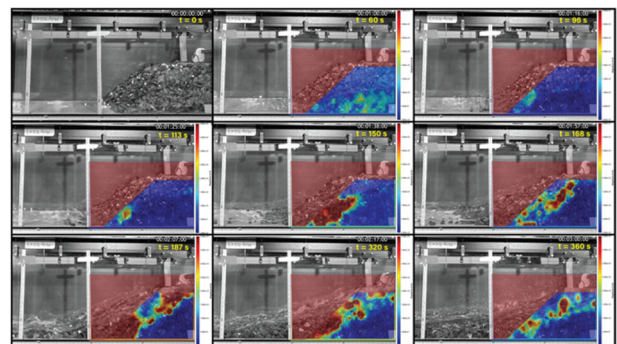
Figure 11 PIV analysis of the velocity magnitude during the test at a discharge rate of 40 m³/h

In contrast, the 40 m³/h case (Figure 11) displayed a markedly different velocity pattern. High-magnitude particle movement appeared much earlier, with localized zones of intense displacement forming between 71 and 97 seconds during the initial seepage and toe instability phase. Once overtopping began at 121 seconds, velocity magnitudes rapidly increased across a larger portion of the slope. The breach evolved into a headcut failure, with rapid upslope migration of the scarp and complete breach development by 168 seconds—approximately half the time required in the 30 m³/h test.
