X-ray CT Imaging of Internal Erosion in Sand with Loose Zones Under Seepage Flow

ABSTRACT: A laboratory experiment was conducted to clarify the internal erosion mechanism in sand with weak zones, such as cracks, under infiltration conditions. Referring to the hole erosion test (HET), the experiment involved preparing homogeneous specimens made of mixed sand and clay, as well as specimens with a loose zone, named coarse soil pipe (CSP), preset in the center of the mixed sand. The water flow rate was incrementally increased to measure the changes in the hydraulic gradient and conductivity during the flow, and the turbidity of the recovered water was also measured. Additionally, after the water flow, the sand specimens were visualized using microfocus X-ray computed tomography (CT), and image processing was performed to investigate the changes in the internal state due to the water flow. Laboratory experiments showed that clay flowed out of all the specimens when water passed through them. The hydraulic conductivity increased as the water flow rate increased. However, in specimens with a CSP, high turbidity of the water passing through the sand was observed, which indicates a large a

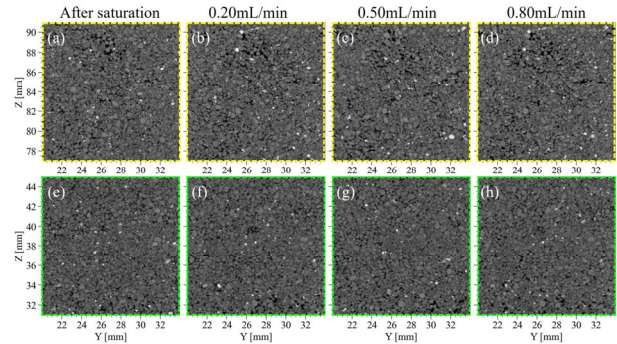
Figure 6. Enlarged CT image of Case A.

The upper section indicates the upper part of the column (downstream), and the lower section indicates the lower part of the column (upstream).

No significant changes in the internal structure owing to internal erosion were observed on the enlarged CT image. Furthermore, even in Case B, where the CSP was placed in the center, no significant erosion of the CSP wall surface was observed, and the shape of the hole appeared to have been maintained. However, when calculating the change in the gray

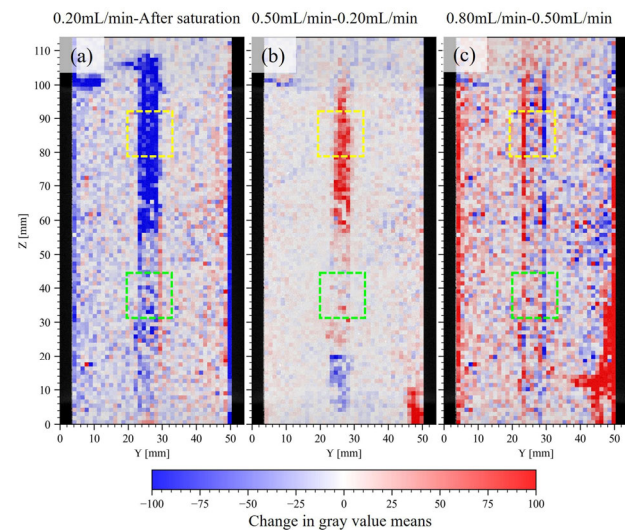
Figure 9. Difference calculation results for two images of Case B.

In Case B, which had a CSP in the center, different changes were observed at each step. When the flow rate was 0.20 mL/min, a region of reduced gray values was observed along the flow direction in the CSP zone (Figure 9 a). These changes were related to the particles flowing into the CSP zone in the previous stage and being discharged outside the column, as well as the erosion progression on the CSP wall. In addition, changes in gray values were observed in zones other than the CSP zone. At a flow rate of 0.50 mL/min, an area of increased gray value along the flow direction was observed in the CSP region (Figure 9 b). Meanwhile, the gray value remained almost unchanged in the regions outside the CSP. The gray value decreased in the lower (upstream) part of the column, suggesting that the sand and clay in this region were transported to the upper (downstream) part by the upward flow. Although

significant changes in the gray values were mainly observed in the CSP until this stage, when the water flow rate reached 0.80 mL/min, changes were observed not only in the CSP but also in the overall specimen, transitioning to changes similar to those in Case A (Figure 9 c). Figure 10 shows that such changes occurred not only in the YZ section, but also throughout the entire specimen. This indicates that the CSP corresponds to the sand and clay flow path.

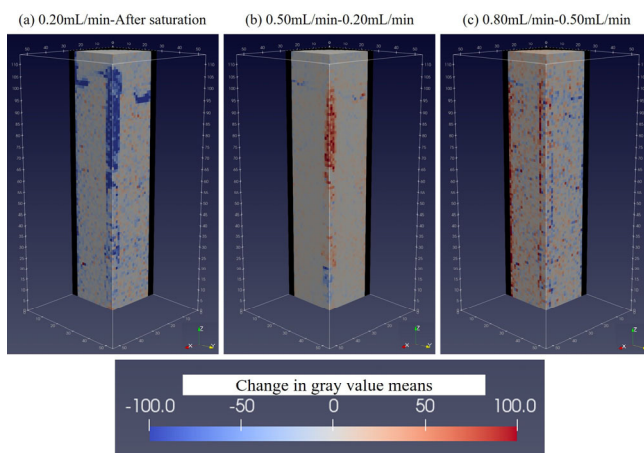
Figure 10. Image processing results in Case B (3D).
