Experimental study about recovery of bearing capacity against train load by reconstruction work of embankment damaged by rainfall

Takaki Matsumaru, Taketo Sato

Structure Technology Division, Railway Technical Research Institute, Japan, matsumaru.takaki.35@rtro.or.jp

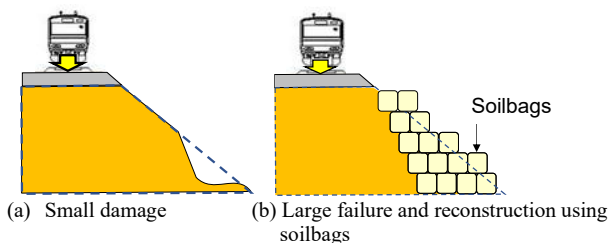
Figure 1. Illustration of scale of damage of railway embankment due to rainfall.

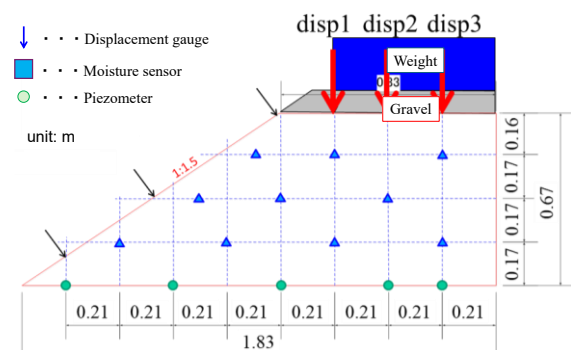
Rainfall infiltration and loading experiments were conducted on a 1/6-scale embankment model, in order to investigate the resistance of the embankments against train loads for the case of collapse. Figure 2 shows an illustration of the embankment used in the experiments. The height of embankment was 0.67 m and the gradient of the slope was 1:1.5. The crushed stone was provided at the top of the embankment with 0.1 m layer. The material of the embankment was Inagi sand. The material properties are shown in Table 1.

Figure 2. Illustration of model embankment.

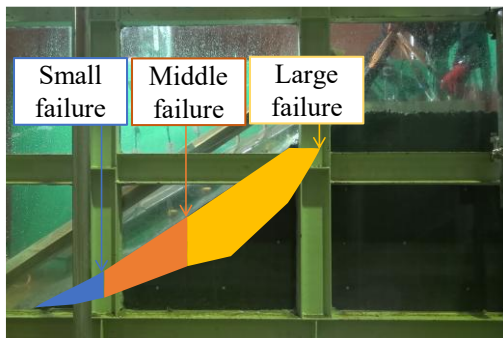
The amount of rainfall was set at 30 mm/h in all three cases. Sprinkling rainfall causes collapse of the embankment in stages and loading tests for applying train loads were conducted at the timing of small, medium, and large collapses, based on the collapse shapes of the embankment as shown in Figure 3. In Cases 1 and 2, the load was applied as soon as preparations for loading after sprinkling rainfall. On the other hand, in Case 3, taking into account the time required for inspections and other procedures until the resumption of actual train operation, the load was not applied immediately after rainfall sprinkling was stopped. A delay of about an hour and a half was considered in this test. The applied load was set at 774.2N, which is equivalent to the actual EA load (R.T.R.I., 2023) of 170kN applied to the top of the embankment.

Figure 3. Failure pattern of embankment.

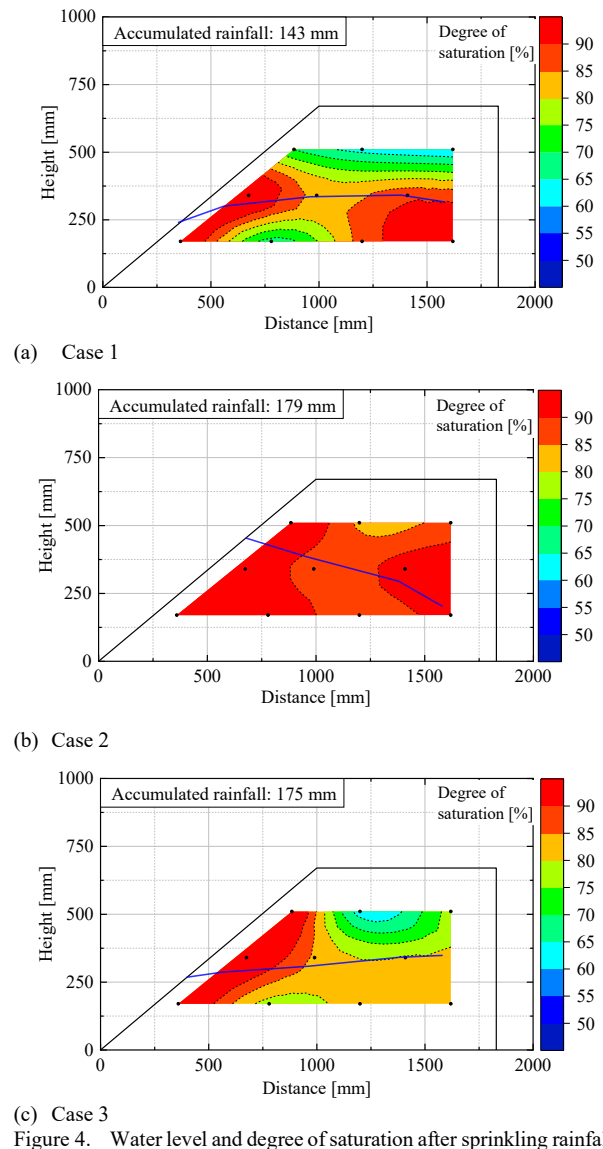
Though the timing of the collapse of the embankment differed for each case, the total amount of rainfall was 143 mm in Case 1, 179 mm in Case 2, and 175 mm in Case 3. Figure 4 shows the water level and distribution of the degree of saturation in the embankment for each case when the large scale of failure was observed. In all cases, the degree of saturation increased and the water level was also formed. The water level and the degree of saturation rose more in Case 2 than in Cases 1 and 3 because the embankment density in Case 2 is higher, resulting in a smaller permeability coefficient, and the embankment strength is higher. There was no significant difference in the water level and degree of saturation between Cases 1 and 3.

Figure 4. Water level and degree of saturation after sprinkling rainfall.

In particular, the difference from Case 3 was that there was no significant difference in the distribution of degree of saturation and water level as shown in Figure 4 (a) and (c), so it is assumed that there was a difference in the distribution of the degree of saturation between the two cases above the soil moisture sensor installation positions. From these results, it is considered that the degree of compaction and the distribution of the degree of saturation in the embankment affect the settlement at the top when the train load acts. In the case of an embankment with a small degree of compaction, even if the collapse surface does not reach the ballast, it is possible that the stability against the train load will not be sufficient if the degree of saturation at the top of the embankment is high immediately after rainfall.

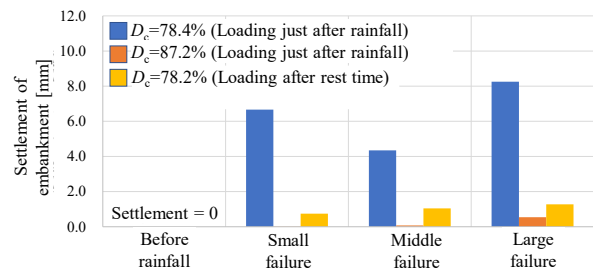
Figure 5 shows the settlement at the top of the embankment when the train load was applied in accordance with the collapse scale of small, medium, and large in Cases 1 to 3. In Cases 2 and 3, the settlement of the embankment was small regardless of the collapse scale. However, in Case 1, the settlement of the embankment at the top increased when the train load was applied, even when the collapse scale was small.

Figure 5. Relationship between scale of failure and settlement.

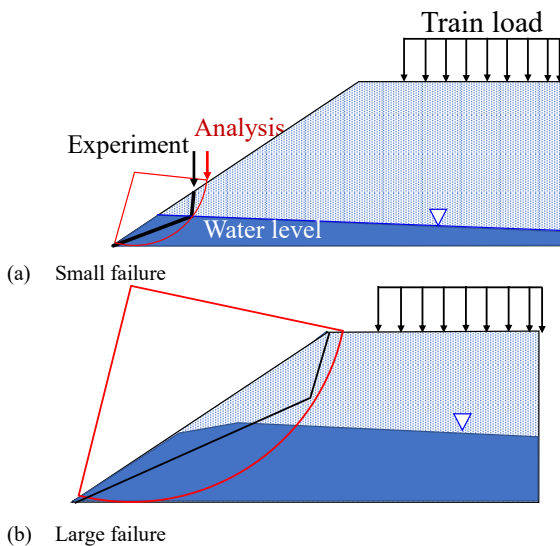
Figure 6 shows the comparisons of slip surfaces obtained from experiments and stability analyses. Though the circular slip from the analyses were a little bit deeper than those of the experiments, the shapes were similar. Furthermore, in the stability analysis, the stabilities of the damaged embankments under the applied load were also evaluated. From the analyses, the stabilities of the embankments were still kept after the occurrence of failure, so the analyses coincided with the tendencies obtained from series of tests.

Figure 6. Result of stability analysis using circular slip method.

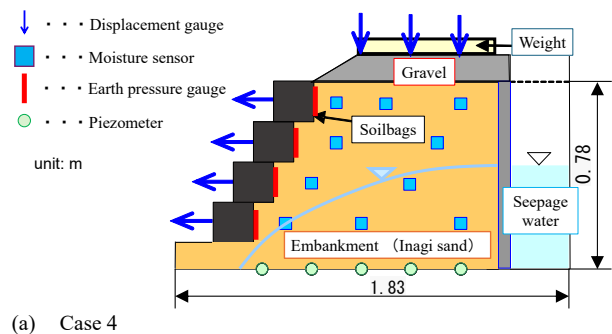
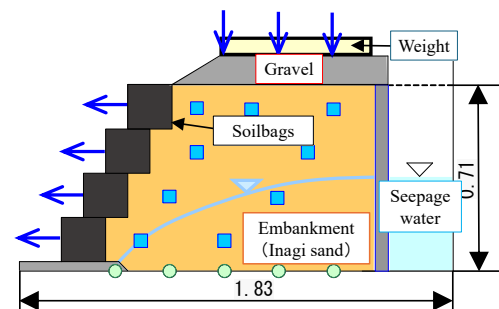
The model embankment was constructed using Inagi sand, as in the test in Chapter 2, and the degree of compaction was targeted at approximately $D_c=80\%$, as in Cases 1 and 3. Two cases of tests were carried out in this experiment, and the difference between the cases was in the preparation conditions for the support ground below the sandbags, as shown in Figures 7 (a) and (b). In Case 4, the same Inagi sand as the embankment was used, whereas in Case 5, crushed stone was used in order

to increase the bearing capacity at the bottom of the sandbags and improve drainage from the sandbags. In both cases, five rows of $\phi 20$ mm drainage pipes were installed in the depth direction of the support ground to lower the water level behind the sandbags, making it easier for water to drain outside the embankment. To measure the earth pressure, the sandbag model was made of mortar to ensure reaction force, and an earth pressure gauges and load cells were installed. The mass and size were made to be 1/6 of the actual size, and the sandbag model is a square with one side measuring 17 cm. Since friction between the back embankment and the sandbags was thought to be important in the rainfall sprinkling and loading tests, the friction coefficient of the model sandbag was adjusted to that of an actual large one, and the fabric of the sandbag was attached with adhesive to five sides of the sandbag model except for the front side. The sandbags were arranged in a single row after a stability study against the load was conducted in advance. In the rainfall sprinkling and loading experiment, first, without rainfall, the water level in the embankment was raised by supplying water from the tank installed behind the embankment while maintaining the water level at 400 mm, and then rainfall of 30 mm/h was applied from the rainfall sprinkler to increase the degree of saturation in the embankment. This assumes a situation in which the railway embankment collapses due to rainfall, and then emergency reconstructions are made with large sandbags, and then rainfall occurs again, causing the increase of the water level and degree of saturation in the embankment. After rainfall sprinkled, the weight was applied to simulate the load of a train. In addition, if the settlement of the embankment top and the horizontal displacement of the sandbags that occur after loading are small, the load was increased to grasp the deformation of the embankment and sandbags.

(a) Case 4

(b) Case 5

Figure 7. Illustrations of the model embankments.

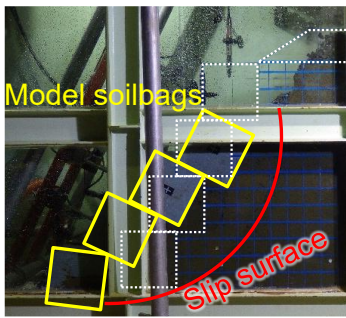
water tank behind the embankment was kept at about 400 mm, and when the accumulated rainfall after the start of sprinkling reached about 30 mm, a large collapse occurred in the embankment, centered on the location of the large sandbags above the second tier, as shown in Figure 8. Although it can be judged that the rainfall resistance has improved compared to the experiments mentioned in Chapter 2, it is considered that the stability against rainfall is not sufficiently secured. The water level in the embankment at the time of the collapse was about 150 mm at the position closest to the sandbags shown in Figure 7 (a), and it is assumed that pore water pressure was also acting on the bottom sandbags, even though a drainage pipe was installed.

Figure 8. Photos of damaged embankment in Case 4.

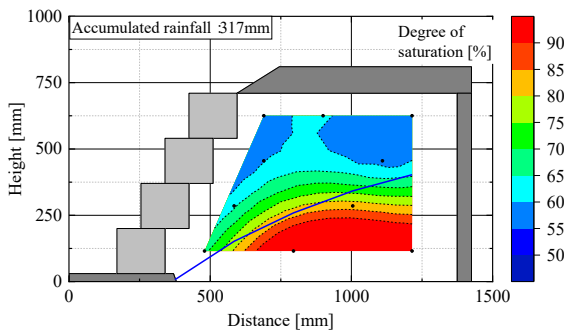
On the other hand, in the test of Case 5, the water level from the backfill was set to about 400 mm, and a total amount of rainfall of 317 mm was applied with a rainfall intensity of 30 mm/h, but the embankment did not collapse due to seepage water from the backfill and rainfall. Based on the test result of Case 4, although the rainfall resistance of the embankment was improved by restoration using sandbags, it is thought that in order to ensure sufficient stability, it is necessary to ensure the bearing capacity at the bottom of the sandbags and to lower the water level at the back of the sandbags. Figure 9 shows the water level and degree of saturation in the embankment immediately before the loading test after rainwater sprinkling. The degree of saturation remained at about 50% near the surface of the embankment, but as the water level reached about half the height of the embankment, an increase in degree of saturation was observed above the water level.

Figure 9. Water level and degree of saturation in Case 5.

Figure 13 shows the water level and distribution of degree of saturation in the embankment after rainfall sprinkling. As with the emergency reconstructed embankment shown in Figure 9, there is a tendency for the water level to gradually decrease from the embankment behind the sandbags toward the crushed stone layer, and no water level is formed in the covered embankment in front of the sandbags. The crushed stone layer at the bottom of the sandbags acts as a drainage blanket, and the increase in degree of saturation of the covered embankment on the front side is also suppressed to about 70%. In the damaged embankments in Cases 1 to 3, as shown in Figure 4, increases in water levels and degree of saturation were observed even near the slope. However, this was not the case in the reconstructed embankments, and it is believed that no remarkable changes occurred in the front of the embankment that was covered with soil.

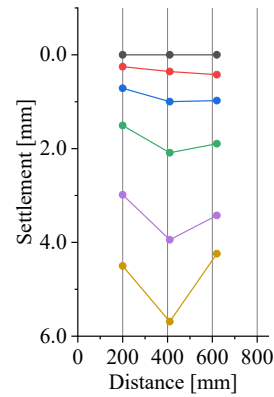
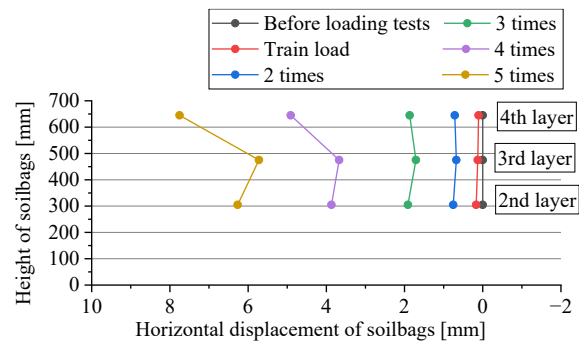
Figure 10 shows the distribution of vertical displacement at the top of the embankment and horizontal displacement at each sandbag when the train load was applied, in the test of Case 5. The horizontal axis of vertical settlement means the distance from the shoulder of the embankment. The load was applied up to a level equivalent to five times the train load. Even when the load was twice the train load, the settlement at the top of the embankment was about 1 mm, and the displacement towards the front of the sandbags was also kept to less than 1 mm. When the load was subsequently increased, the vertical

displacement at the top and the horizontal displacement of the sandbags increased, and the same level of bulging occurred throughout the sandbags up to a load of about three times the train load. When the load was increased beyond four times the train load, the bulging of the top sandbag became obvious, with a maximum displacement of about 8 mm. However, even when the load was five times the train load, the embankment did not collapse.

(a) Settlement at top of embankment

(b) Horizontal displacement of soilbags

Figure 10. Settlement of embankment and lateral displacement of soilbags.

Figure 11 shows the calculated results for the safety factor about sliding force and the eccentricity against tipping obtained by stability calculation at the overturning moment for each applied load. The results show that there is no significant eccentricity against overturning moment even when a load up to five times the train load is applied, as shown in (b). However, when a load equivalent to more than three times the train load is applied, the safety factor about sliding force for the large sandbags in the bottom two tiers falls below 1. The horizontal displacement of the sandbag position obtained in the experiment as shown in Figure 10 was large in the second tier from the bottom, while the safety factor obtained by calculation

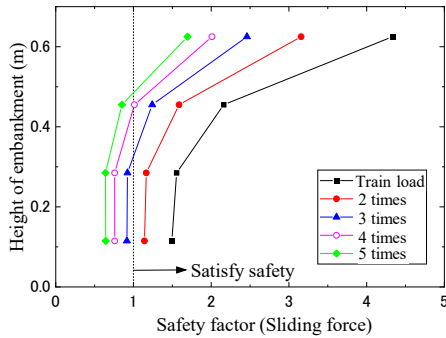
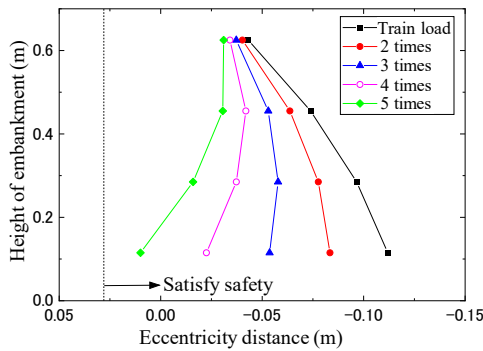
becomes smaller from the bottom tier, suggesting that sliding displacement occurs from the bottom tier of sandbags. In the experiment of Case 5, high-quality crushed stone was laid under the sandbags, and it is thought that the friction between the crushed stone and the sandbags suppressed the displacement of the bottom tier of sandbags. Although there are differences in the deformation modes of the sandbags as described above, as shown in Figure 10, in the experiment, when the load was more than three times the train load, there was an increase in the amount of settlement at the top of the embankment and the horizontal displacement of the sandbags themselves. It is confirmed that the horizontal displacement of the sandbags in response to the increase in the applied load in the experiment is expressed in the stability calculation as a decrease in the safety factor against sliding.

(a) Sliding force

(b) Overturing moment

Figure 11. Safety factor obtained from stability analysis.

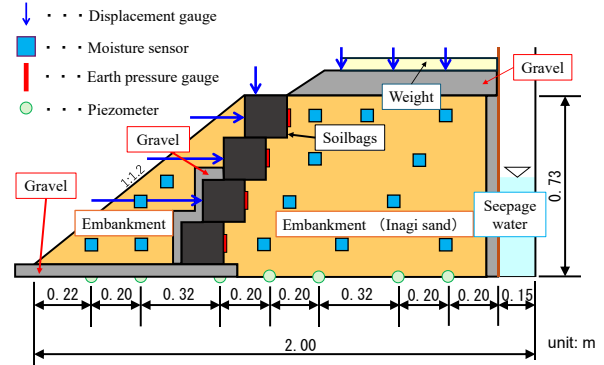
Rainfall sprinkling and loading tests were conducted on the embankments that had been temporarily restored using large sandbags, with the aim of covering the front of the sandbags with soil to make the structure permanent without removing the sandbags. The experimental case was Case 6, and the illustration of the model embankment is shown in Figure 12. The front side of the sandbags was covered with the same Inagi sand as the backfill of the sandbags, with a slope of 1:1.2 and the degree of compaction of $D_c=80\%$. In order to improve drainage on the covered soil side as well, crushed stone was laid up to the height of the second step between the bottom of the embankment and the sandbags.

Figure 12. Illustrations of the model embankment in Case 6.

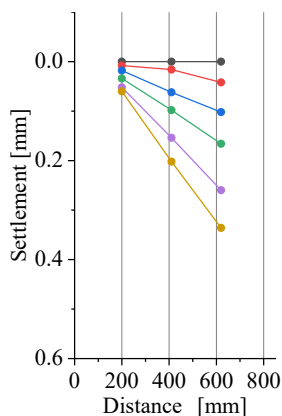
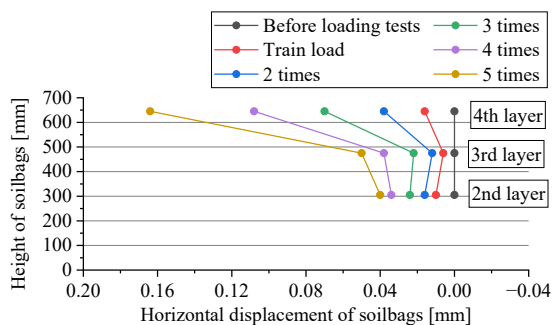
Figure 14 shows the distribution of horizontal displacement at each 4 and vertical displacement at the top of embankment when the train load was applied. Focusing on the horizontal displacement of the sandbags, the horizontal displacement occurring throughout the sandbag model in this reconstructed structure was small, and even in the top sandbag, which showed the largest horizontal displacement, it was about 1/50 of that in the emergency reconstructed embankment of Case 5 as shown in Figure 10. In addition, the increase in horizontal displacement was further reduced in the second and third sandbags, and it is considered that the embankment covering the front side of the sandbags had an effect of reducing displacement. The distribution of settlement of the top of embankment occurred almost uniformly in the emergency reconstructed embankment but occurred greatly near the back of the model embankment in this reconstructed structure. This is thought to be because in this reconstructed structure, the horizontal displacement of the sandbag was reduced, so the top of embankment near the slope shoulder was less likely to settle, and the area near the back of the embankment, where the degree of saturation had increased due to the influence of the water of the backfill, was more likely to settle. The amount of settlement that occurred in this reconstructed embankment was approximately 1/10 of that in the emergency reconstructed embankment. A comparison of the horizontal displacement of the sandbag model and the settlement of the top of the embankment showed that the displacement was reduced by covering the front of the sandbags with embankment.

(a) Settlement at top of embankment

(b) Horizontal displacement of soilbags

Figure 14. Settlement of embankment and lateral displacement of soilbags.
