# Cracking of the cover layer leading to backward erosion piping

**ABSTRACT:** In the Netherlands, over 1300 km of the levees must be reinforced by 2050 as part of the Flood Protection Program. Innovative calculation techniques, driven by new knowledge, aim to optimize these reinforcement efforts. One of the dominant failure mechanisms that causes the required improvements is backward erosion piping. In assessing the probability of occurrence for this mechanism, the formation of an exit point in the cover layer is critical. The current assessment method does not explicitly account for the development of a crack in the cover layer. Including the cracking behaviour of the cover layer in the assessment framework would offer a more realistic and potentially more favourable evaluation of levee stability. Therefore, a comprehensive investigation was conducted, including a literature review, 13 geocentrifuge model tests, and two full-scale field tests. For the exit point formation of the cover layer, a physical description was written. This was primarily based on observed behaviour from the centrifuge tests. It was found that cracking started at the bottom of the cover layer, proceeding

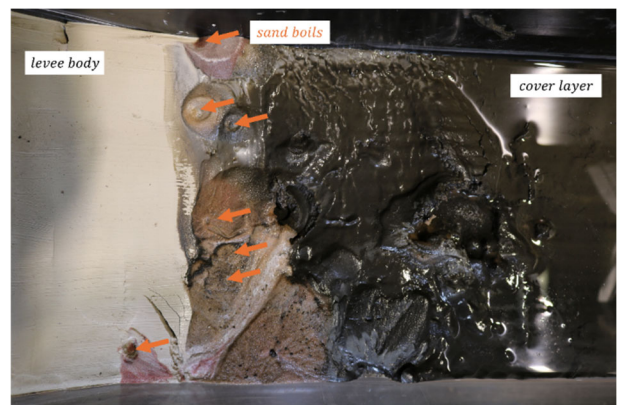
Figure 8. Geocentrifuge model (top view) with sand boils (indicated by orange arrows) located at the toe of the levee.

The diagonal crack was present over the entire (in plane) length of the model. It is located at the toe of the levee, and the crack was observed to start at the bottom of the cover layer, propagating upwards. The diagonal crack consistently formed at an angle of approximately 60–65° from the horizontal direction. The length of the uplift zone was 15–45 m (187–559 mm on model scale). At the top of the cover layer, sand boils were observed at the location of the toe (Figure 8). Furthermore, in six of the tests, lateral cracks were observed, and in four of the tests, these sand boils occurred at the location of these lateral cracks.

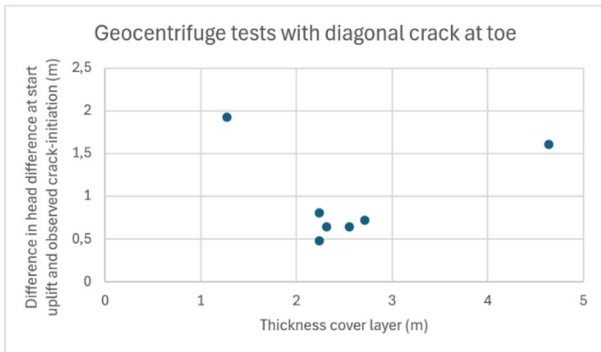
The head difference against cover layer thickness is plotted in Figure 10. The hypothesis was that the thicker the cover layer is, the more resistance it would give to cracking. Unfortunately, there is no clear relationship found. It should be noted that for the test with a cover layer of 1.3 m, first a lateral crack was observed and from that crack a diagonal crack developed further. For the test with a cover layer of 4.6 m, it should be noted that the crack-initiation was observed but the crack did not fully propagate to the full thickness of the cover layer and did not lead to sand transport through the diagonal crack.

Figure 10. The head difference between uplift and cracking and the thickness of the cover layer during geocentrifuge tests with diagonal crack at toe (normal scale).

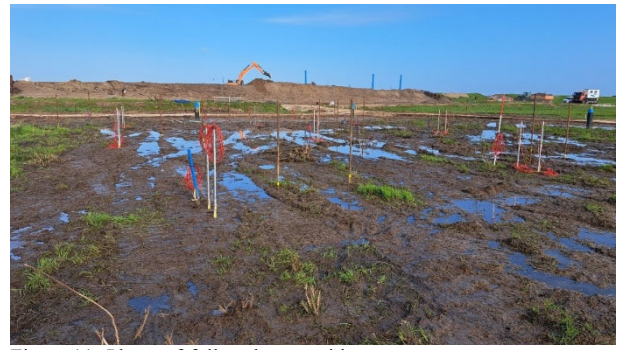
In the two full-scale tests, uplift conditions were reached over a period of several days, and the deformation of the cover layer was measured. The subsoil of the tests consisted of a cover layer of 3-3.5m of sandy clay and peat overlaying an aquifer. A comprehensive publication detailing the full setup, methodology and results of this field experiment, is currently in preparation.

Figure 11. Photo of full-scale test with pore water pressure meters at the front.

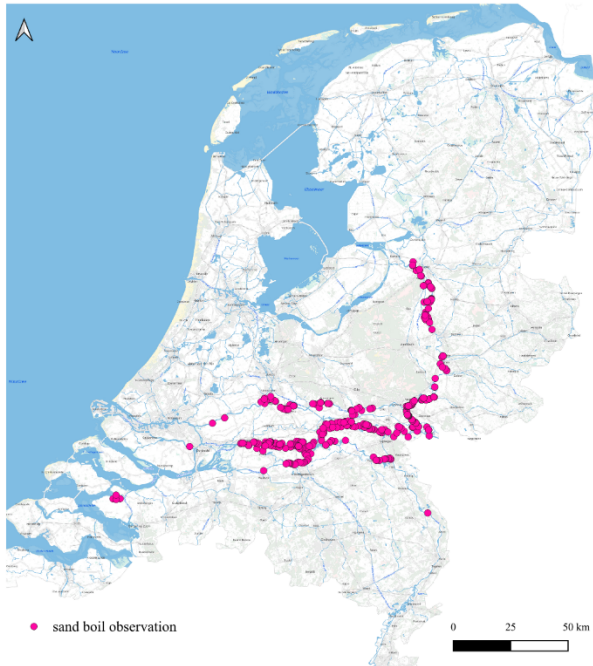
The distribution of sand boils in the Netherlands

Field observations of sand boils connect to the physical description in the sense that both uplift and heave have occurred. Previous analysis of the Dutch national dataset (Figure 14), comprising over 800 recorded sand boils, showed a trend of fewer occurrences in areas with thicker cover layers (Figure 15).

Figure 14. Sand boil locations in the Dutch national dataset.

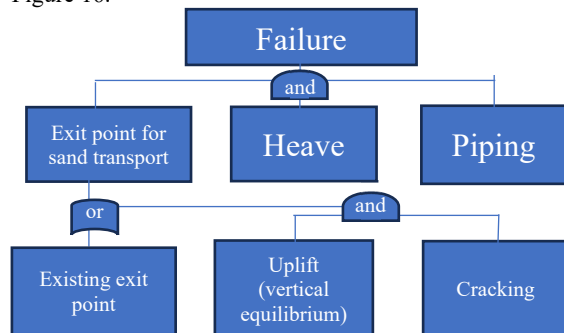
The uplift submechanism of piping could alternatively be considered as the formation of an exit point for (sand) boils and subsequently piping. The updated failure tree is shown in Figure 16.

Figure 16. Extended submechanisms of failure by backward erosion piping.
