# Stresses and strains in the Evinos dam, Greece

G.T.Dounias & E.O.Papageorgiou – *Edafos Ltd, Athens, Greece*

**ABSTRACT:** The behaviour of the core and shoulder materials of the 126m high Evinos embankment dam is presented during construction and a subsequent rest period of 3 years. The paper presents information regarding total stress built up, pore water pressure generation and the stress paths followed by the different materials. It assesses the material properties and the potential for hydraulic fracture of the core.

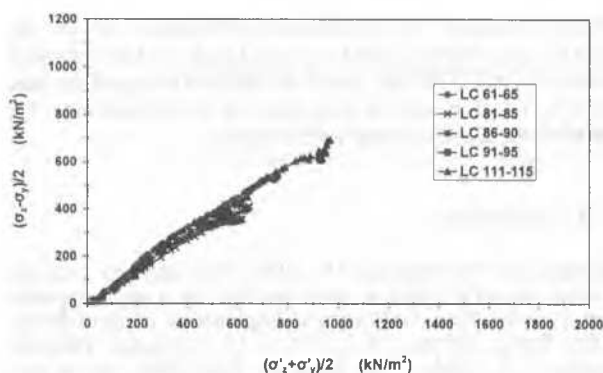
(a) Gravel shoulders

Figure 4. Stress paths during construction and rest period

Stress paths on a  $(\sigma'_z + \sigma'_y)/2$ ,  $(\sigma_z - \sigma_y)/2$  space are shown in Figure 4. Because of  $\sigma_z$  being very similar to the major principle stress, these stress paths can be considered a good approximation of the paths in terms of principle stresses. The paths followed by the cells installed in the gravel shoulders (Fig. 4a) indicate a  $k_0$  condition with an average  $k_0=0.18$ . Assuming conservatively that this average path follows the failure envelope, the resulting

The strain path in the core (LC 71-75) is initially indicating "oedometer conditions" but later bends showing lateral expansion. The pressure cells at this location (Fig. 4b) show a stress path pointing to shear failure in compression, compatible with the strain path. The pressure cells in the gravel shoulders (LC 61-65 & LC 81-85) show  $k_0$  conditions (Fig. 4a) again compatible with the strain path.

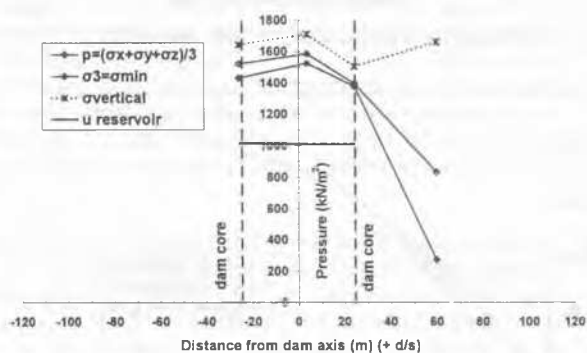
Figure 5. Mean, vertical and minimum total stresses across the core, IX

(a) Across upper row of cells

(b) Across lower row of cells

The mean, vertical and minimum total stresses across the core are plotted in Figure 5 for the two rows of earth pressure cells. Also plotted is the pore pressure for a reservoir level at the spillway crest. For the deeper row of instruments both the mean and the minimum total stress is well above this reservoir pressure indicating complete safety against the mechanism of hydraulic fracture. At the higher row the mean and vertical total stresses are above reservoir pressure but the minimum stress is lower indicating a possible small potential for hydraulic fracture. It has been observed that total stresses increase during impounding, following the increase in pore water pressure. This increase will most probably be adequate to completely eradicate any danger of cracking. Stresses near the centre of the core are higher than near the boundary. If a possible imperfection near

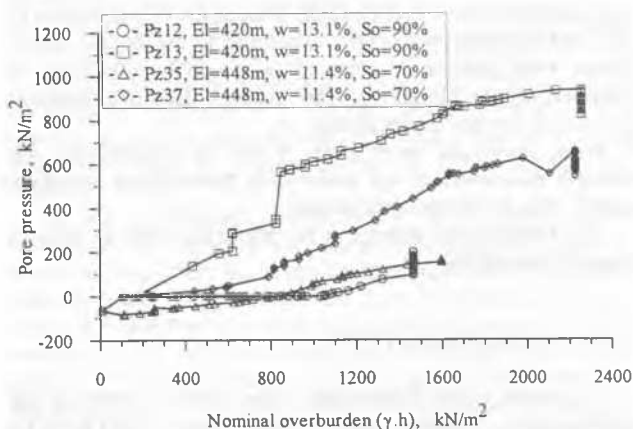
Figure 6. Core piezometer readings – effect of placement moisture content (Dounias et al, 2001)

A large number of vibrating wire piezometers was installed in the shoulders and the core of the dam. They were fitted with a high air entry ceramic capable of measuring small suctions. The development of pore water pressure in the core was influenced heavily by the placement water content. Measurements of typical piezometers are presented in Figure 6. Where water content, and degree of saturation, was high, positive pore pressures were generated by nominal overburden pressures of 200 – 300 kN/m<sup>2</sup>. Where the initial degree of saturation was less than 80% a much higher overburden pressure was needed. During the 3-year rest period following construction some piezometers showed slow dissipation. This behaviour indicates a low permeability. An approximate one-dimensional analysis indicates permeabilities one order of magnitude lower than the values measured in-situ. Thus there is confirmation that a low permeability close to that of a clay fill was achieved in the core.
