## ORIGIN OF GEOTECHNICAL DISPUTES AND THEIR RESOLUTION

**Sven Hansbo**

**SYNOPSIS:** The purpose of this paper is to highlight some of the most frequent causes of disputes due to geotechnical problems appearing in structural engineering. Examples of disputes, experienced by the Author, and their origin and resolution are presented. Dispute resolution mechanisms are discussed. Main subjects for discussion are proposed.

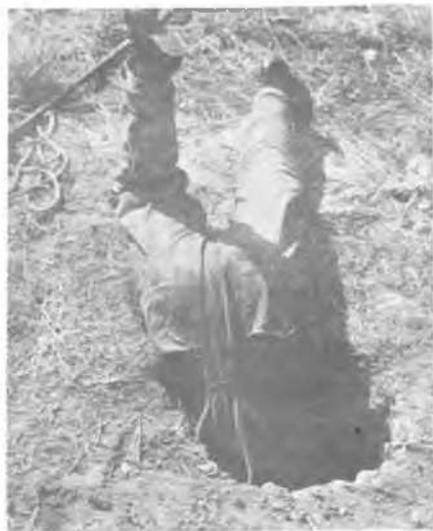
**Fig. 1.** Soil investigations are carried out in many different ways and, therefore, the adopted procedure in the chosen method of soil investigation has to be defined in the geotechnical report.

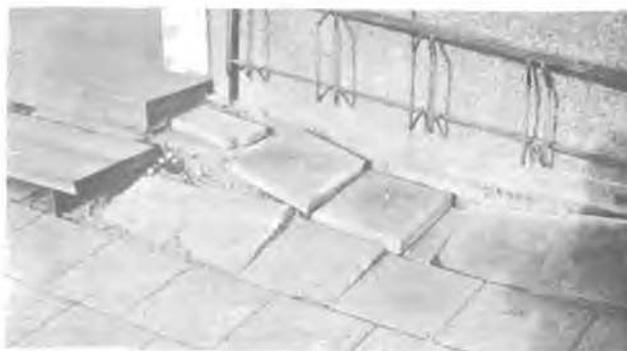
**Fig. 3** Groundwater lowering causing subsidence phenomena is frequently an origin of disputes.

In the geotechnical design, the foremost problem to be solved is to make the foundation and excavation design in a way to avoid detrimental total and differential settlements and negative effects on the surroundings. The effect on the groundwater condition by the building activities, possible groundwater outtake, surfacing, etc. has to be foreseen within acceptable limits (Fig. 3).

(ii) *Groundwater lowering.* This is a case where, in spite of a quite extensive and detailed soil investigation, erratic soil conditions entailed serious problems for the contractor and the client.

The soil at the site consisted of peat and various fill material on deep deposits of partly loose silt and fine sand. Layers or pockets of coarser material were noticed. The groundwater level was situated slightly above the excavation level for the building, except for part of the building area, about 1100 m<sup>2</sup> in size, where the excavation had to be carried out to a depth of about 3 m below the groundwater level. On the basis of the soil investigation, the consultant presented a detailed plan for the excavation. Groundwater lowering was suggested to take place before excavation of the deeper part of the building area by means of well points (according to the vacuum method).

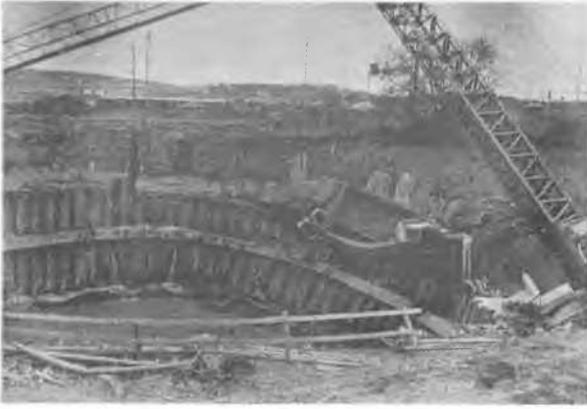
**Fig. 2.** Problems encountered during excavation often cause the contractors great concern. Ground failure due to hydraulic uplift.

(i) *Hydraulic uplift.* An illustrative example of the serious consequences of insufficient soil investigations and ignorance of the effect of groundwater conditions is given by the problems encountered in the dry dock at Åndalsnes on the west coast of Norway, intended for the construction of off-shore platforms.

The soil at the site was found to consist of river sediments of organic sand and silt covering silty clay with some silt and sand layers and silt/sand pockets. The clay was underlain by a ridge of sand and gravel wedging into the site of the dry dock from the north-west. The top surface of the ridge was at a depth below the bottom of excavation varying from

It was obvious that the geotechnical consultant had misjudged the geotechnical conditions. The site investigation was insufficient and, above all, did not reveal the geo-hydrological conditions at the site. After a great number of additional soil investigations, necessitated by the problems encountered, it could be stated that the safety against hydraulic uplift of the bottom of excavation was insufficient. The consultant, in his analysis, had assumed that the hydraulic head in the silt and sand seams to be found in the clay underneath the relief wells would reach a maximum corresponding to the average sea water level. However, pore pressure measurements made outside the excavation, after the trouble had started, showed a hydraulic head of + 3.5 m, *i.e.* 3.5 m above average sea level. Of course, the pore water pressure underneath the dry dock would decrease occasionally due to the decrease in overburden pressure entailed by excavation which might inveigle those concerned into a delusive feeling of safety. Thus, with time the hydraulic head will most certainly regain its original level.

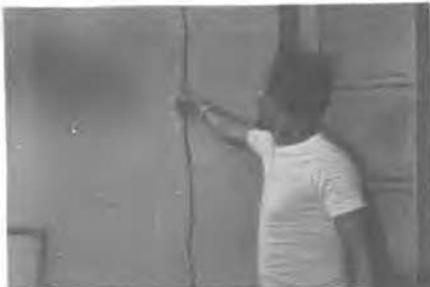
Fig. 4. Cracking of silo walls very costly for the consultant.

As a result, the silo pressure calculated by the consultant and used as design values was considerably lower than if he had followed the recommendations given in the German Standard. For example, the design pressure according to DIN 1055:6 would be about 1.65 times the value given by the consultant at 10 m depth and 1.41 times the value given at 20 m depth (at the bottom of the silo). The consultant's case was aggravated by the fact that the permissible stresses used in his design of reinforcement were above those accepted in the code.

After the silo concrete walls had started cracking, the storing capacity had to be reduced to about 60 % of its full capacity. Compensation for economic losses was required from the consultant but their insurance company refused to pay. The case was, therefore, summoned before the
