# GROVEHURST DOCK DAM, FOUNDED ON RECENT ALLUVIUM

A.C. MEIGH, M. Sc. (Eng.), E. Eng., F.I.C.E., M. ASCE.  
E.T. HAWS, M.A. M.N.Z.I.E.  
Soil Mechanics Ltd. London, England.

**SYNOPSIS** The dam was constructed under tidal conditions on a soft clay foundation, without dewatering or removal of the clay. Initial closure to normal high tide level was achieved by end tipping, the cross-section being determined by displacement of the alluvium. Vane tests in the foundation were made before, during and after construction, and the position of the fill/alluvium interface was followed by boring. The final profile was designed section-by-section as construction proceeded. The strength reduction by remoulding was followed as the alluvium was displaced and the subsequent increase by thixotropic regain and later the effects of consolidation. The same sequence was studied in the laboratory. Substantial settlements and cracking took place as was expected, but as the dam was extended to the designed profiles the rate of settlement decreased to a small value. It is estimated that the long-term factor of safety will approach 1.5.

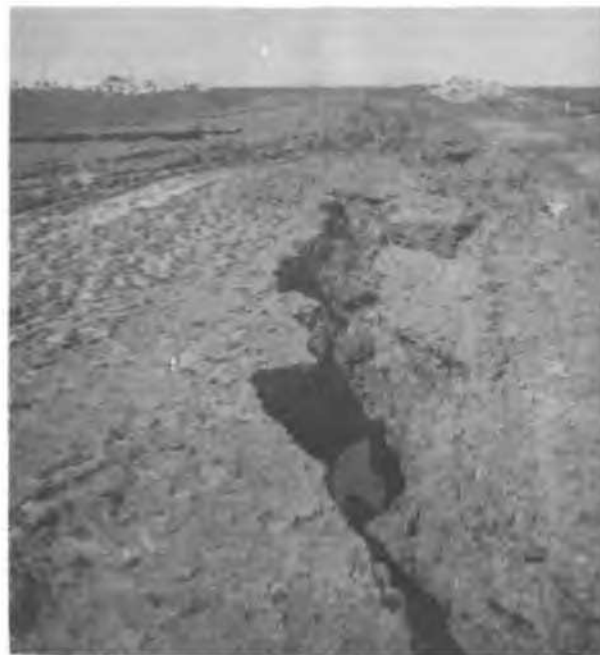
Fig. 4 Cracking after prolonged heavy rain following completion of first stage fill

From the start the extensive settlement of the fill was accompanied by the development of cracks, and this was specially noticeable after the closure when superimposed loads were again increased due to the second stage heightening. A prolonged period of intense rain accelerated and spread the formation of cracks at one stage (Fig. 4) and remedial work was carried out rapidly on sealing the cracks to prevent the entry of water and further softening.

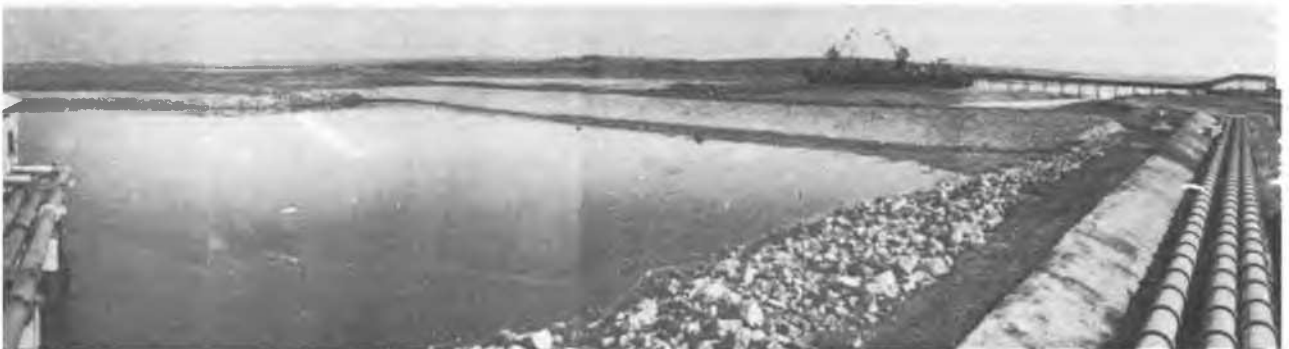
Fig. 9 Completed dam and discharge pipeline, from reservoir side.
