SLOPE STABILITY STUDIES FOR THE DELTA-MENDOTA INTAKE CANAL

WILLIAM H. WOLF

W.G. HOLTZ

SUMMARY

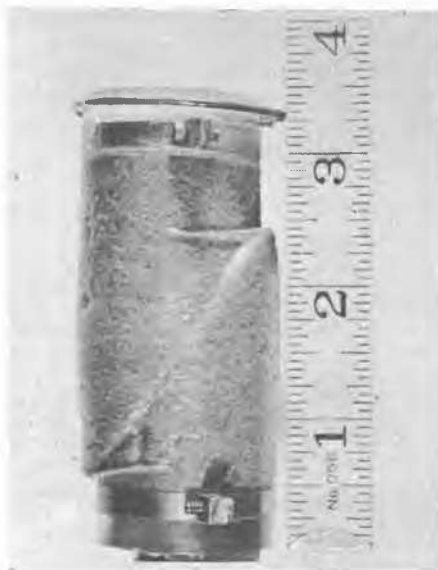
FIG.3

Triaxial shear specimen after failure.

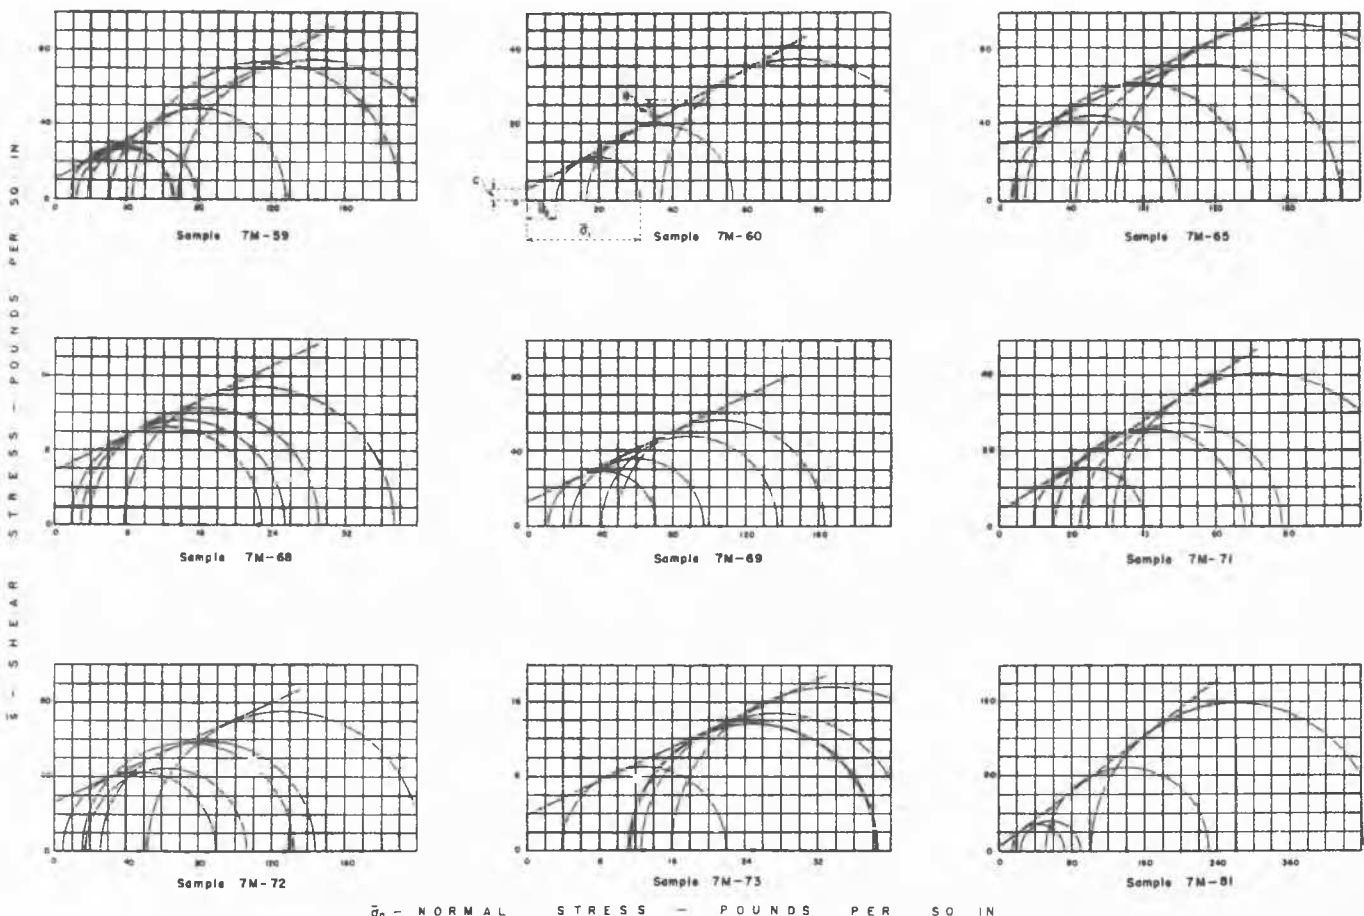
FIG.6

DELTA-MENDOTA INTAKE CANAL FOUNDATION MATERIALS MOHR'S ENVELOPES OF LIMITING SHEAR RESISTANCE
