UTILITY OF LOESS AS A CONSTRUCTION MATERIAL

W. J. TURNBULL

Field and laboratory studies on a major construction project in Nebraska demonstrated that silty loess soil could be safely used as embankment material for dams and, in the natural state, as a foundation for dams and hydraulic structures. Favorable behavior during the nine years since construction has justified the design procedures developed as a result of the preconstruction studies.

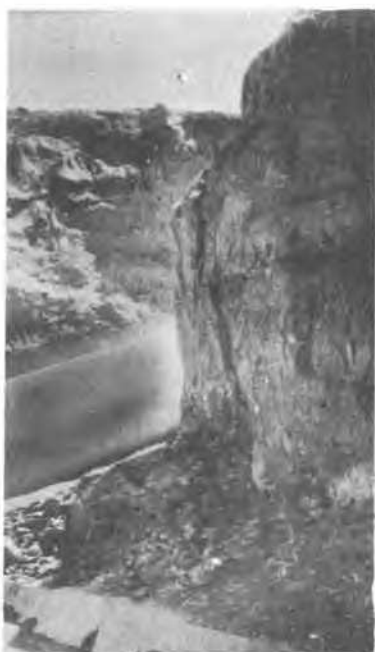
FIG. 2

Columnar slouching of silty loess bank

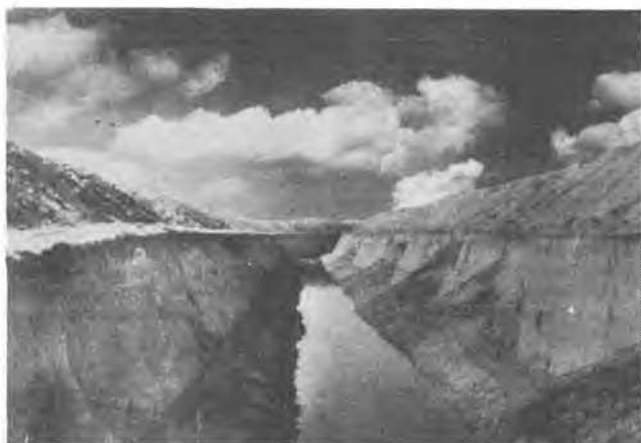
FIG.14

General view of experimental section through deep cuts in silty loess. Note several sloughs along right bank and absence of slough in left bank. The latter bank was laid back toll on 1/2 at a height of 55 ft.

The backslopes 3) for the deep cuts through the loess ridges were designed on the basis of direct shear tests on undisturbed samples at natural field moisture. The relatively low factor of safety of 1.1 to 1.2 was used because it was not believed that subsequent overloading of the banks could take place to the extent of materially infringing on the designed stability. Table 2 shows the backslopes adopted for the various types of soil encountered. The adoption of these steep slopes rather than using those usually considered by designers as necessary in this area would save in excess of 5,000,000 cu yd of excavation. The soundness of the design of the slopes for the deep cuts was questioned by many engineers, and a large-scale field test was conducted while construction was in progress. In one instance a backslope of 1 (vertical) on 1/4 (horizontal) was continued past the design height of 55 ft to a height of 62 ft, at which height sloughs were occurring quite often, the first slough having occurred at a height of 58 ft. Figure 14 shows a view of this experimental section.

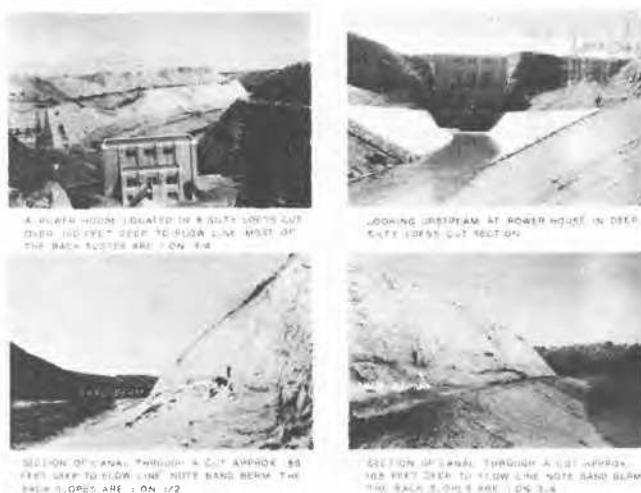
FIG.15

Typical views of deep cut canal sections in silty loess

The dams were constructed with 1 on 3 side slopes and after 9 years there has been no evidence of instability. The high differential foundation settlements anticipated (2 to 5 ft) did take place and the dams proved to be sufficiently plastic to deform with the foundation. Grouting was successful in preventing excessive settlement on the major concrete hydraulic structures and insured their stability. The stability of the deep cut slopes has been entirely satisfactory, except for occasional sloughs and wind erosion on an occasional sand stratum. It is estimated by the writer that 90 per cent of all sloughs which have occurred on the steep back slopes occurred within the first 3 days after excavation. Figure 15 shows typical views of the deep cut canal sections.

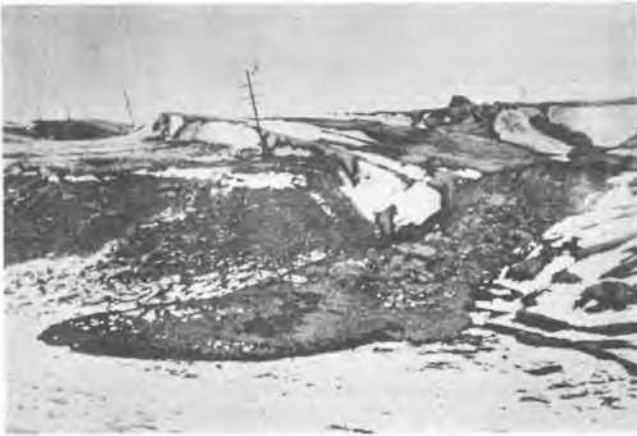
FIG.16

Flow slide in loose fill, silty loess soil

Figure 16 shows a typical flow slide which occurred in silty loess soil at a road crossing ramp along the outer bank of a canal in side-

hill cut. The material involved in the slide was loose fill material cast from the canal section, which subsequently became saturated. The void content of the loose fill material was estimated at 55 to 60 per cent. Saturated natural and compacted soil adjacent to the slide showed void contents of 48 and 38 per cent, respectively. Since there was no evidence of the flow slides affecting the natural or compacted soil, it might be deduced that liquefaction of the disturbed silty loess under relatively low loads could occur at a void content somewhere between 48 and 55 per cent.
