Seismic ground improvement: stone columns performance for a power plant in the southern alluvial plains of Guatemala.

KEYWORDS: Alluvial plains, Guatemala, liquefaction mitigation, earthquake, stone columns, vibro replacement, settlements, CPT.

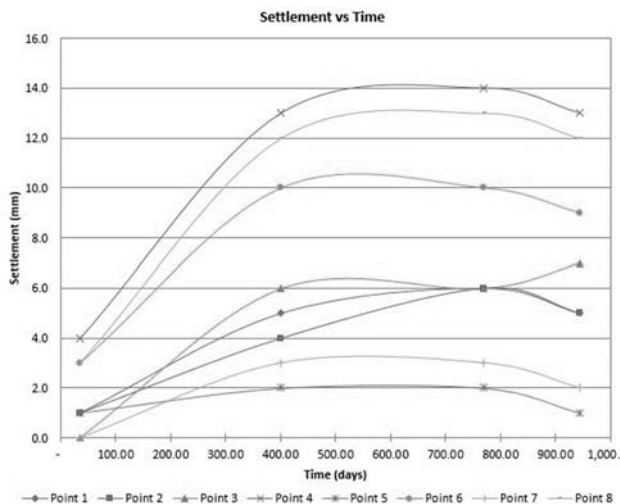
Figure 3 shows the graph of the total settlement of each point and Figure 4 shows the graph of the incremental settlement, both graphs shows a trend that no major settlements occurred after the third reading, about a year after the Power Plant operation began. It is important to mention that on 7th of November of 2012 an Earthquake of 7.4 Magnitude occurred, the epicenter was located in the Pacific coast of Guatemala at about 70 km from the site. During this event liquefaction was observed in Champerico and Ocos, both seafont communities as well as in San Pedro, San Marcos the largest town near to the epicenter.

Figure 3. Settlement at each point

The settlements of the engine warehouse of Genosa power plant reached an average of 7 mm, about 15% of the initially estimated settlement calculation, with a maximum value of 14 mm. The greater settlement values were observed in the corner areas suggesting a distention or confinement loss in these areas.

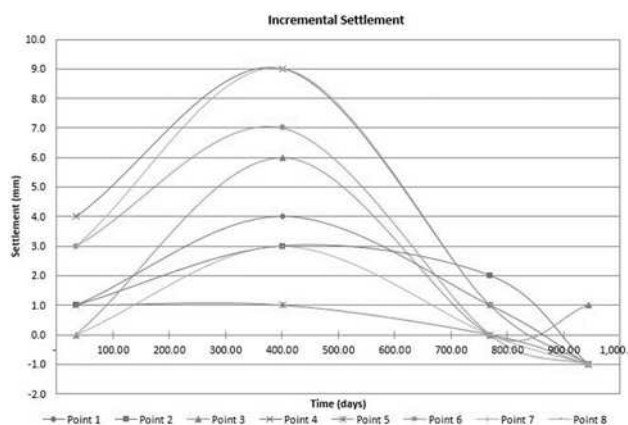
Figure 4. Incremental settlement at each point.
