Geotechnical characterization for a large urban excavation in Manizales, Colombia

The paper presents the geotechnical characterization for a large permanent excavation with some 400 m length and maximum depth of 40m required for the development of the Mall Plaza construction site in Manizales, Colombia. The site is in the middle of a highly populated area in a terrain with large topographic gradients. A regional fault with large displacements and its associated damage zone, some 100 m wide, crosses the site diagonally. The main rocks found in the site are graphitic schists. A diorite inclusion was found emplaced locally in the fault width zone. The terrain is overlaid by volcanic ash coverage from several eruptions of the Ruiz Volcano as well as colluvial deposits from quaternary earth flows and avalanches, common in the region. The zone has an average annual rainfall of 2000 mm, and is located near seismically active faults, capable of producing up to magnitude 7 earthquakes with recurrence within the design lifetime span of the project. Due to this adverse geological and environment conditions, the excavation have a high risk. Initial conventional wash borings and small diameter

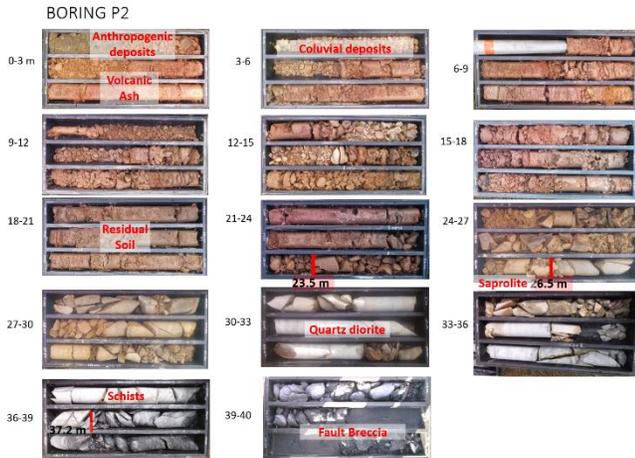
Figure 4 - Photographic record of P2 drilling located in the middle on the northern border of the project area.

Figures 4 and 5 show photographic records of exploration drilling made during design studies, where the different materials found in the area can

Figures 4 and 5 show the photographic record of two of these bore holes. A continuous recovery was achieved in all the materials, which could establish an adequate geological description and geo mechanical classification of the rocks as well as perform tests on cores of unaltered material. The presence of a quartz diorite intrusion was identified along the shear area. It was also found that schists in the shear zone are completely disintegrated and weathered, giving place locally to a gravelly soil in silty matrix with clay gouge veins.

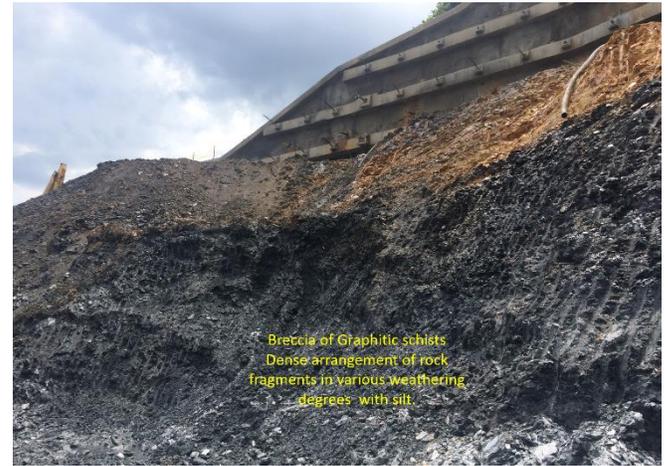
Figure 7 - Excavation slope in the fault zone in the center of the project area.

be seen. Figures 6, 7 and 8 show photographs of materials found during excavation for the project.

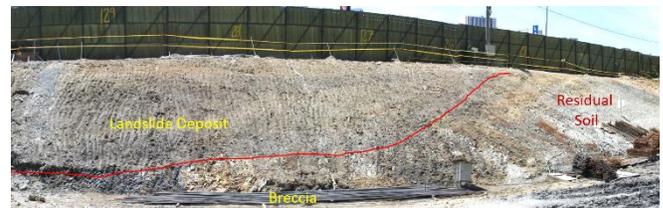
Figure 8 - Excavation slope the western side of the project.

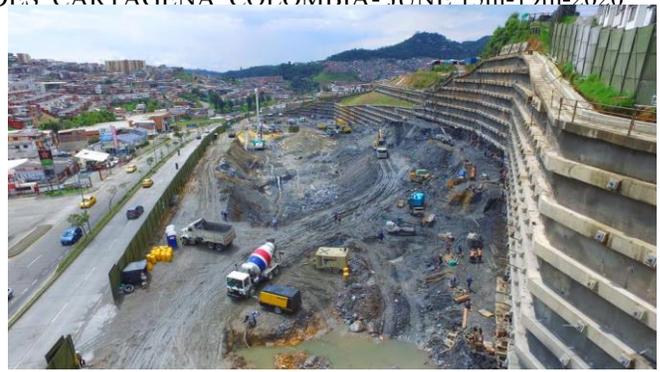
Figure 12 – View of the excavation during construction.

Figure 12 show the wall during construction in a view towards the west. The higher zone of the wall under construction can be seen to the right in the photo. The general extension and the context location of the urban excavation is shown in Figure 13.

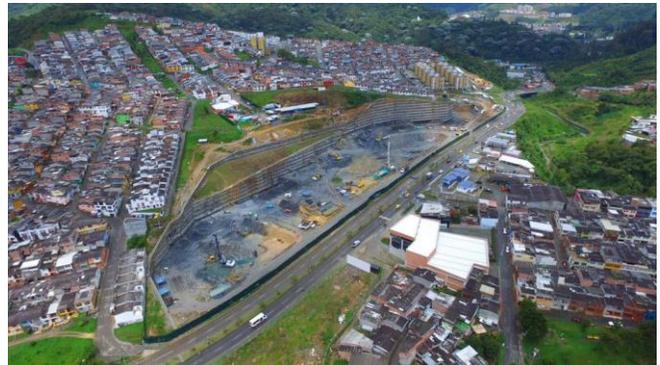
Figure 13 – Air view of the excavation during construction.
