Development of a Treatment Strategy Applicable to Field Conditions for the Repair of Vertical Fractures in Concrete Using MICP

Gloria M. Castro¹, Grainne El Mountassir², and Rebecca J. Lunn, MBE FREng FRSE FICE³

Concrete plays a vital role in infrastructure and is often exposed to harsh conditions. Reducing the permeability of damaged concrete through durable repairs is crucial to prevent further deterioration. This study develops a Microbially Induced Calcite Precipitation (MICP) treatment for field conditions, targeting millimeter-scale, vertical fractures with limited access. Treatment used three injection ports while ultrasonic and representative permeability measurements characterized crack evolution. After treatment, the crack permeability decreased significantly, and the treated block showed a repair tensile strength of 0.5 MPa compared to the original concrete's 2 MPa. SEM-EDS analysis revealed a well-distributed, strongly cemented repair interface. The study demonstrates that MICP can effectively seal vertical fractures, providing a durable, low-permeability repair suitable for field conditions.

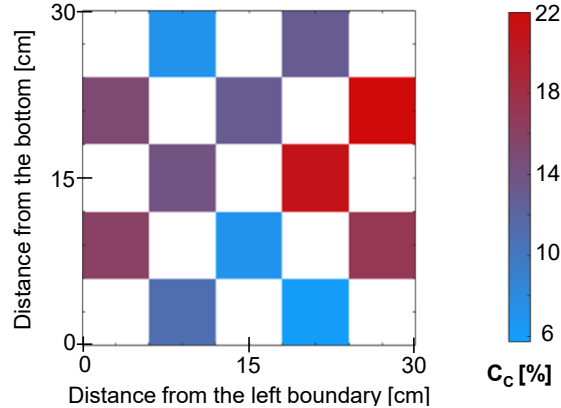
After the final permeability measurement, the repair was extracted from the acrylic plates and divided into a grid of 5x5 squares of 6 cm side. Carbonate content C_c was then measured on every other square, displaying an overall well-distributed precipitation pattern (Fig. 5). Nevertheless, low C_c values near the middle-bottom injection ports suggest that the injection through the bottom ports should not be avoided as treatment fluids were rapidly used near the injection ports used (middle and top), resulting in reduced resources available to the bottom area.

Fig 5. Carbonate content along the repaired fracture after 6 MICP cycles.

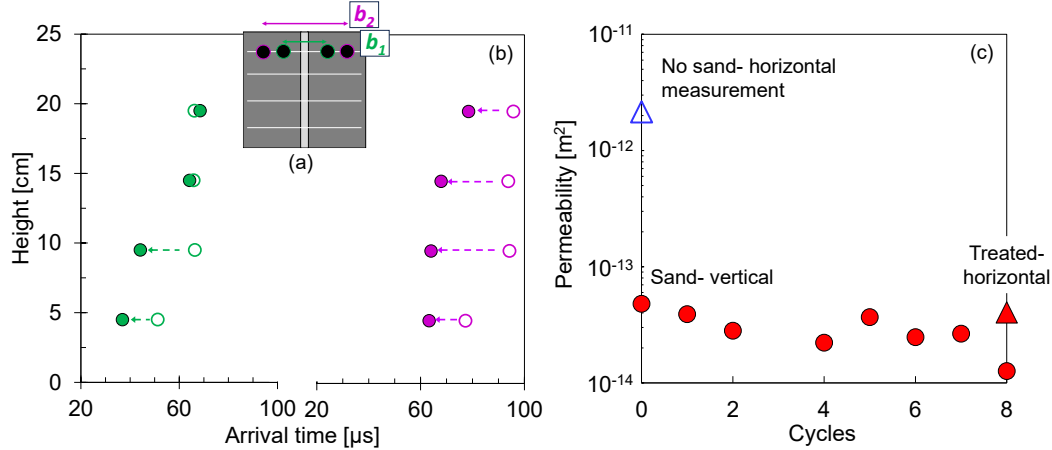
Arrival times at measurements taken further from the latex membrane (b_2 in Fig. 7a and b), display a consistent enhanced wave transmission (i.e. reduced arrival time) along the fracture depth in comparison to measurements of an empty fracture prepared following the same procedure but without the MICP treatment. Measurements taken too closed to the latex membrane did not show significant variations (top values of b_1 in Fig. 7a).

Fig. 7. Transmission properties after MICP treatments. (a) p-wave arrival time along repaired fracture depth. Open symbols display values for an open fracture joint by a latex membrane and filled symbols display measurements after 8 MICP cycles; (b) fluid permeability evolution during the treatment process. Triangles display horizontal measurements and circles vertical.

A pundit equipment was used at the end of the MICP treatment to assess the homogeneity of the repair along the fracture depth (Pundit-200 Proceq, with 54 kHz transducers connected). The transmitter and receiver transducers were set in contact with the concrete block across the repaired fracture at two distances ($b_1=10.35$ cm and $b_2=20.7$ cm) at four locations along the fracture depth (Fig. 7a).

Horizontal and vertical permeability measurements display a permeability reduction of about two orders of magnitude (Fig. 7b). Most of the reduction in permeability is given by the injection of the filler (carbonate sand + bacteria), and additional drop in permeability results as bio-precipitates bind the sediment inside the concrete fracture. Additionally, the pore volume of the fracture was reduced by 84% (1150 ml before treatment and 190 ml after). Both reduction in permeability and pore volume are key in the decrease in concrete degradation as it diminishes the ingress and retention of damaging substances.
