## **Riprap Protection Around Bridge Piers in a Degrading Channel**

Yee-Meng Chiew<sup>1</sup>

### **ABSTRACT**

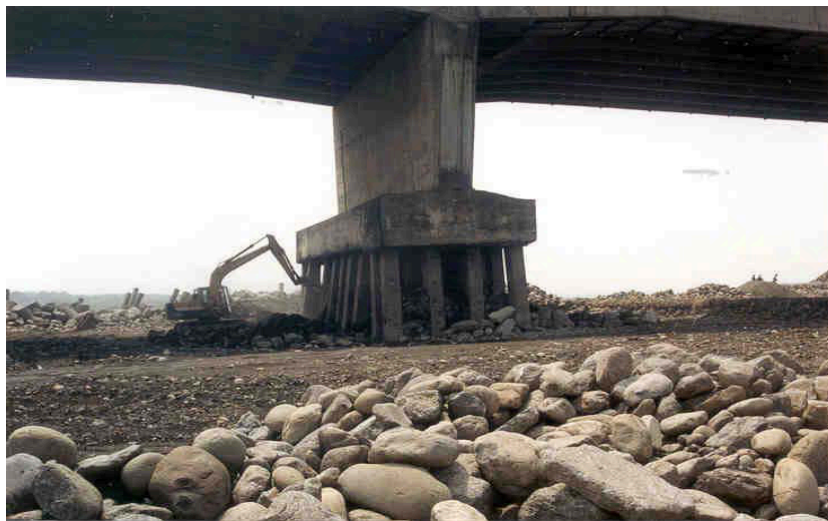
Figure 1. Bed Degradation at Kaoping Bridge, Taiwan causing exposure of pile foundation

in certain rivers, it is clearly not universal. The failure of Kaoping Bridge in southern Taiwan is an excellent example of the important correlation between riverbed degradation and bridge pier stability. Figure 1 reveals how bed degradation has exposed the pile foundation, while Figures 2(a) and 2(b) show the eventual demise of the bridge on August 28, 2000. The cause of failure of Kaoping Bridge is complex but it would not be erroneous to state that it is closely related to the combined effect of general and local scouring.

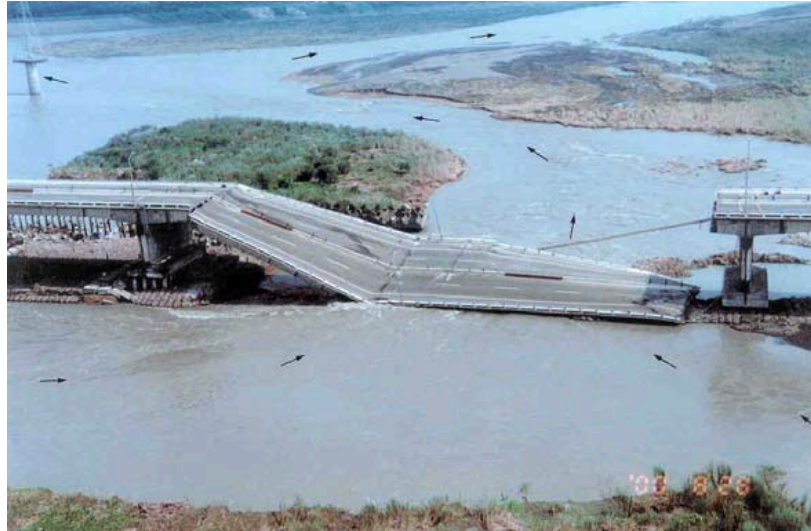
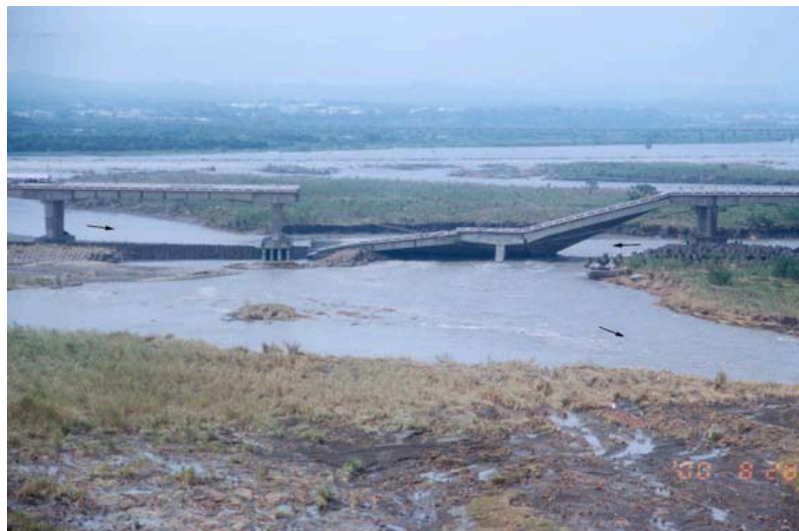
**(a) Looking downstream**

**(b) Looking upstream**

Figure 2. Failure of Kaoping Bridge, Taiwan due to a combination of general and local scour (Courtesy of Professor C. Lin)

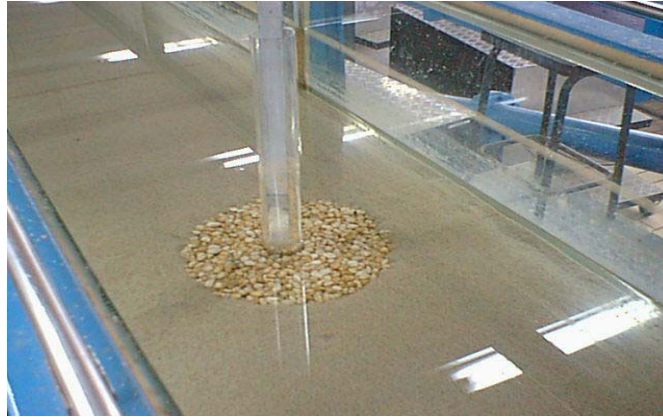
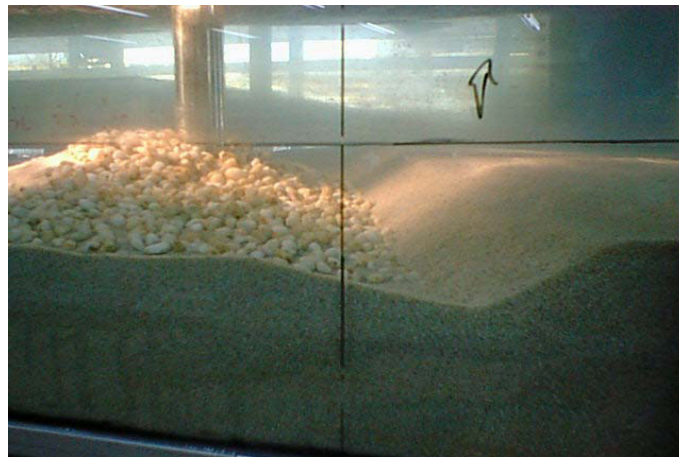
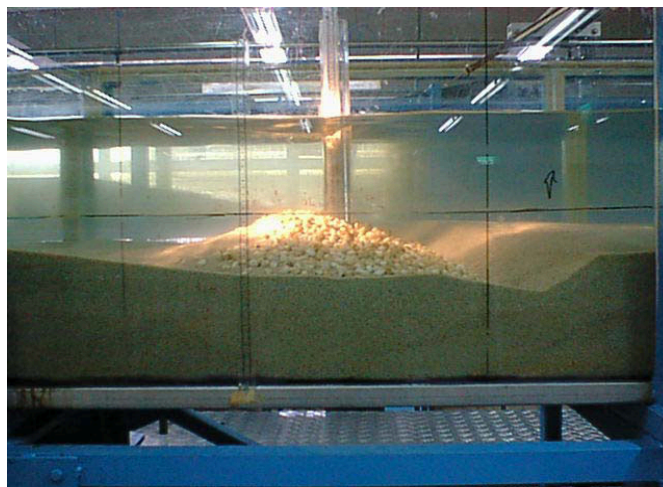
(a) Riprap layer at the commencement of test

(b) Formation of riprap mound around pier (flow from right to left)

(c) Dune approaching the riprap mound which is generally stable  
(flow from right to left)

Figure 6. Formation of riprap mound around bridge pier in a degrading bed

sediment was eroded, a small indentation forms, causing the riprap stone to drop into it. This observation is consistent with those described in the literature, for example, Chiew (1995). With time, bed feature destabilization, caused by the propagation of dunes past the pier and the riprap layer, sets in resulting in damages to the riprap layer. This phenomenon was described in detail in Chiew and Lim (2000) and Lim and Chiew (2001). In this test, an additional dimension, which was not observed in these previous studies, is present in that the sediment bed is also subject to degradation. Although the entire bed degrades, the riprap layer did not because it is designed to withstand the flow at  $U = 1.4 U_c$ , i.e., shear failure of the riprap stones did not occur. As a result of this, a mound consisting of the riprap stones forms around the pier. This phenomenon is often observed in the field. The photographs in Figure 6 show the formation of the riprap mound around the pier. Figure 6(a) shows the layout of the riprap layer around the cylindrical bridge pier before commencement of the test. The second figure (Figure 6b) shows a close-up view of the riprap mound after general degradation of the bed level, while the large stones making up the riprap layer remain intact. Figure 6(c) shows the side view of the riprap mound with a dune approaching it. At this stage the riprap mound is generally stable because general scour has rendered a lower velocity excess for the given steady flow condition in the study. Moreover, the rate of sediment transport has also decreased markedly.

The riprap mound that formed around the pier shown in the present study is not uncommon in many field conditions. It forms because the entire bed degrades due to general scour while the riprap stones remain intact. This is because the latter is designed to resist the flood flow. At this juncture, the riprap layer appears to be able to function as it was intended. In this study, a second flood with a similar  $U/U_c$ -value as the first was simulated after the formation of the riprap mound to examine whether it can protect the pier against further erosion. Besides this, because much of the sand has already been eroded from the flume, additional sand was placed in the flume at a location upstream of the pier and riprap mound. When the flow was initiated, dunes were formed and they propagate past the riprap mound. When the dune approached the mound, water flowed over the dune crest and reattached onto the riprap layer. Observations show that this reattached flow is very important in destabilizing the riprap stones, as was also observed in the study by Chiew and Lim (2000). When this takes place, the exposed riprap stones were eroded and transported downstream exposing the layer to winnowing failure, where the underlying fine sediment was lifted through the voids formed by the interstices of the larger stones. This causes the stones to self-embed, leading to its eventual failure. Figure 7 shows the riprap mound after it was subjected to a second flood of a similar magnitude. The first photograph shows the riprap mound just before the dune arrives at the pier. At this point in time, the riprap layer is subjected to high erosion, due partly to the reattachment of flow over the dune crest. This flow is very efficient in eroding the large riprap stones, especially for those that are

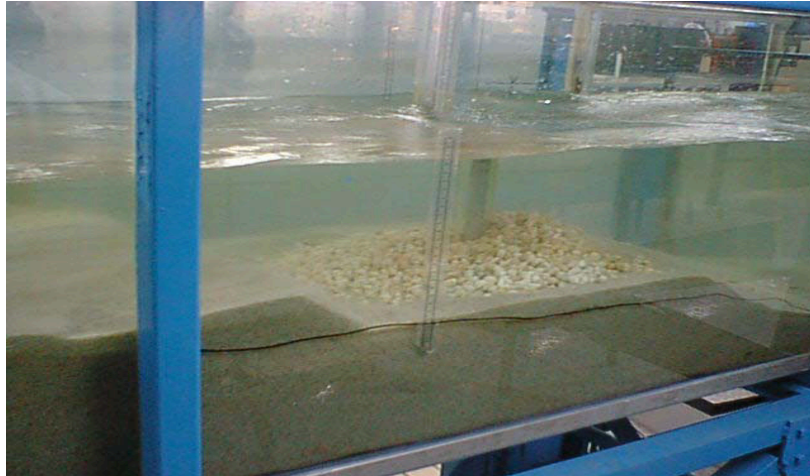
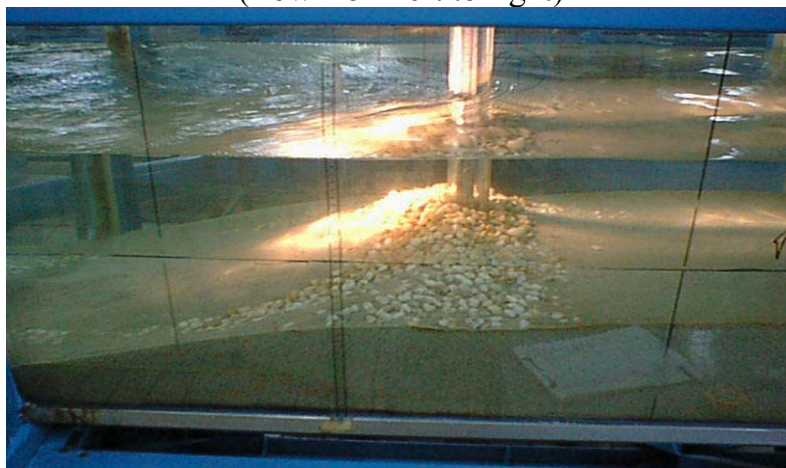
(a) Dune from second flood approaching the riprap mound  
(flow from left to right)

(b) Dune completely bury the riprap mound  
(flow from left to right)

(c) Remains of the riprap mound after subsidence of the second flood  
(flow from right to left)

Figure 7. Effect of second flood on riprap mound

exposed. Many stones were eroded by the reattached flow over the dune crest. The second photograph shows that the riprap layer was completely embedded by the propagating sand dune. At this juncture, it is surmised that little erosion was taking place, but some form of position readjustment was probably unavoidable. The last photograph shows the remains of the riprap mound after subsidence of the second flood. Clearly the riprap mound is significantly different from that shown in Figure 6. Many of the stones making up the riprap layer were entrained and transported downstream. A large degradation, which resembles the lee-wake scour associated with erosion around a submarine pipeline (Chiew, 1990; Sumer et. al, 1988), can be seen downstream of the pier. A comparison of the riprap mound in Figure 7(c) and those in Figures 6(b) and 6(c) reveals significant differences between them. It is not unreasonable for one to infer from this study that further floods will eventually cause the complete demise of the riprap layer.
