Influence of Topography and Geological Structures on Road-Cut Failures in Central Highlands, Sri Lanka

ABSTRACT: The geometric relationship between foliation or bedding planes of rock and topographical slope is a critical factor in determining slope stability of road-cuts. Under this study, an attempt was made to classify the attitudes of topography with respect to the geological structures to define susceptible classes for road-cut failures. Strike and dip of bedrock foliation, topographic slope angle and direction were measured at 136 road-cut failures along some selected roads in the Central Highlands. Deviation and apparent dip angles were calculated at each site to classify topography into over-dip, under-dip, steepened escarpment, and subdued escarpment. It was noted that road-cut failures are slightly higher in dip slopes than in scarp slopes and are rare in intermediate slopes. The 0° to 10° range of deviation angle is highly unstable in road construction and widening. Road-cuts in under-dip and subdued escarpment conditions are more favorable to failure than those in over-dip and steepened escarpment conditions. Road-cuts in slope angle range of 21° to 30° have a higher s

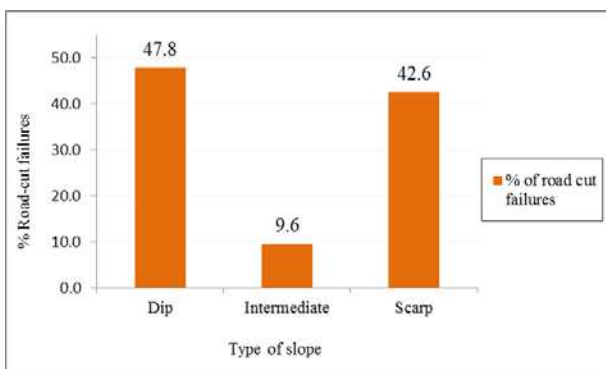
Fig. 3 Percentage of road-cut failures Vs type of slope (classification based on deviation angle)

According to calculations of Table 2, percentage of road-cut failures is considerably higher in both dip and scarp slopes than intermediate slopes. Failures are slightly higher in dip slopes than that in scarp slopes. Failures are rare in intermediate slopes (Fig. 03).

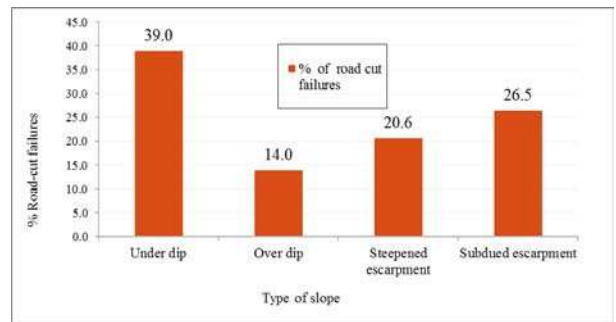
Fig. 4 Percentage of road-cut failures vs type of slope

According to Table 3, failures in under-dip slopes are higher than those in over-dip slopes. Fig. 4 shows that percentage of road-cut failures in subdued escarpments is higher than that of in steepened escarpments. Cooray in 1984 reported a contrary view to this observation. However, his work was not based on road-cut failures but on landslides.

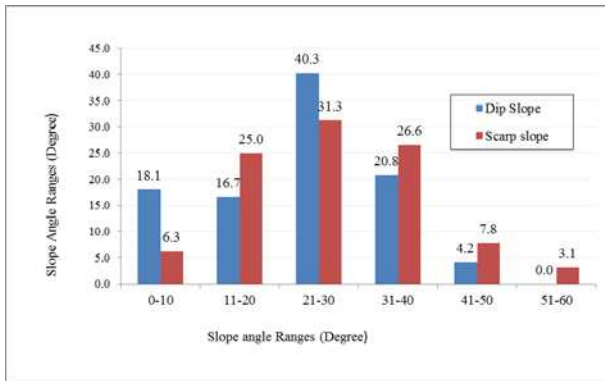
Fig. 5 Percentage of road-cut failures vs slope angle ranges (degree)

According to Table 4, there is an increasing trend of failures in the slope angle range of 0° to 30° and then decreasing trend with the increase of slope angle in both the dip and scarp slopes. The highest failures were recorded in the slope category (21°-30°) in both the slope types (Fig. 5). This diagram indicates that failures are rare in locations where slope angles are greater than 40° in dip slopes and less than 11° in scarp slopes.
