The paper was published in the proceedings of the 7th International Young Geotechnical Engineers Conference and was edited by Brendan Scott. The conference was held from April 29th to May 1st 2022 in Sydney, Australia.

Designing a breakwater in Apia: Results, challenges and recommendations

ABSTRACT: The Port of Apia, Samoa, is undergoing a development project to upgrade its facilities and infrastructure. As part of this project, an extension and remediation of the existing breakwater were assessed to provide further protection from swell waves and cyclones, thereby reducing delays in port operations. To inform the design of the breakwater, three boreholes were drilled in Apia Harbour, each recovering ~20m of very loose/soft sediments overlying basaltic lava flows. This recent borehole data was combined with the historical data to develop a geological ground model of the site. Using the ground model, liquefaction and slope stability analyses were undertaken for the breakwater extension and remediation. Analyses indicate likely liquefaction of the loose sediments leading to lateral displacement of the breakwater. The results were compared with the performance of the breakwater duri

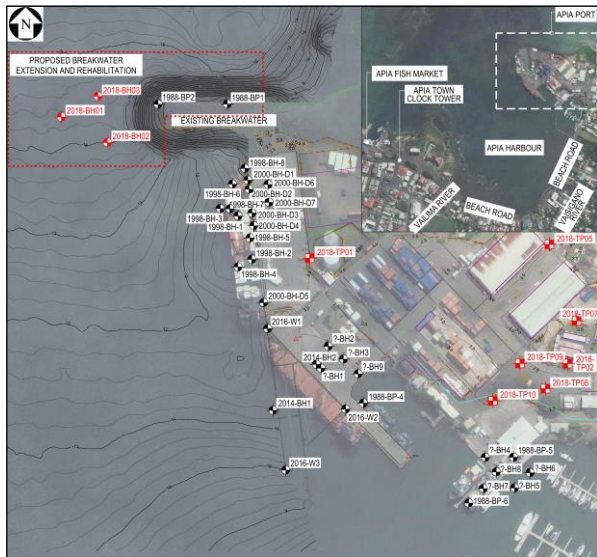
Figure 1. Map of Apia Port. Red and black symbols show the locations of investigations completed as part of this project, and black symbols show the locations of historical investigations. The inset map shows the locations of the port and Vaisigano River in Apia.

Apia is located on the northern coast of the island of Upolu, Samoa. The Port of Apia is located 1.2km northeast of Apia's central business district, at the north-eastern end of Apia Harbour (Figure 1). The water depth of the harbour increases from -1mCD where the Vaisigano River enters the harbour to about -16mCD north of the existing breakwater. The Vaisigano River contributes a significant sediment supply to the harbour, with

Three boreholes were drilled in 2018 to the west of the existing breakwater using a QM200 rotary rig, aboard the jack-up barge Tuhura. Testing comprised standard penetration tests (SPTs) and shear vanes in cohesive sediments. Laboratory testing (gradings and Atterberg limits) was completed to confirm the sediment grain size and plasticity. Data from historical investigations at the Port, including at the site of the existing breakwater and wharf, was also used. Investigation locations are shown in Figure 1.
