Founding on (un)known chalk in Aalborg

C. T. Leth

COWI A/S, Denmark, ctl@cowi.dk

The North Denmark Region wishes to build a new hospital to accommodate all hospital functions in Aalborg. At a budget of DKK 4.1 billion, the complex of buildings will cover 155,000 m². The first turf was cut in 2013 and the construction works will run from 2015 to 2020. The foundation level will vary from approximately four metres to ten metres below ground surface.

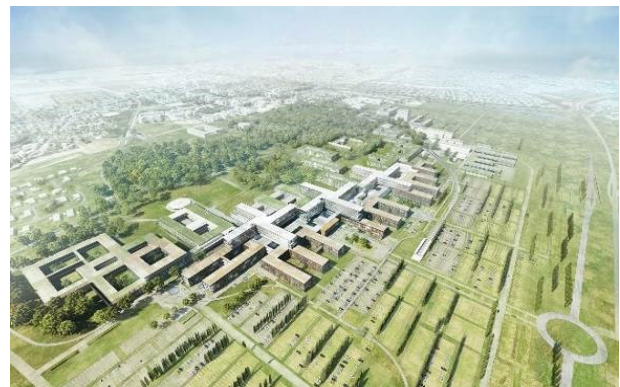
Figure 1: Illustration of Nyt Aalborg Universitetshospital (NAU).

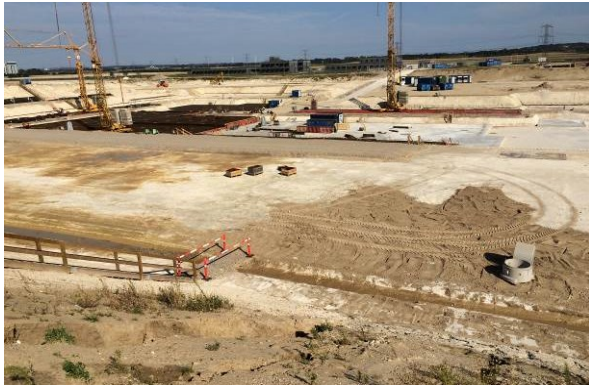
Figure 2: Excavation for basement level K2.

The building is constructed in an open excavation of 250 x 300 m. Existing terrain level varies between level (DVR90) +10 m to +18 m and deepest foundation (basement level K2) is level +2.95 m.

Ground water level is measured as high as +5.5 m and a temporary groundwater lowering is installed consisting of 18 dewatering wells with a yield of approx. 80 m³/h.

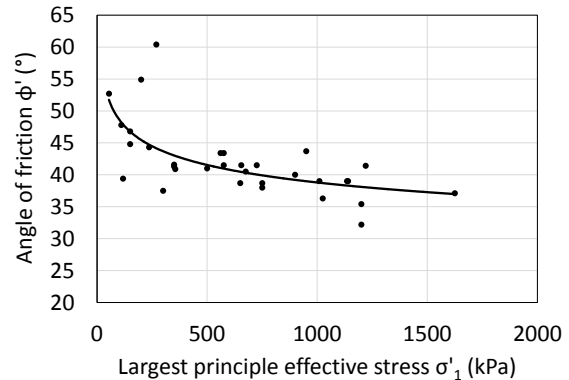
Figure 4: Angle of friction from previous triaxial tests

The triaxial tests indicates a variability of ϕ' with the stress level, represented by σ_1' . For normal foundation stress levels less than 1,000 kPa it seems that an effective angle of friction $\phi' \geq 38 - 40^\circ$ may be applied. In some projects lower values of ϕ' have been used in the topside zone of chalk, where ϕ' for remoulded/weathered chalk may be indicated as low as $30 - 33^\circ$.

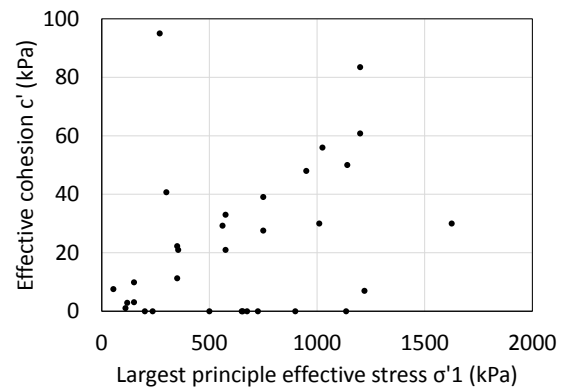
Figure 5: Effective cohesion from previous triaxial tests

The effective cohesion varies and seems to be nearly independent of the stress level and the evaluated angle of friction, which presumably is caused by more or less random fracturing of the chalk and evaluation of parameters from individual tests. Consequently, it has often been necessary to choose a conservative value $c' = 0$ kPa in the design of structures.

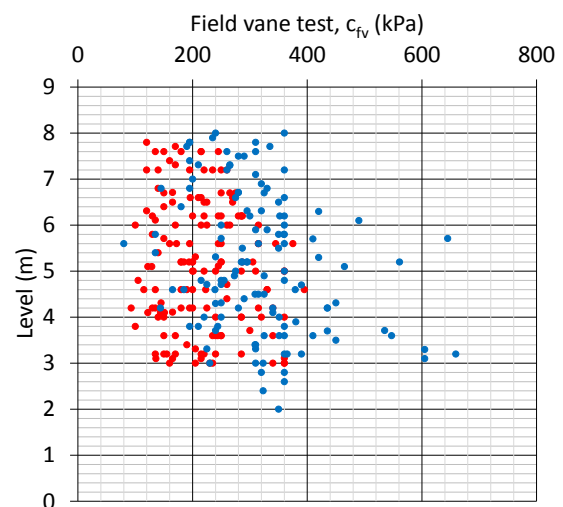
The measured strength in the chalk from the field vane tests between level +8 m and +2 m are plotted in Figure 6, where the field vane tests carried out from existing terrain has been plotted in blue where-as the latest field vane tests carried out from excavated level is plotted in red.

Figure 6: Field vane tests. Blue: before excavation and Red: after excavation to level +8 m.

It is observed from Figure 6 that there is a significant variation in both horizontal and vertical direction of the measured field vane strengths prior to excavation across the site with majority of the measured values between 200 kPa and 400 kPa, though with some outliers between 80 kPa and 660 kPa.

Comparing the measured field vane strength values from before and after excavation shows a general tendency of strength reduction after excavation, where the majority of the measured values after excavation are between 100 kPa and 300 kPa, with some outliers above 300 kPa.

The variation in horizontal and vertical direction may be explained by the nature of the upper part of the chalk with variation in hardening and fractures.

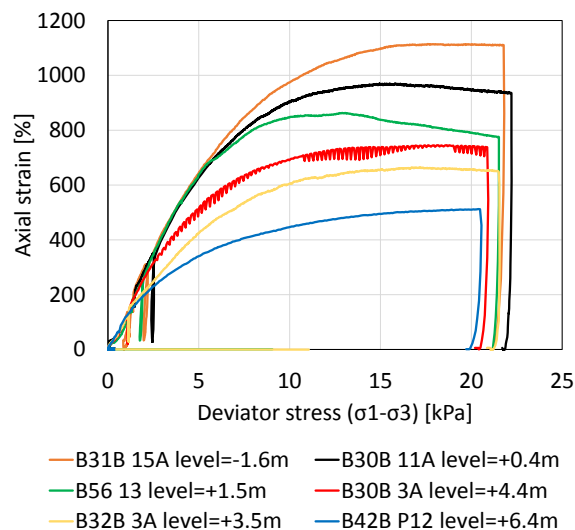
The measured stress-strain curves from the six CAU tests are plotted in Figure 7 for comparison.

Figure 7: Stress strain curves from CAU tests

It is observed from Figure 7 that the strength generally increases with depth, and that the samples exhibit the same behaviour from 0 % to 1-1.5 % axial strain. The behaviour deviates after an axial strain of 1-1.5 %, with the three deepest samples bundled until an axial strain of 5-6 %.

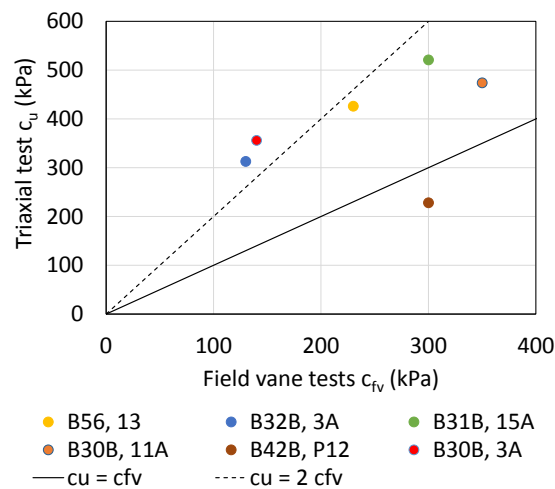
The undrained shear strength determined from the CAU tests is plotted in Figure 8 with corresponding strength determined by

Figure 8: c_{fv} versus c_u from CAU tests

field vane tests. Comparison of results from triaxial tests and field vanes gives a factor of $\mu = c_u/c_{fv} = 0.76 - 2.54$, and Figure 8 shows that a factor of $\mu = 1.0$ is applicable and reasonable conservative for the site. This complies with findings from other locations in the Aalborg area, cf. Figure 3, for $c_{fv} < 450$ kPa.

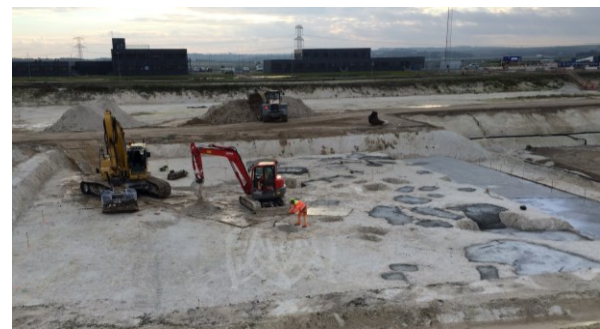
A situation with 'chimneys' at level +6.5 m can be seen at Figure 11. The foundation area consists of a section with many 'chimneys' (right side of photo) and a section without any chimneys (left side of photo).

Figure 11: Excavations of 'chimneys'

Existing terrain level was for the area shown in Figure 11 at +12.0 m with stratigraphic sequence of 1 m topsoil, 1 m glacial meltwater sand and chalk from +10.0 m. One of the 'chimneys' was measured to 400 mm in diameter and 3.1 m in depth, equivalent to bottom level at +3.4 m or approx. 8.5 m below terrain.

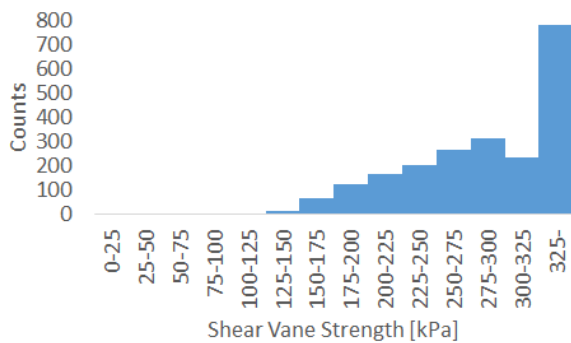
The variation in the undrained strengths measured by use of the field vanes are shown in Figure 12. It was possible to measure up to 330 kPa. Strength requirement was set by the designers to 150 kPa.

Figure 12: Variation in shear vane strength measured during inspection.

The slab at the deepest basement level has an area of 9000 m² where two small areas, in total 50 m², was replaced with concrete as geotechnical inspection showed unacceptable strength characteristics.
