Large scale driving of concrete piles in stiff to very stiff clay

ABSTRACT

1 INTRODUCTION

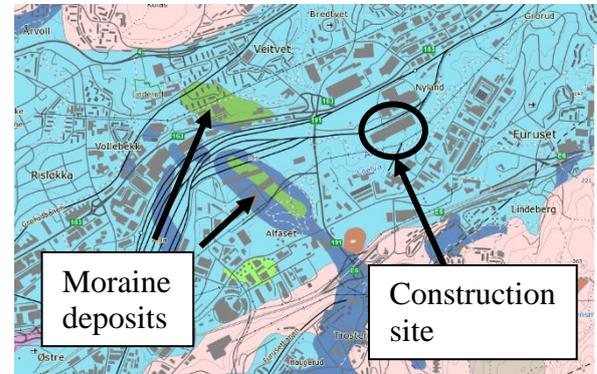
Figure 4: Geological map of the Alnabru area. Green is moraine deposits, blue is marine deposits and dark blue is beach deposits. (source: ngu.no).

An overview of the slide area and the morain is shown in Figure 3. The slide masses are therefor still covering the "undisturbed" sediments in large areas northeast of the moraine formation, shown in Figure 4.

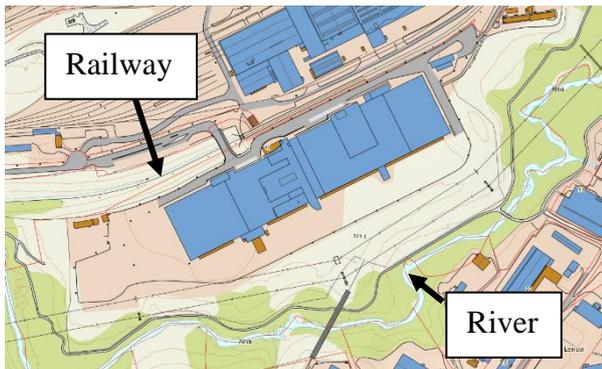
Figure 5: New warehouse in between railway cut and river ravine

The construction site is situated on a plateau at about 118 to 120 masl, and is surrounded by ravines and cuts. To the east, south and southwest, the river Alna flows at the bottom of a ravine about 8 to 12 m deep. To the north, a railway freight line runs past the site. The railway line lies partially at the bottom of an open cut up to 10 m deep, and partially in an open concrete culvert. Figure 5 shows the warehouse location between the river ravine and railway cut.

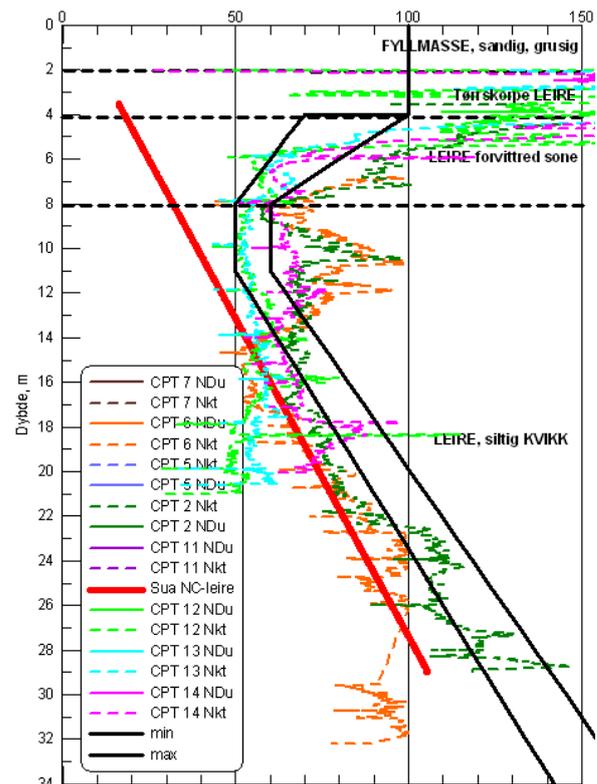
Figure 6: Undrained active shear strength based on CPTU soundings

The general soil profile at the site is about 1-2 m of various fill material over a stiff to very stiff clay layer. The stiff clay layer is the reconsolidated landslide masses from the quick clay slide mentioned earlier, and has a thickness of about 5 to 10 meters at the construction site. Below the landslide masses, the "undisturbed" clay is quick and slightly overconsolidated. Figure 6 shows a general profile of undrained active shear strength based on interpretation of CPTU soundings. The red line is the shear strength of a normally consolidated clay for comparison.

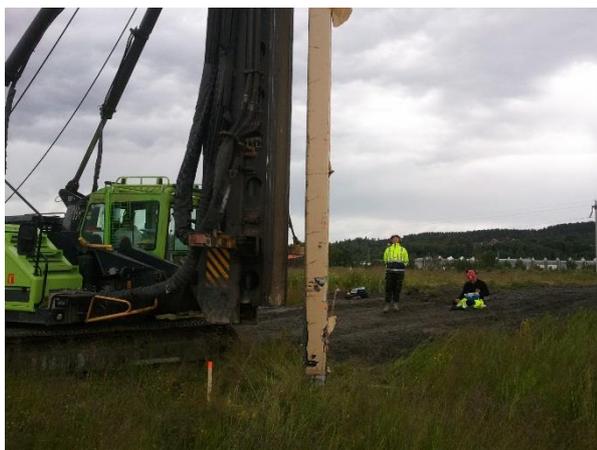
Figure 7: Test piling with PDA-testing

The test-driving was performed in late June and early July of 2012. A total number of 24 P270NA piles and 2 P230NA were driven using a 60 kN hydraulic hammer. The piles were scattered over the construction site, covering different variations in ground conditions. Out of the 26 test-piles, 2 piles broke during driving. The setup of test-piling at the site is shown in Figure 7.

During test-driving, 7 piles were driven with PDA-sensors mounted. The sensors logged the whole driving process of the piles, from terrain and down to stop criteria when hitting either bedrock or moraine layers. This gave an output of the tension stresses in the piles for all blows during the driving history. Results from PDA measurements confirmed previous analysis results that tension stresses were within acceptable range for the piles, and the project could continue with concrete piles as planned.

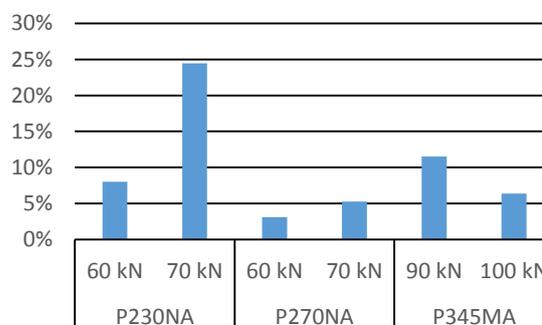
Figure 8: Percentage of broken piles by cross section and hammer size

Figure 8 shows the distribution of broken piles by cross section and hammer size. The most obvious result is the combination of P230NA piles and 70 kN, which proved to be significantly unfavourable. Driving of the smallest piles with this hammer was therefore stopped completely as soon as the broken piles percentage was identified to be that high compared with other combinations. In general, P230NA and P345MA piles proved to be more difficult with respect to pile breakage compared with P270NA piles.

Another observation from Figure 8 is the fact that the combination of P270NA piles and 60

kN hammer weight was the best combination with respect to number of broken piles. This was the same combination that was used during test-driving, and one could therefore say that the test-driving setup was not able to capture some difficult aspects of the pile-driving job at the site.

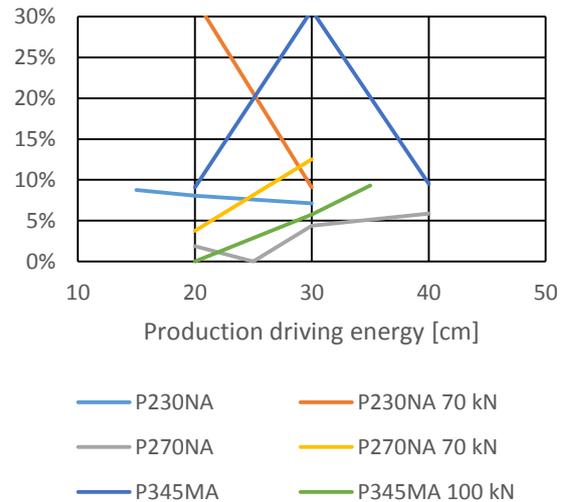
Figure 9: Percentage of broken piles by cross section, hammer size and driving energy

Figure 9 illustrates the percentage of broken piles by driving energy. Combinations with fewer than 10 piles (ref. Table 2) are left out of the diagram. The hammer-pile-combinations P230NA-70 kN and P345MA-90 kN obviously stand out as generally unfavourable. For other combinations,

reducing the energy during driving clearly reduces the number of broken piles. Reducing the energy increases the number of blows required to get the pile down to bearing layers, increasing the sum of dynamic loading on the pile during installation. From reduced energy also follows reduced stresses in the pile during driving, and the reduced stresses means less chance of the pile breaking over time.

The effect was especially significant when reducing energy from 30 to 20 cm for P270NA piles driven with 70 kN hammer. This combination was used for about 1/3 of the total number of piles in the project (Table 1).

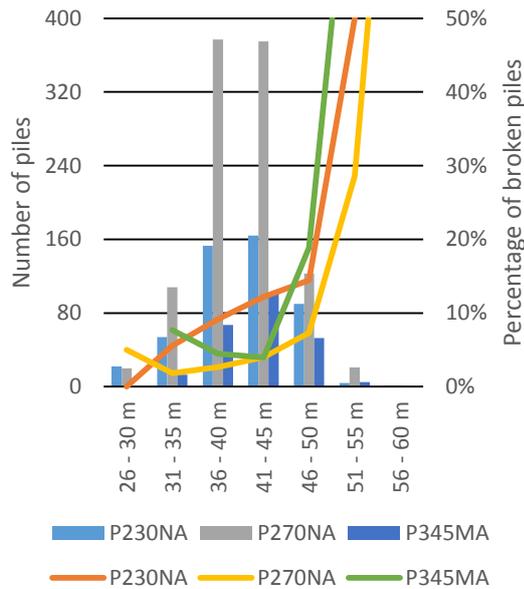
Figure 10: Number of piles and broken piles by pile length

The columns in Figure 10 show an overview of the total number of piles for each cross section and total pile length interval. The graph lines illustrate the percentage of broken piles for the corresponding cross section and total pile length interval.

According to figure 9, the number of broken piles increases significantly when the total pile length increases over about 46-50 m. Almost all P230NA and P345MA piles and about 30 % of P270NA piles longer than 50 m were broken. About 15 to 20 % of P230NA and P345MA piles and 7 % of P270NA piles between 46 to 50 m long were broken.

An increasing pile length increases the risk of some kind of unfavourable curvature of the pile, increasing the risk of breakage. The increased length also comes with an increase in total number of blows and cycles of dynamic stresses.

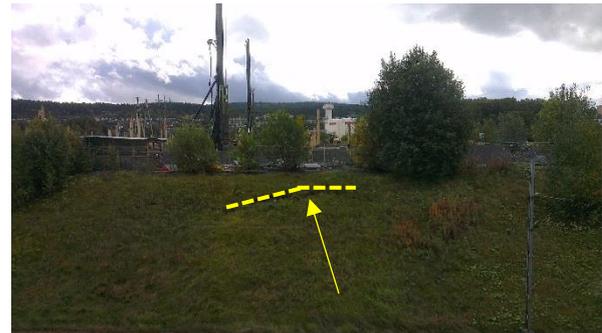
Figure 11: Surface crack in slope (marked with yellow dashed line)

In September 2012, after a heavy rainfall, surface cracks were observed in the slope towards the railway line. The appearance of the crack coincided with pile driving near the top of the slope. Figure 11 shows a picture taken from the other side of the railway cut, with the pile driving cranes working in the background.

Even shallow surface slides could cause concerns regarding operation of the railway line, and driving of concrete piles near the slope was stopped immediately. The slope was instrumented with electronic piezometers and inclinometer casing. The piezometers measured a very high pore pressure, with a magnitude in the order of the same as the vertical overburden (meaning that the effective stresses were very small). Inclinometer measurements were done with short time intervals for the first period of time after installation, but indicated no significant movement in the slope.
