Foundation treatment of Isimba hydropower project

N.A. Rugaba

UEGCL, Kampala, Uganda

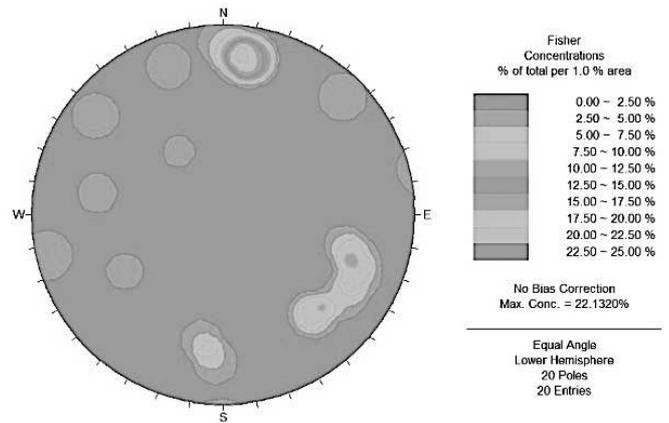
Figure 1. RED Rock Joints Pole Stereonet Plot

The stereographic analysis results are presented in **Error! Reference source not found.** and **Error! Reference source not found.**. The analysis indicate that the key joint structures are vertical to sub-vertical which suggest the use of inclined grout holes for the grout curtain. “Curtain grouting” means grouting of rock in one or more lines of holes spaced to form a curtain barrier.

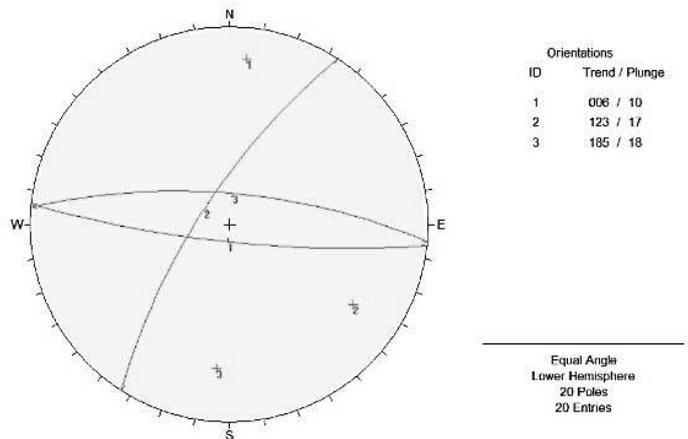
Figure 2. RED Rock Joints Plane Stereonet Plot

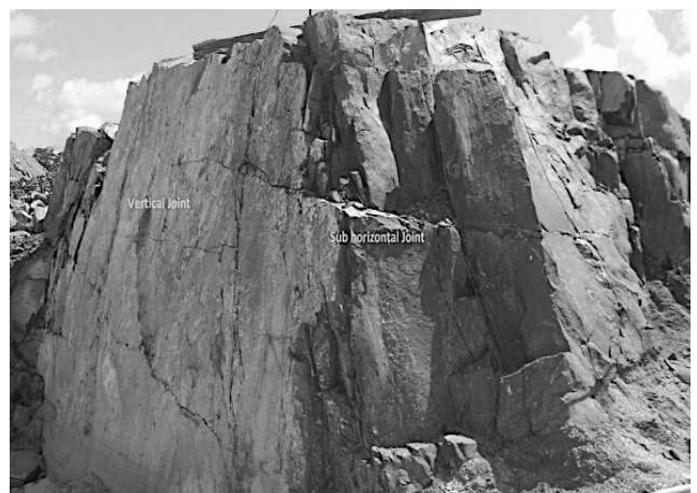
Figure 3. RED Amphibolite Rock Joint Sets

The rock jointing system is usually not formed by a single joint set. If primary rock joints are of first importance, other secondary or more joint sets with different orientation exist in the rock mass. This global rock joint configuration allows the grout to enter and fill the joints, since they are all interconnected.

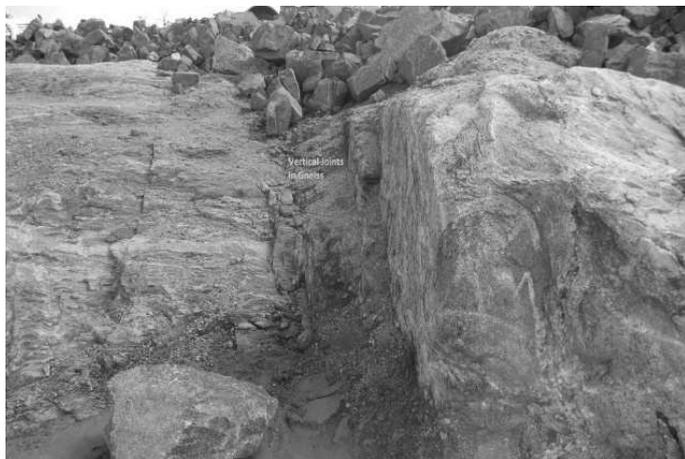
Figure 4. RED Gneiss Rock Vertical Joint Sets
