The paper was published in the proceedings of the 10th International Conference on Physical Modelling in Geotechnics and was edited by Moonkyung Chung, Sung-Ryul Kim, Nam-Ryong Kim, Tae-Hyuk Kwon, Heon-Joon Park, Seong-Bae Jo and Jae-Hyun Kim. The conference was held in Daejeon, South Korea from September 19th to September 23rd 2022.

High speed observation on damage process of embankments during earthquakes in a centrifugal acceleration field

R. Ibuki, T. Doi & J. Izawa

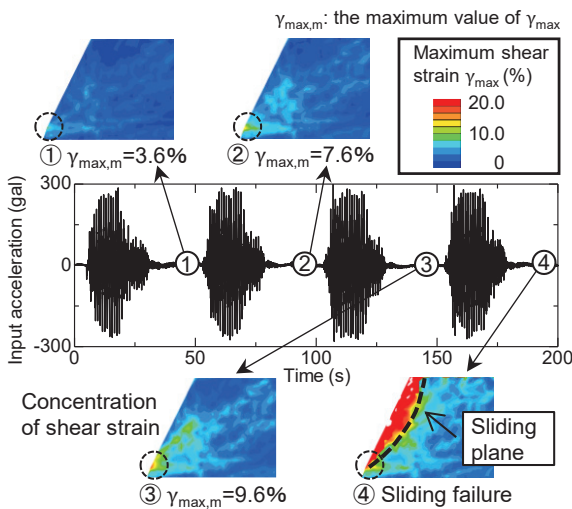
Fig. 1. The damage process up to sliding failure in the case with a steep slope (reconstruction Izawa et al., 2022). $\gamma_{max,m}$ is the maximum value of γ_{max} .

Izawa et al., 2022 conducted a series of the centrifuge shake table tests to observe the damage process of embankments during earthquakes using the PIV analysis (White and Take, 2003). They found that the damage process up to occurrence of sliding failure depends on the slope of embankments. For embankments with a steep slope, the shear strain concentrates near the toe of the slope and causes sliding failure as shown in Figure 1. On the other hand, for embankments with a gentle slope, shaking-down settlement mainly occurs without sliding failure even against severe earthquakes. In addition, they have proposed a performance verification method,

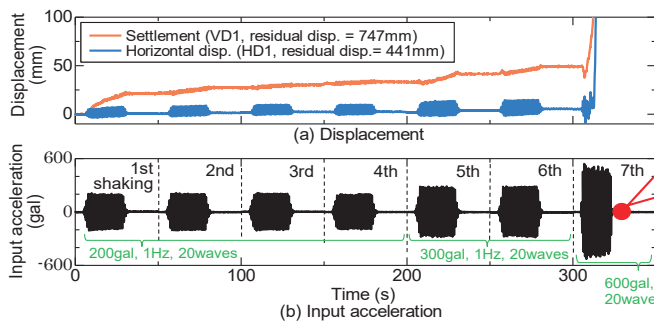
Fig. 4. Time histories of displacement and input acceleration.

Some types of sinusoidal seismic waves were repeatedly applied so that the deformation process until the sliding failure of the embankment could be observed in detail. Figure 4 shows the time histories of the settlement (VD1), horizontal displacement (HD1) and the input acceleration from 1st to 7th shaking.

From 1st to 6th shaking, the settlement at the crown gradually increased without large residual horizontal displacement. In 7th shaking, the horizontal displacement increased rapidly, and the embankment collapsed showing clear sliding plane as shown in Figure 5. Figure 6 shows magnified view of the time histories of the horizontal displacement and the input acceleration at 7th shaking. The red plots in Figure 6 indicate the capturing timing of digital images. Upper part of Figure 7 shows the digital images at 7th shaking step and the distributions of the maximum shear strain (γ_{max}) obtained from the PIV analysis. In the PIV analysis, the digital image taken just before 1st shaking is used as the initial state. The maximum value of γ_{max} is also indicated as $\gamma_{max,m}$ in Figure 7. It is confirmed that shear strain

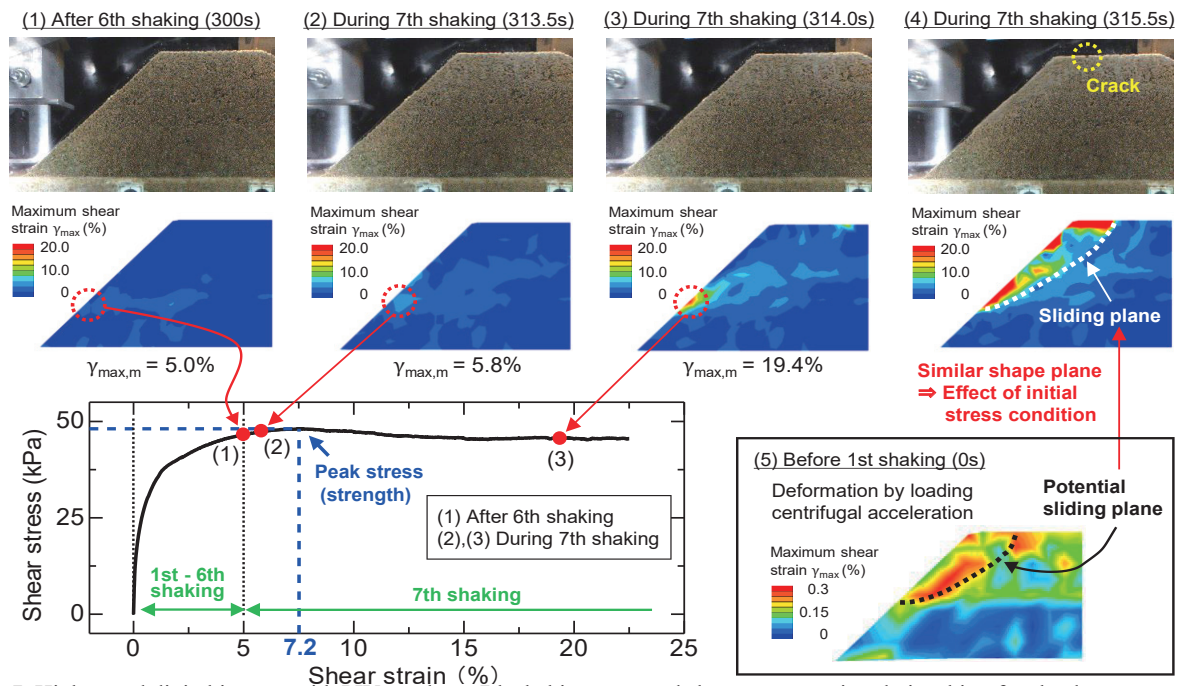
Fig. 7. High-speed digital images with PIV results at 7th shaking step, and shear stress-strain relationship of embankment material.

gradually concentrated at the particular part of the slope (we call this part “strain concentration part” hereafter) and progressed into the inside of the embankment during shaking. After that, a sliding plane appeared and the embankment collapsed (Figure 7(4) at 315.5s). Lower part of Figure 7 shows the stress-strain relationship of the Edosaki sand obtained from the monotonic shear loading test with the hollow cylinder torsional shear test apparatus at confining pressure of 50kPa. In this paper, we treat this stress-strain relationship as the relationship between shear stress and maximum shear strain at the strain concentration part in the model embankment. Approximately $\gamma_{max,m}$ of 5.0% occurred before 7th shaking as shown in Figure 7(1) (at 300s), which did not reach the strain at peak stress of the embankment material (7.2%). During the 7th shaking, $\gamma_{max,m}$ at the strain concentration part increased and reached 7.2% between 313.5s and 314.0s. Note that 7.2% is the peak stress indicated lower part of Figure 7. After that, shear strain rapidly increased and finally collapsed while showing the sliding plane as shown in Figure 7(4). This means that an embankment would show sliding failure when the shear strain at the concentration part near slope reaches the strain at peak stress of the embankment material. This damage process is in good agreement with the previous study (Izawa et al., 2022). Furthermore, it is found that the strain concentration part observed during shaking corresponds to that at initial condition as shown in Figure 7 (5). It can be said that the strain begins to concentrate at the edge of the potential sliding plane formed before shaking and progresses along the plane during earthquake. The edge of the plane observed in this test, that is, the strain concentration part, was located

relatively upper part on the slope. This result is thought to be the cause of weak part at the slope created during construction process.
