# Effect of soil nails in repairing damaged reinforced soil walls

**ABSTRACT:** It is known that reinforced soil walls have higher earthquake resistance compared to conventional retaining walls. However, it is reported that some reinforced soil walls were damaged by large earthquakes such as the 2011 Great East Japan Earthquake. Geogrid reinforced soil walls (GRSW) usually use only geogrids as reinforcing members. But if it is thought that the stability of the damaged GRSW is not enough with only geogrids after the earthquake and the damaged GRSW needs to be repaired, it is expected to add the soil nails afterwards. To investigate the effect of soil nails in repairing damaged geogrid reinforced soil walls (GRSWs), a series of model shaking table tests on GRSWs was carried out to simulate earthquake damage by the first shaking, repair with soil nails, and the second shaking to estimate seismic stability of the repaired GRSW. The results showed that the seismic resistance of the damaged GRSW was improved by adding soil nails. The effectiveness of adding soil nails in improving seismic resistance was found to depend on the length of the soil nails and the degree of damage to the GRSW

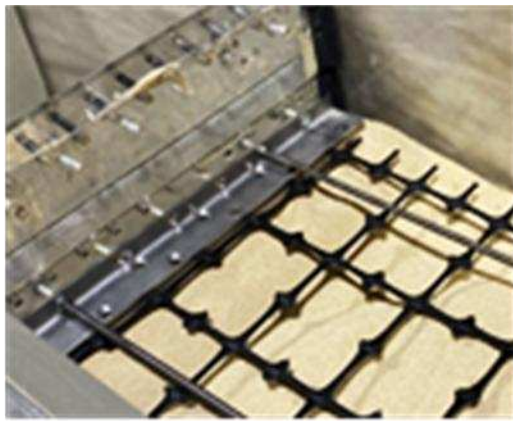
Figure 3. Model geogrid and nails fixed to the facing panel.

geogrid in the real GRSW. 200 mm or 300 mm long screw rods with  $\phi 5$  mm were used for model soil nails as shown in Figure 3. Optical targets were placed within the backfill soil to monitor strain condition by GoPro Hero 7 camera rigidly connected to the front of soil container.

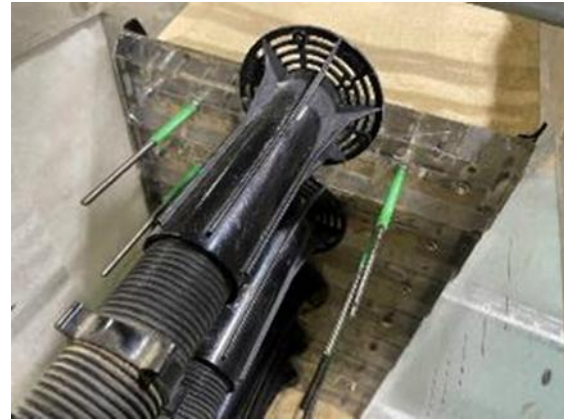
Figure 5. Support in front of facing panels and insertion of soil nails.

Supports were used when the model GRSW was made to keep the facing panels vertical. But they were also used in the first series of shaking to limit the tilting angle of the wall within the designated value and when the soil nails were inserted before the second series of shaking as shown in Figure 5.

tilting is thought to be medium damage (Izawa and Kuwano, 2011). Supports were fixed in front of the GRSW in the first series of shaking to stop the tilting within the predetermined value of 2% or 4%. After the first shaking, soil nails with the length of 200 mm or 300 mm (Ns2 or Ns3) were inserted as shown in Figure 5. The supports were removed and the second series of shaking was applied until the full collapse to investigate the behaviour and seismic resistance of the repaired GRSW during the following earthquakes.
