# Coseismic and Post-Seismic Slope Instability along Existing Faults

**Abstract.** The world in the 21st Century faces increased hazards of gigantic earthquakes and heavy rains as compared with the previous century. Under this circumstances, coseismic landslide is one of the important topics in geotechnical earthquake engineering and is promoted by the increased precipitation both before and after the gigantic earthquakes. This paper shed light on this topic, paying attention not only to the effects of strong shaking but also to the important role played by faults, which are either active or inactive. The fault action consists of the rock fissures along the fault and possible water ejection from the fault plane. The rock fissures made by the fault dislocation causes the long-term instability of mountains slopes for years or for centuries after strong shaking.

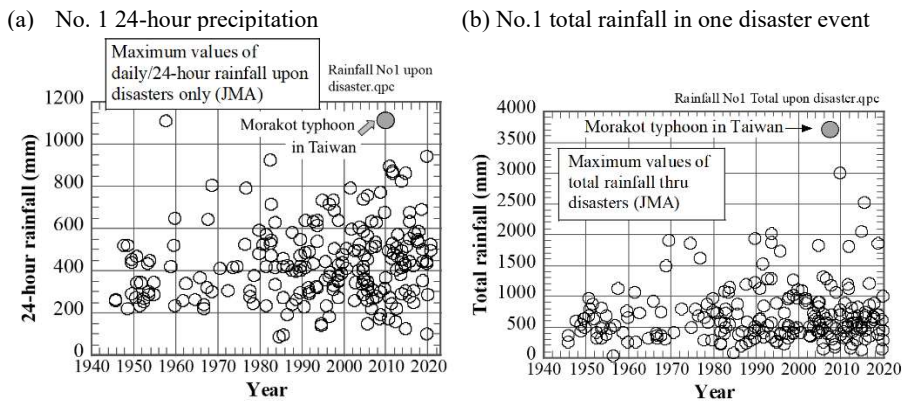
Fig. 3. History of rainfall records in Japan that triggered disasters since 1945.

This situation is worsened by the recent increasing trend of precipitation that is a very important cause of flood and landslide disasters. The recent increase of rainfall is possibly a consequence of the global climate change but I cannot make any definite remark on this issue. Only what I can do is to present data recorded and reported by established institutions. While many institutions have been publishing the annual or extreme daily rainfall records that are increasing, I collected the only precipitation records that induced flood and sedimentary disasters in Japan since 1945 [3]. Because a heavy but short rainfall event does not trigger disaster, Fig. 3 indicates the nation's No. 1 rainfall record of one-day (or recently 24-hour) precipitation as well as the total rainfall during one disaster event. It is shown here that the upper bound of the disastrous rainfall have been increasing since 1990s, implying that the risk of significant rainfalls has been aggravating for the past 30 years. By combining the views on earthquakes and rainfalls, it can be said that the risk of the compound disasters as induced by earthquakes followed by heavy rain or, conversely, the antecedent rainfall followed by earthquakes is becoming significant nowadays.

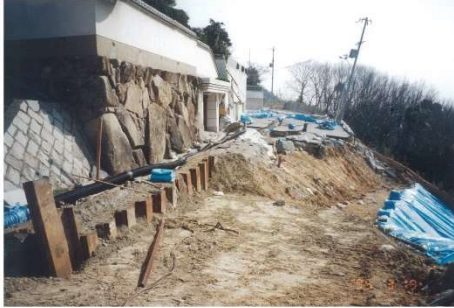
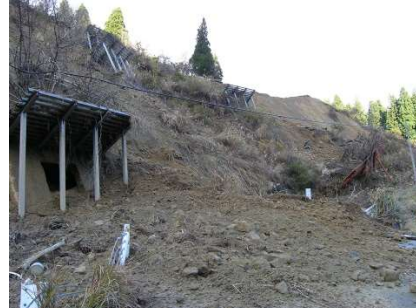
(a) Kobe in 1995

(b) Niigata-ken-Chuetsu in 2004

Fig. 4. Coseismic landslides induced by two different earthquakes with similar magnitudes.

The effects of the antecedent rainfall are captured by looking at Figs. 4 and 5 that illustrate the less important occurrence of coseismic landslide during the 1995 Kobe earthquake ( $M_w=6.9$ ) together with the rainfall history together with the similar information of the 2004 Niigata-ken-Chuetsu earthquake ( $M_w=6.6$ ) (for their locations, see Fig. 6) which was preceded by a heavy rainfall and was associated with many coseismic landslides.

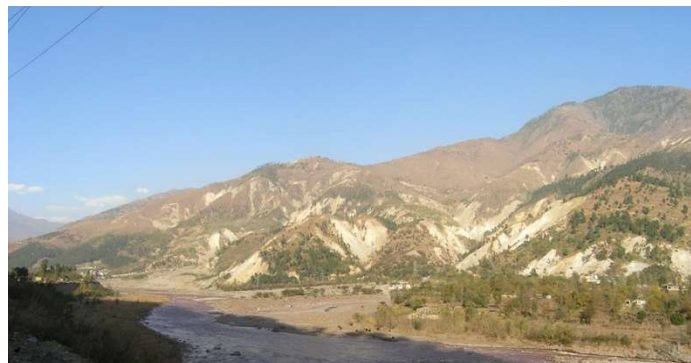
**Fig. 8.** Landslides along the fault valley caused by the 2005 Kashmir earthquake (south of Balakot).

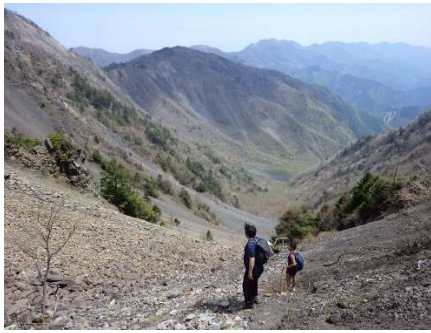
**Fig. 9.** Landslide at Ohya, Shizuoka, Japan.

The present paper calls attention upon the effects of existing fault, which is not necessarily the causative fault, on the landslides induced by an earthquake. Figs. 9 and 10 show the landslides at Ohya and Shichimenzan in central Japan (Fig. 6). Both sites have been unstable for many centuries. Legends say that the Ohya landslide was triggered by the 1707 Hiei earthquake of  $M_w=8.7-9.3$  with the volume of the failed sediment = 94 million  $m^3$  [10]. The other one at Shichimenzan is old as well, having been

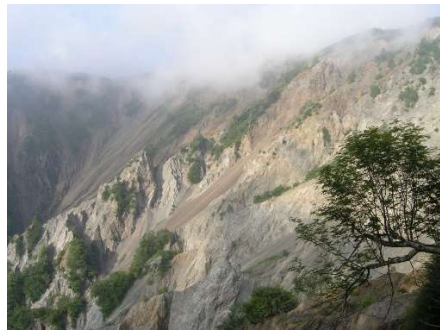
**Fig. 10.** Landslide at Shichimenzan, Shizuoka, Japan.

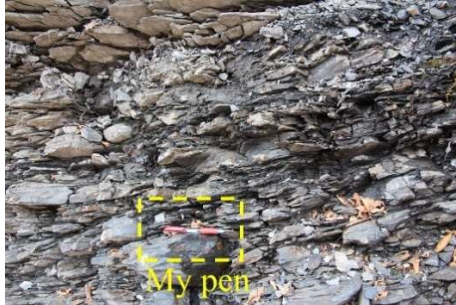
**Fig. 12.** Fractured rock of Ohya landslide site.

In clear contrast, the Ohya and Shichimenzan slopes (Figs. 8 and 9) have been unstable for centuries. One possible reason for this is many and frequent strong seismic events caused by the 1707 ( $M_w = 8.7-9.3$ ) and 1854 ( $M_w = 8.4-8.6$ ) earthquakes as well as many events in the past. The other reason is the weak geology as indicated by the fractured rock mass (Fig. 12) as a consequence of the accumulated damaging effects of the fault action.

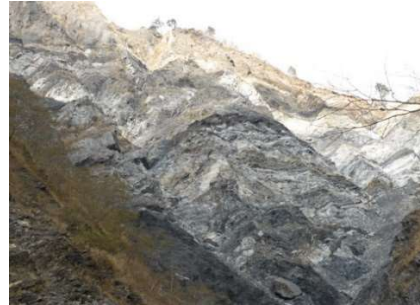
**Fig. 13.** Folded rock mass of Ohya.

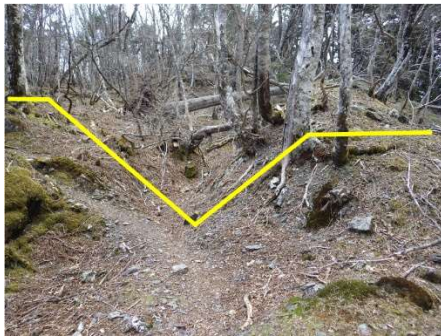
**Fig. 14.** Creep deformation at Ohya..

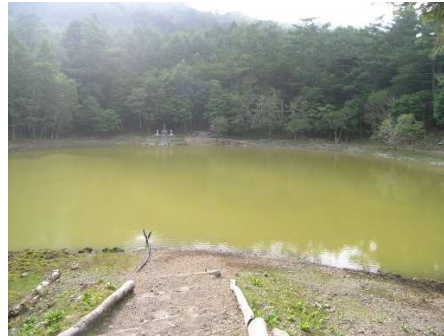
**Fig. 15.** Small lake formed by creep deformation/depression of Shichimenzan Mountain.

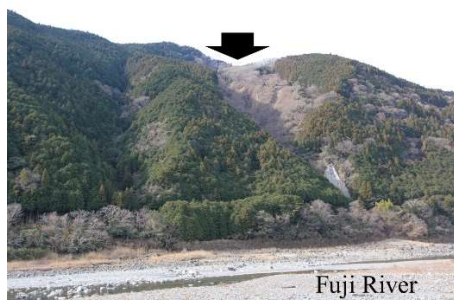
Fig. 17. Shiratoriyama slope that failed in 1707.

To the south of Shichimenzan (Fig. 6), there is another unstable mountain body that is called Shiratoriyama Mountain (Fig. 16). Although low (568 m in altitude), this mountain caused coseismic landslide disasters twice in the recent history; in 1707 upon the Hoei earthquake of  $M_w=8.7-9.3$  and in 1854 upon the Ansei Tokai earthquake of  $M_w=8.4-8.6$ . During both events, the landslide mass blocked the Fuji River channel at the bottom (Fig. 17) and, most probably, the dam breaching caused further disasters. It is thought that the 1707 landslide left a substantial amount of material at the top which partially fell down in 1854 [13]. Still there is a big mass of earth at the top.

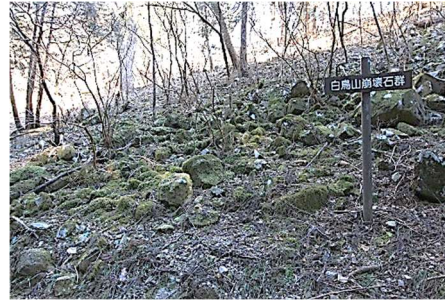
Fig. 18. Cobbles on the flank of Shiratoriyama near the headscarp of the failure in 1707.

Shiratoriyama mountain appears very fragile, comprising fractured or broken pieces of rock: Fig. 18 illustrates the mountain surface near the headscarp where there are many cobbles that are said to be a product of geological procedure. It is noteworthy in Fig. 16 that this mountain is located near the southern tip of Minobu Fault that has recently been registered as an active fault [14]. There are possibly the effects of fault movement on the quality of the rock mass of the mountain. It should be stressed that rock fracturing effect of a fault can remain for a long time even if the fault has ceased its activity and is not considered active anymore.

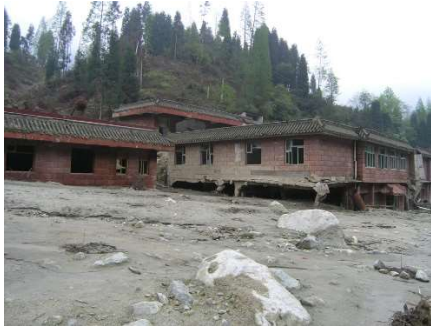
**Fig. 19.** Buildings in Yinchanggou Gully destroyed by debris flow during post-seismic rainfall.

The long-term instability of mountain slopes was a serious problem in Sichuan Province of China after the Wenchuan earthquake [15]. In addition to the coseismic landslides in May, 2008, the heavy rainfall in September triggered additional landslides in the fault-affected area. Fig. 19 illustrates one of the examples of the post-seismic disasters in which the debris came from the coseismically disrupted mountain slope behind the town (Fig. 20). Fig. 21 shows another landslide caused by the post-seismic heavy rain. This landslide occurred in a slope made of mud stone that had been most probably prone to deterioration by infiltration of rain water (or slaking) and could not remain stable. Obviously, there are two kinds of post-earthquake instability caused by 1) mountain slopes disrupted by strong shaking (generation of cracks and fissures) as shown in Fig. 20, and 2) rainfall erosion of soil deposits on slopes and in valley bottoms. The former case implies the vulnerability of mountain slopes along faults under strong shaking. It took 5-7 years for the mountain slopes to be stabilized and recover vegetation cover (Fig. 22).

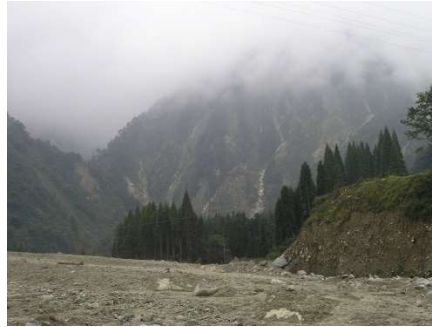
**Fig. 20.** Disrupted mountain slope as the source of debris flow.

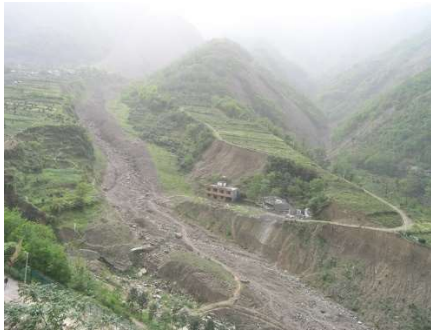
**Fig. 21.** Landslide to the west of Qushan Zhen induced by post-seismic rain.

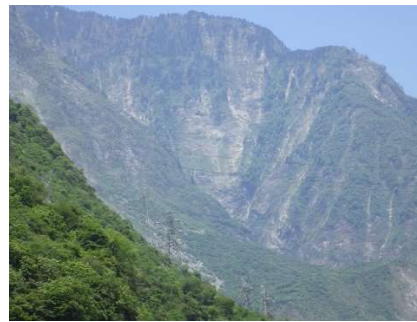
**Fig. 22.** Recovery of vegetation on slopes that was failed in 2008 (picture taken on May 15 2018).

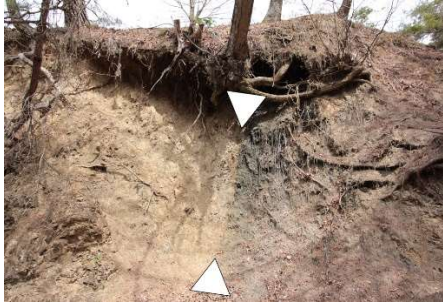
**Fig. 23.** Exposed fault dislocation at Itayama within the Ina section of MTL.

The Median Tectonic Line (MTL) is a long and old fault that runs in the approximately E-W direction in the western part of Japan (“d” and “e” in Fig. 6). It started its activity in the Cretaceous Period [16] and the dislocation to date has accumulated to 60 km [17] or more. Fig. 23 shows one of the MTL outcrops in the Ina region. It is hence reasonable to expect the fault-induced fracture of rocks along it. While very little is known about the activity of MTL (causing earthquakes) during the historic times (in the past 1500 years or so), its Ina section triggered two damaging earthquakes in 8th Century (probably in AD 715) and then in 1718. Fig. 24 illustrates one of the sites of the historical coseismic landslides in Tohyama Village of Ina. The more serious problem along MTL is the instability of mountain slopes undergoing heavy rainfalls. Fig. 25 shows the site of Ohnishi Yama landslide (1961) and Fig. 26 indicates the ongoing instability at Tobigasu.

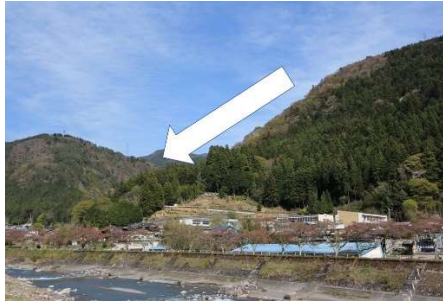
**Fig. 24.** Site of historical landslide triggered by Tohyama earthquake of Magnitude = 7 in 1718.

In line with the previously-described sites, it is likely that the MTL dislocation in the past affected the mechanical property of the mountain slopes in the Ina region. This idea seems supported to a certain extent by the landslide disasters as shown in Figs. 24 and 25. In this perspective, Matsushima [18] assembled the historical data on earthquakes and landslides in Ina, which are both coseismic and non-seismic. The

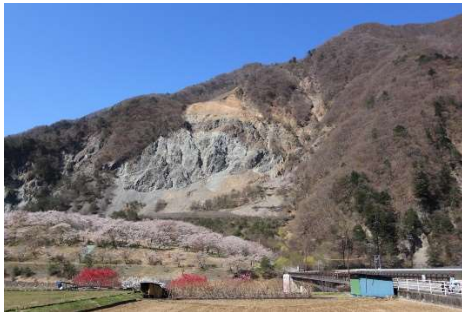
**Fig. 25.** Ohnishi Yama landslide site immediately upon MTL.

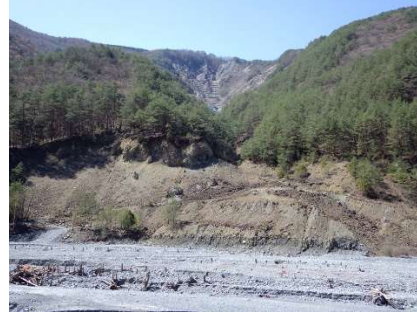
**Fig. 26.** Tobigasu slope failure along MTL

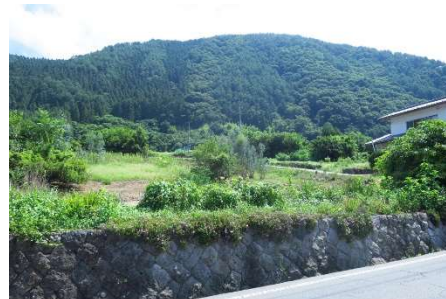
Fig. 29. Present view of the Makiuchi landslide site.

Matsushiro in Central Japan (Fig. 6) was affected by seismic tremors in middle 1960s (Fig. 28). This event was characterized by substantial water ejection and induced landslides. JMA [23] presents photographs of significant water ejection from hot springs in the area. Eventually, a huge landslide was triggered by water ejection. The mechanism of water ejection-induced landslide is simple and understandable from the soil-mechanic viewpoints; pressurized water came up from the deep elevation and increased the pore water pressure in the slope, while the total stress was unchanged, thus reducing the effective stress and shear strength in the slopes. Later, water injection tests were conducted in Matsushiro [24] in order to verify that the increased water pressure triggered the fault rupture at depths by reducing the effective stress. The landslide site remains vacant today due to the possible risk of reactivation of water ejection and landslide (Fig. 29).

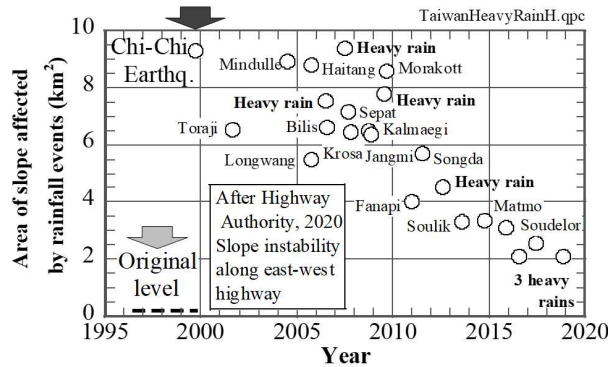
**Fig. 30.** Summary of slope instability in Central Mountain of Taiwan drawn after data of Highway Office of Taiwan [25].

Section 3.4 addressed the slope instability that started after the earthquake and lasted for many years. Similar problem occurred after the 1999 Chi-chi earthquake in Taiwan (Mw=7.6) and Pakistan in 2005 (Mw=7.6). Fig. 30 shows the extent of slope instabilities within a selected area along the East-West Crossing Highway in the mountainous area of Taiwan Island. It appears that the size of slopes affected by typhoons and rainfalls after the Chi-chi earthquake increased drastically but then decreased slowly towards the original level. This decreasing process took twenty years. During this process, however, there was a positive correlation between the amount of rainfall and the increment of landslide area (%) (Fig. 31), suggesting that the decreasing landslide size in Fig. 30 was possibly the consequence of less amount of rainfall during the post-earthquake years. To investigate the rainfall effect quantitatively and illustrate the vulnerability, the vulnerability index was defined by

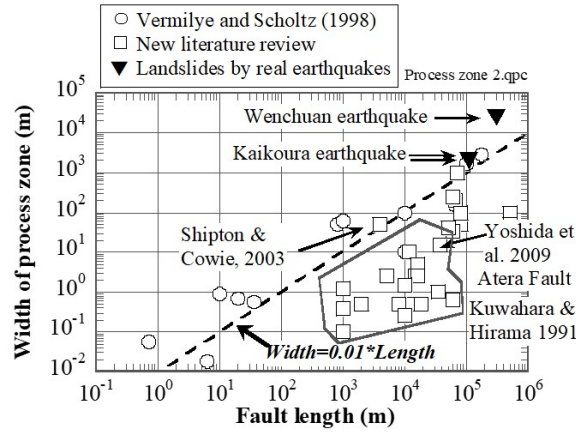
Fig. 34. Empirical relation between the width of process zone and the length of the causative fault [26-29].

The fault effect mentioned above is otherwise called the process zone and its width (Fig. 33) was originally supposed to be 1% of the fault length on the basis of field inspection [26]. Fig. 34 illustrates this 1% correlation together with the results of more literature information collected by the author. This figure shows that “1%” is a good value for the upper bound of the process zone width while there are narrower width at several places. Note that the judgement of the process zone is subject to personal judgment and difference.

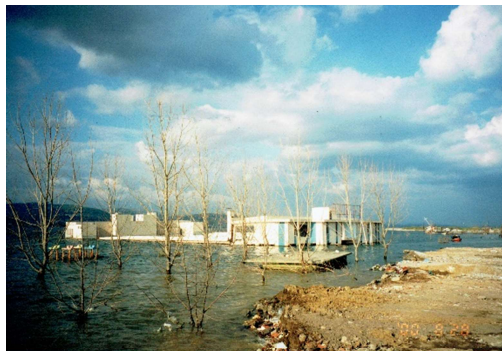
Fig. 36. Subsidence of the coast line of the Izmit Bay.

The pull-apart mechanism of a strike-slip fault produces a basin where a unique geotechnical problem occurs. Fig. 35 illustrates schematically the mechanism of a pull-apart basin where the lateral extension of the earth crust results in vertical compression and depression. One of the examples of this type of geomorphology is the Izmit Bay of Turkey whose southern coast line was affected by subsidence (Fig. 36) and submarine landslides [30].

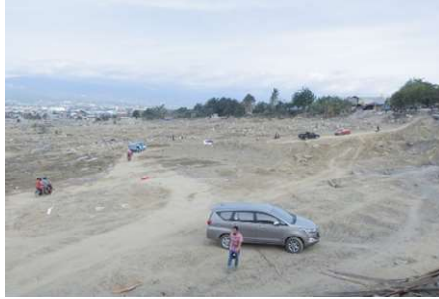
**Fig. 38.** Landslide at Balaroa.

Fig. 38 shows one off the four big landslides that occurred in the Balaroa area in the southwestern suburb of Palu City. The size of this landslide was 0.85 km in length and 0.58 km in width, making the area 0.39 km<sup>2</sup>, while the ground gradient was merely 2 % on average. Similar to the other three landslides of this type, the surface soil of about 3-5 m in thickness suffered from liquefaction and the slope instability was induced. The induced soil displacement in the horizontal direction was 500 m or more, which was notably greater than those of other liquefaction-induced displacement in gentle slopes (typically 1-2% gradient) that were merely several meters [32]. The similar extent of displacement occurred in other three big landslides in Palu Basin as well. The notably long distance of displacement implies that the disaster in Palu Basin had something special in its mechanism.

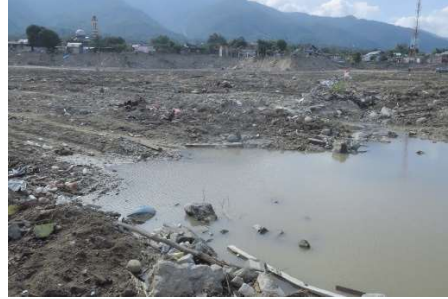
**Fig. 39.** Water spring observed at the bottom of Balaroa landslide on November 2nd, 2018.

The second special feature of the landslides was the existence of substantial ground water ejection as evidenced by the water springs recorded five weeks after the disaster in the exposed slip plane (Fig. 39). Springs were found in other landslide sites as well. It should be recalled that the ample ejection of ground water during the Matsushiro swarm that triggered landslides as mentioned before. The source of this ample ground water is not necessarily the irrigation channel or leakage from local sewage system because the Balaroa site does not have either such a channel or evidence of leakage (Figs. 40 and 41). Accordingly, there seems to be very special feature in the local geology, geohydrology and soil conditions in the four landslide sites. They are special because occurrence of similar landslide is not known elsewhere in the world.

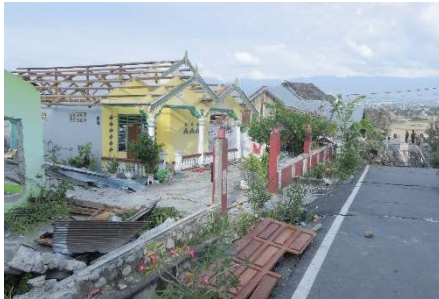
**Fig. 40.** Lack of irrigation channel above the headscarp of Balaroa landslide.

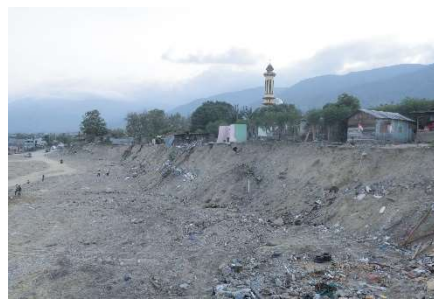
**Fig. 41.** Dry headscarp of Balaroa landslide.
