## Stability Monitoring of Earthquake-Induced Slope Failure and Landslides

### ABSTRACT

An early warning monitoring system is one of the most effective ways to reduce disasters induced by slope instabilities. The 2008 Ms 8.0 Wenchuan earthquake that occurred in Sichuan province, China, induced more than 197 000 slope failures and landslides. To reduce vulnerability to such slope and landslide hazards, an early warning system becomes important, and for this purpose, a newly developed simple and low-cost early warning system for slope failure and landslides is presented here. The new system is based on a tilt sensor that is easy to install. The sensor can monitor water content and slope deformation with a tilt Micro Electro Mechanical Systems (MEMS) module embedded in the sensor unit, and it can transfer real time data via a wireless network. Since 2010, the monitoring system has been used in seven actual large-scale slope failure and landslide sites to validate field performance. In this paper, we report on two monitoring cases to show that the early warning system adequately monitors the stability of slope and debris fields in China and Japan. Based on the field site test results

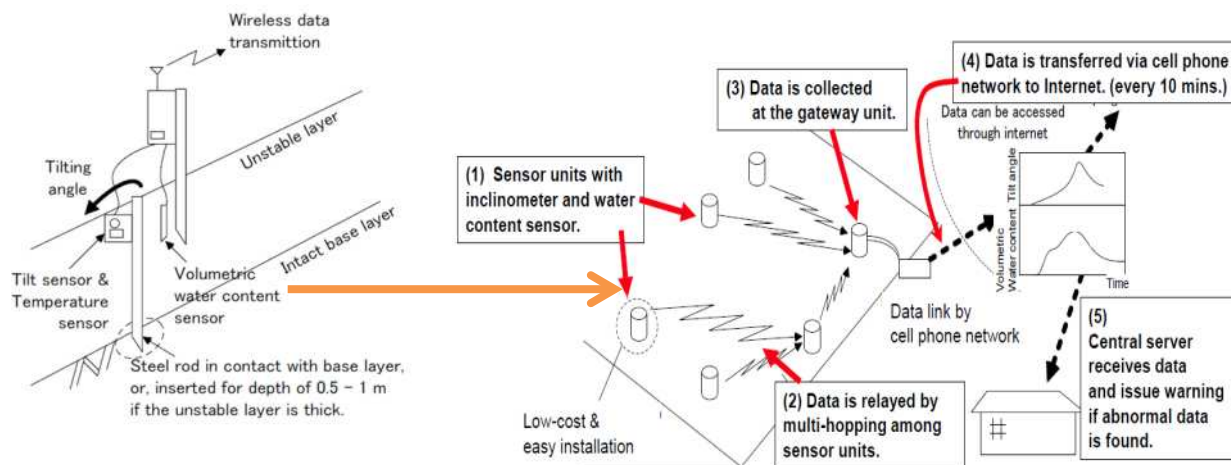
Figure 1. Outline of wireless monitoring and early warning system for slope failure.

This simple low-cost early warning system focuses on only two parameters: the water content of the soil and the inclination of the slope or landslide. The applicability and effectiveness of the system was tested on model slopes under artificial heavy rainfall (Uchimura et al., 2004). The system is powered by batteries, and transfers real-time data via a wireless network. It is low-cost and simple so that non-expert local residents from the assessment area can maintain equipment independently, even in developing countries. Figure 1 shows the basic concepts behind the wireless monitoring and early warning system for slope failure. The system is designed to be wireless, i.e., each unit works autonomously with a microcomputer running on an independent battery or solar-cell power supply. Radio modems operated in the 429 MHz ISM band for Japan and the 434 MHz ISM band for European Union countries and China.

The sensor units measure the condition of the slope periodically, e.g., every 10 minutes. The data are transferred to a gateway unit, which is also placed near the slope, using low-power radio communication modules. The data transmitting distance is 300 to 600 m under typical field conditions. The gateway unit collects the data from all sensor units, and sends them to a data server on the Internet using a mobile phone network. In this way, the data can be searched anywhere and anytime on a website. The data were processed by the server, and any abnormal behavior of the slope can be detected as a precaution of failure. A warning can then be issued.

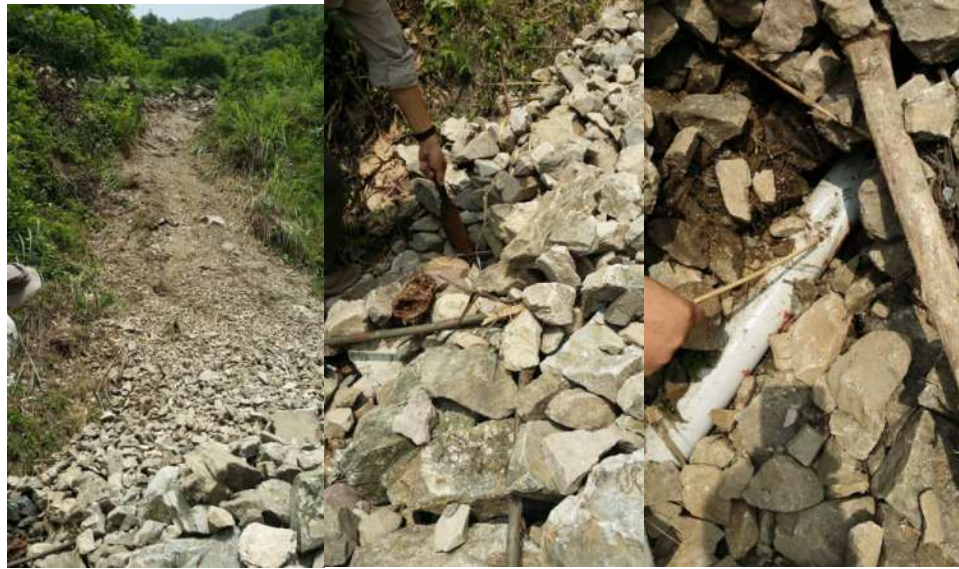
Figure 4. Wireless sensor unit destroyed by suddenly slope failure or rockfall flow

A small-scale slope failure suddenly occurred at the position of wireless sensor unit K-1 on July 6, 2013, without an accompanying increase in rainfall. Another two wireless sensor units maintained normal operations. The site manager became aware of the abnormal behavior from the wireless sensor, and traveled to the field site. He found that the wireless tilt sensor of unit K-1 was completely buried (Figure 4).

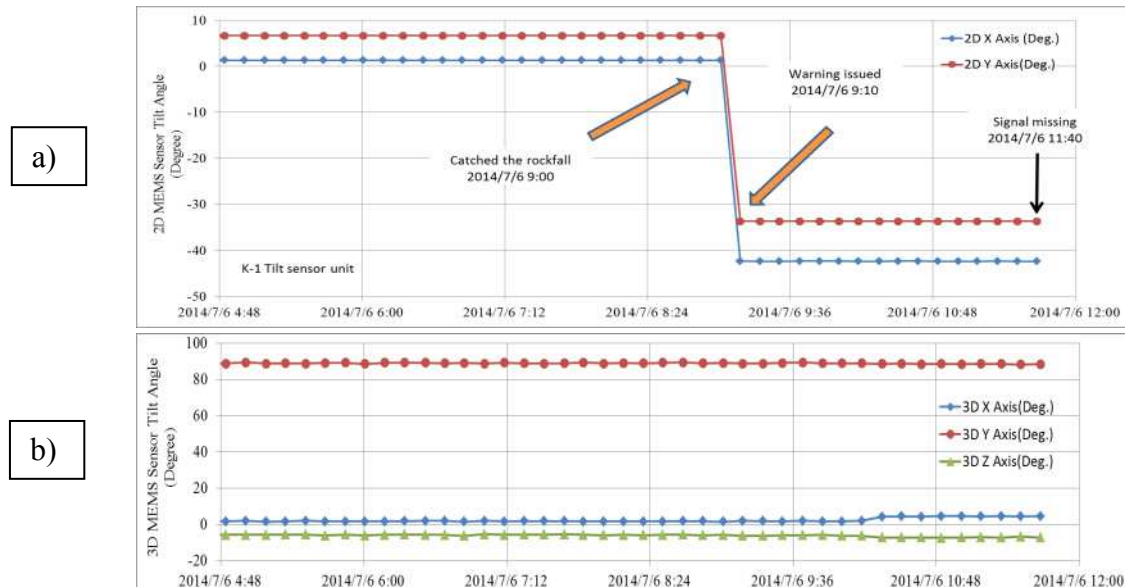
Figure 5. Real time data for sensor unit K-1 around the time of slope failure.

Figure 5 a) shows how the inclination of the 2D MEMS embedded in the separated tilt sensor unit changed over time, and Figure 5b) shows the relationship between the 3D MEMS inclination and time. On this slope, the real-time monitoring system started with three sensor units (Figure 1) 3 months earlier. No rain fell during the collapse of the slope. At 9:00 on July 6, the system showed that the tilt angles of the X and Y axes had notable changes. The output voltages of the 2D MEMS tilt sensor unit reached their limited, which means that the cable that connected the sensor and wireless units had become disconnected or broken, i.e., the separated 2D MEMS tilt sensor unit was destroyed by the first stage of slope failure or rock flow. At this time, the wireless unit continuously transferred the 3D MEMS tilt data, as is normal, to the remote data center. In other words, the system gave us a lot of time, more than 5 hours, to send out warnings.

After 5 hours, another trigger event caused a second slope failure, meaning that an additional large amount of rockfall flow happened. The wireless unit was buried in the slope and the data transfer stopped. Because the first slope failure and second rockfall were located at sensor unit K-1, the deformation of the slope at the time of failure was detected successfully by the monitoring system.

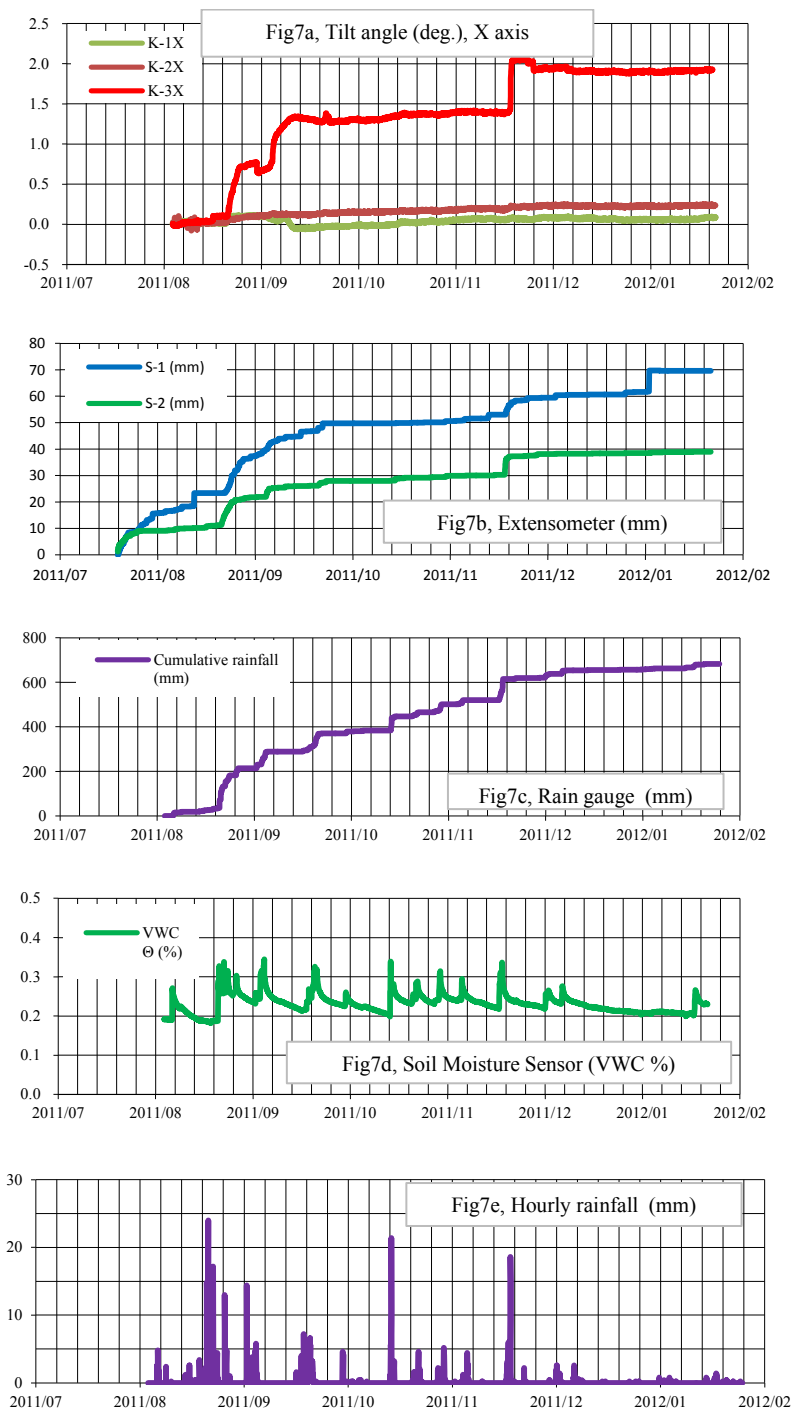
Figure 7 (a) Tilt angle (deg), X-axis, (b) Extensometer (mm), (c) Rain gauge, (d) Soil moisture sensor (VWC %) and (e) Hourly rainfall.

Another set of in-situ measurements are shown in Figures 6 and 7. These concern a period of heavy rainfall in July 2011 that caused a slope failure along a local highway in Kyushu, Japan. During road construction involving substantial earthwork, an emergency monitoring system using multiple borehole inclinometers, extensometers, tilt sensors and rain gauges was established at the slope failure site. To validate the newly developed tilt sensor with field extensometer data, the three tilt sensors were collocated near the fixed pole of the extensometer moving points as shown in Figure 7. At this field location, four additional boring surveys have been undertaken and multiple borehole inclinometers have been installed. Two of the tilt sensors (K-2, K-3) were set up near survey holes 2 and 3. The results of the boring surveys show that the depth of landslide slip surface is 6 m at one location and 14 m at the other, as shown in Figure 8. Figure 7 shows the time histories of the tilt sensor inclination in the direction of the extensometer wire (tilt sensor x axis) and the movement of the extensometer (S-1, S-2); Figure 7c shows cumulative rainfall values by rain gauge; Figure 7d shows the water content determined by the ECH2O water content sensor.

Normally, the fixed pole of a tilt sensor is inserted into a slope surface to a depth of 1.0 m, so that the inclination of the tilt sensor corresponds to the average movement of the slope surface. The results show that the inclinations of the tilt sensors (especially tilt sensor K-3) and the movement of extensometers increased with rainfall, and showed a strong correlation with each other (Figure 7a–e). Figure 9 shows the relation of slope movement (in mm) as measured by extensometer (S-1) plotted against the inclination (in degrees) as measured by the tilt sensor (K-3). An almost linear relationship was found between the extensometer and tilt sensor, except during storm periods such as those that occurred in August, October, and November 2011.

Another important result is that between the start of heavy rainfall and the initiation of a landslide, the extensometer values remain constant but the tilt sensor inclination changes quickly. For example, during the heavy rainfall on November 18, 2011, hourly rainfall was as high as 20 mm and continuous rainfall reached 96 mm in a 16-hour period. During this time, the inclination of the tilt sensor increased but the extensometer readings showed no change (Figure 9). The tilt sensor measures local changes in the slope surface, whereas the extensometer measures overall movement. Because the failure of a slope usually starts from a local region and

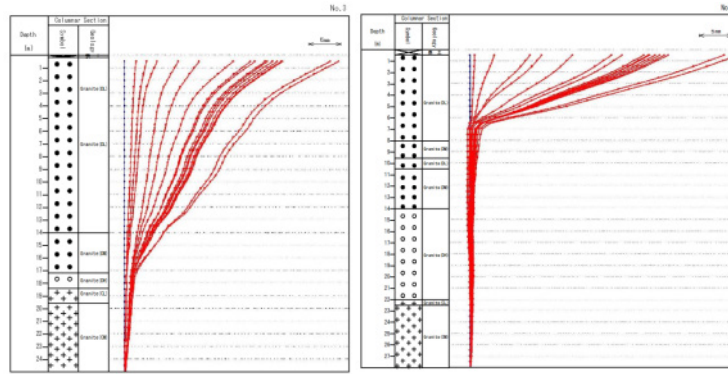
Figure 8. Multiple borehole inclinometers

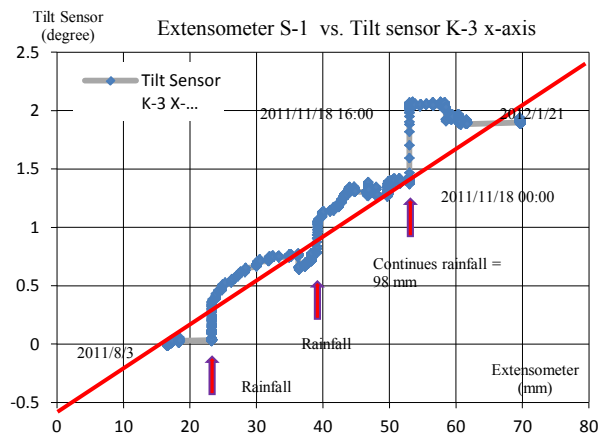
Figure 9. Relation of slope movement to tilt angle
