Earth pressure acting on a deep circular shaft wall

ABSTRACT : There are many facts to be clarified regarding the earth pressures acting on a deep circular shaft wall, and there are very few cases where the actual earth pressures acting on a shaft wall as large as the one in this report have been measured.

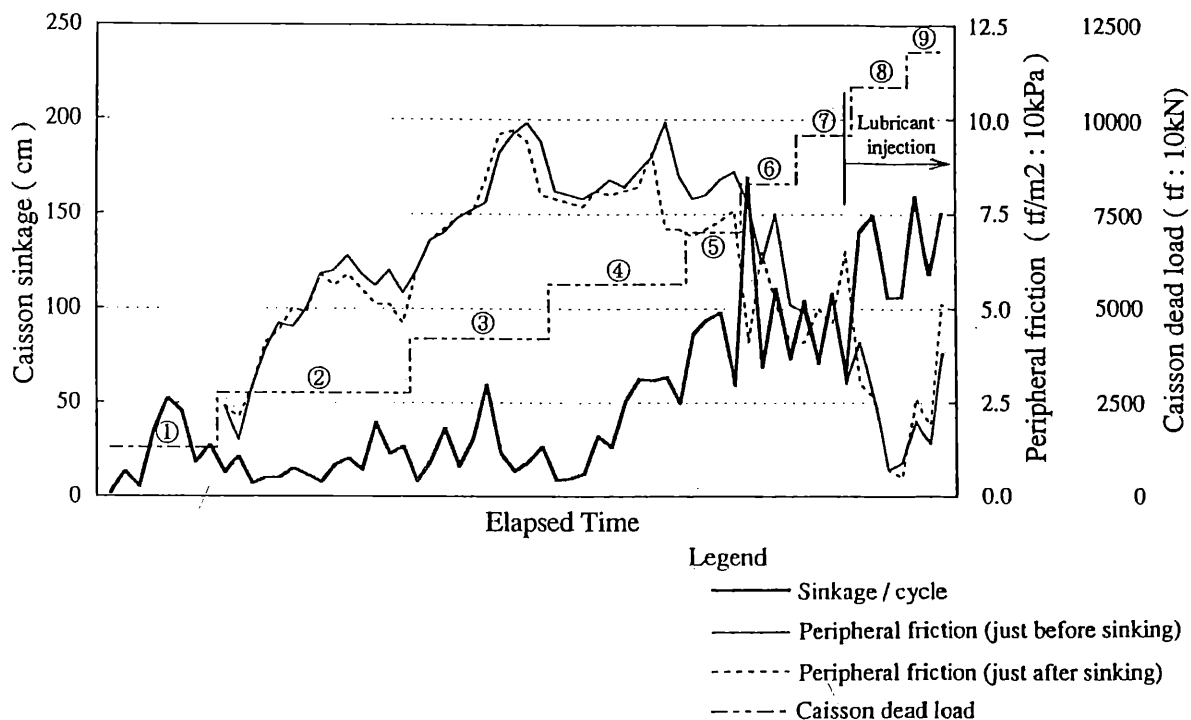
Figure 4 Variations of shaft dead load , sinkage and peripheral friction with time (for No.1 Ring)

As shown in Figure 4, No.1~No.3 Rings sank about 0.2 ~ 0.5 m per cycle, and for No.4~No.9 Rings the sinkage per cycle was considerable, being about 1.0 m.

It was assumed that this large value was due to the large difference in the peripheral friction forces measured directly before and immediately after the sinking of the caisson (Figure 4).

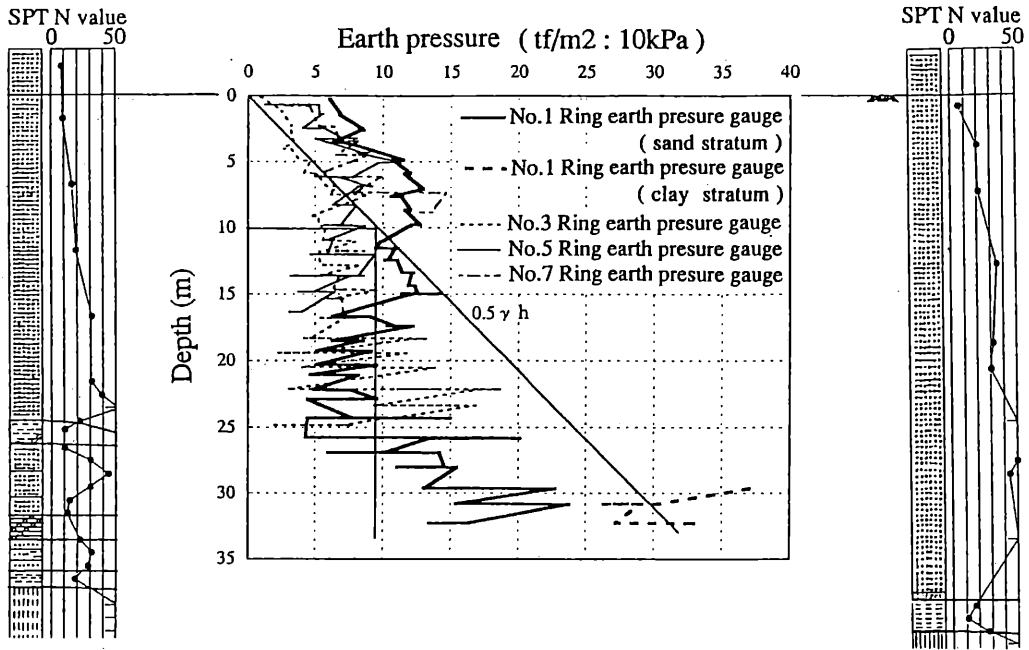
Figure 5 Variation of earth pressure with depth for each pressure gauge

Variations in the earth pressure with depths are shown in Figure 5. From this figure it can be seen that the earth pressures at depths down to 10 m in the upper sand stratum during construction were a little larger than considered (taking the earth pressure coefficient = 0.5), while at levels lower than 10 m the earth pressures were quite small showing no tendency to increase with depth.

As the partial appearance of clay strata occurred in the region of GL - 25 m, the earth pressures of No.1 Ring for the lower part are indicated separately for clay and sand strata. From that point, the earth pressures is large for the clay portion and were approximately equivalent to anticipated values.

It can also be seen that around GL - 15 m, before injection of the lubricant, the earth pressures acting on No.3, 5 and 7 Rings were lower than for No.1 Ring.

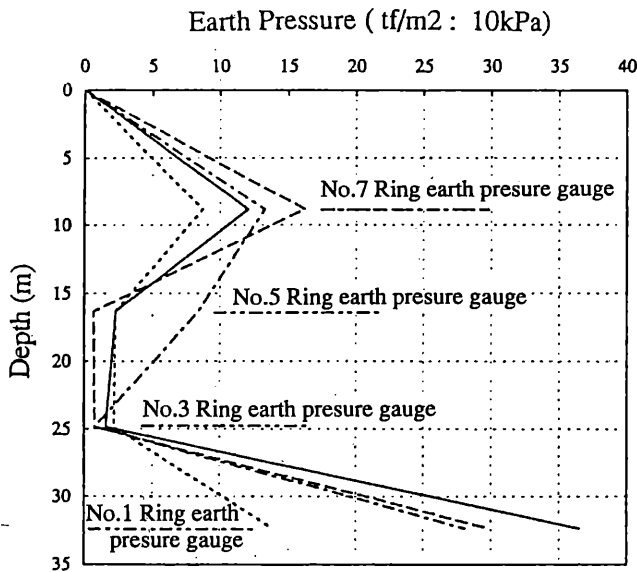
Figure 6 Earth pressure distribution with depth

In Figure 6 is shown the earth pressure distribution with depth approximately one month after the sinking of the caisson to the final position. From this figure it can be seen that the earth pressures for No.3 and No.5 Rings have dropped.

This is assumed to be the result of dispersion of the lubricant liquid pressure and arch action of the ground in the vertical direction causing redistribution of the earth pressure.

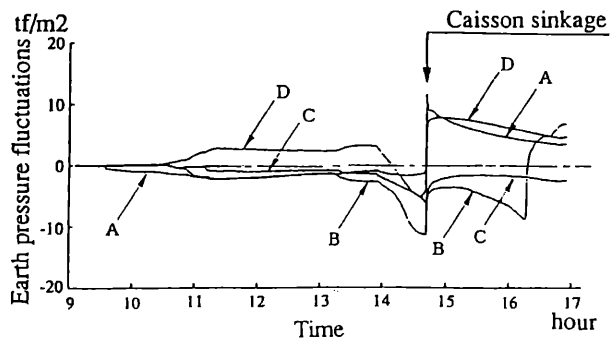
Figure 8 Dynamic earth pressure fluctuation with time (at interval of 0.1 second)

The results of the earth pressure measurements taken at 0.1 second intervals are shown in Figure 8.

From this figure it can be seen that there are pronounced variations in the earth pressure with large caisson sinkage.

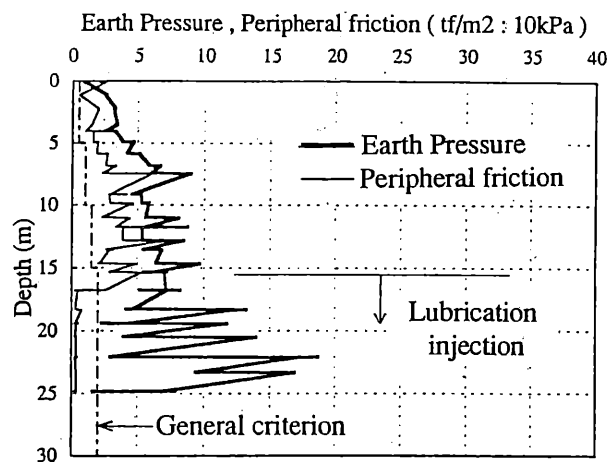
Figure 10 Variation of earth pressure and peripheral friction with depth (No.3 Ring)

The results of peripheral friction force and earth pressure measurements are shown in figures 9 and 10. From these figures it can be seen that the effect of NF sheet was small but that the effect of lubricant injection was considerable.

The friction coefficient for No.1 Ring of the caisson was about 0.7, and for No.3 Ring, for which NF sheet was used, the friction coefficient was about 0.6 .

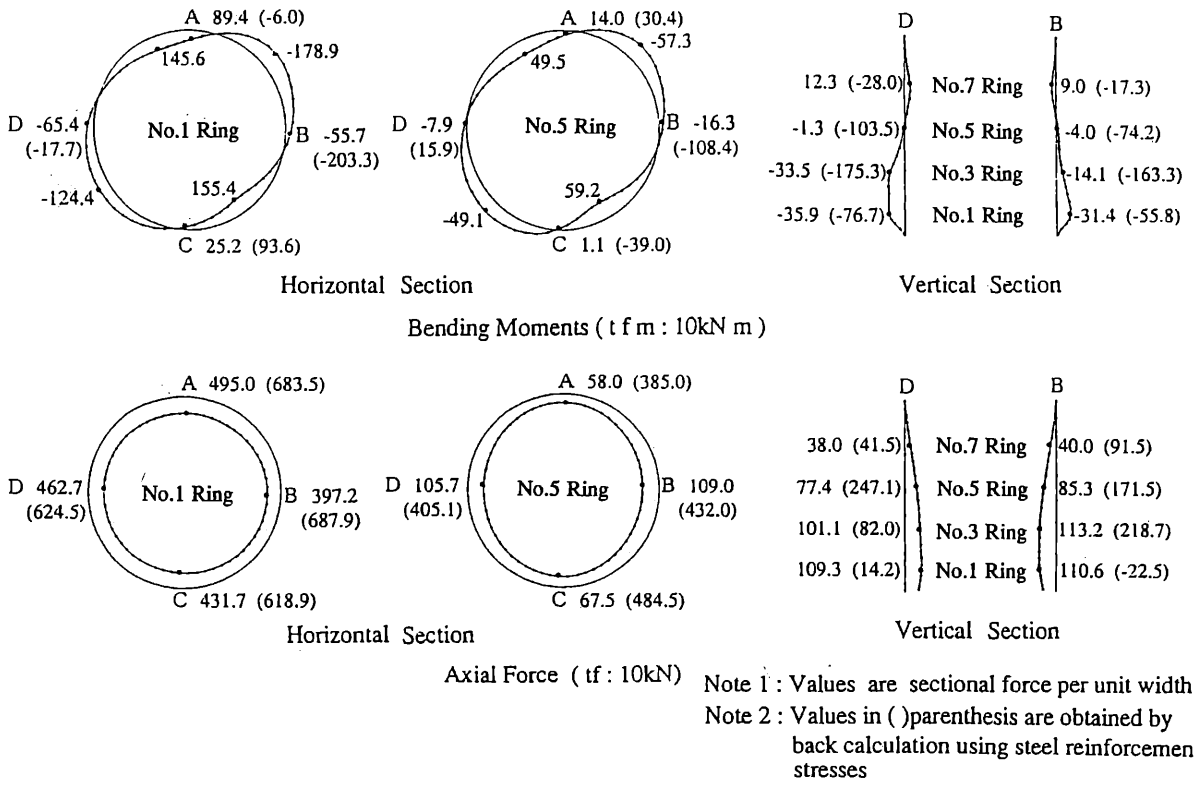
Figure 11 Comparison of section forces obtained by back calculation using steel reinforcement stresses and FEM analysis based on measured earth pressure

In Figure 11 is shown a comparison of the cross sectional forces obtained by back calculation using the measured steel reinforcement stress with the cross sectional forces obtained by 3 dimensional FEM analysis (Figure 12) based on the measured earth pressures (Figure 6).

From Figure 11 it can be seen that in the case of No.1 Ring of the caisson, on which the earth forces were considerable, there is a good analytical agreement for the bending moments and axial forces acting on the wall section. On No.5 Ring, however, where the earth forces were small, noticeable differences occurred in the results.

The cross sectional forces obtained by back calculation from the measured reinforcement stress were corrected to take into account the effect of the thermal stresses and construction conditions. Errors due to influence of such correction were assumed to be large at the portions where the actual cross sectional forces were small .
