The paper was published in the proceedings of the 11th International Symposium on Field Monitoring in Geomechanics and was edited by Dr. Andrew M. Ridley. The symposium was held in London, United Kingdom, 4-7 September 2022.

The practical structural assessment and design aspects of monitoring building structures with regards movements arising from tunnelling, using examples from Bond Street Station Upgrade.

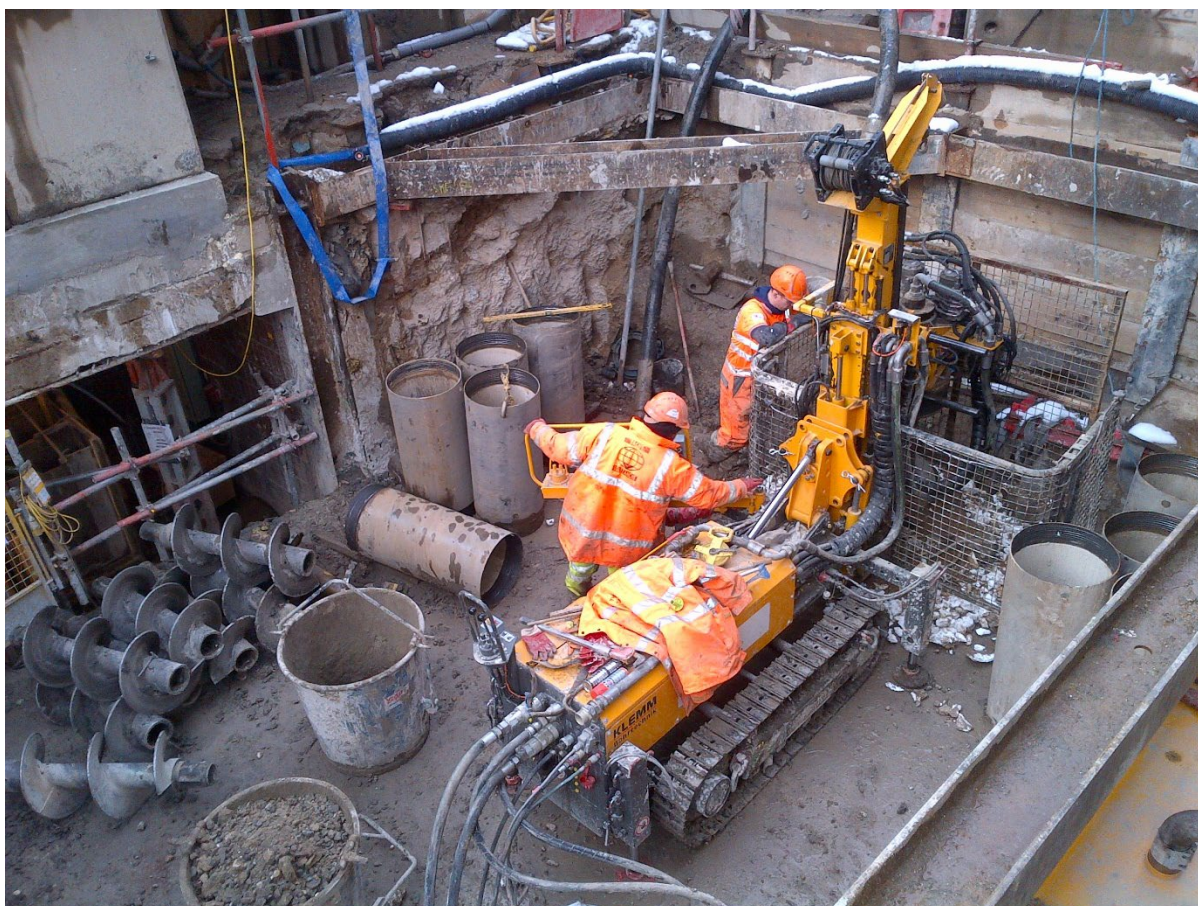
Figure 2: Piling for grout shaft in front of No 2 Stratford Place.
