Wall Construction and Monitoring Program of Tiebacks Walls in a Shale Stratum

Abstract. This paper presents the results of a monitoring program in two tieback walls. Both walls were constructed to preserve the foundation of a highway bridge, to stabilize a slope and to protect an adjacent railroad. Slope deformations and wall deformations were summarized and correlated with construction activities. The construction of both walls involved backfilling and excavation activities. The walls exhibited maximum normalized lateral deformation less than average values reported in the literature. Bulging-type deformation was observed between the ground anchors. The monitoring results showed a beneficial effect of the installation of the soldier piles in a shale layer.

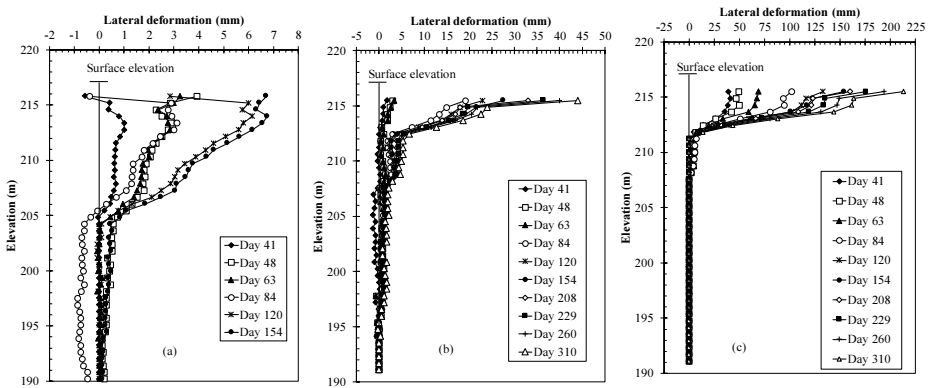
Figure 3 presents the ground deformation measured with the slope inclinometers. Data from the Inclinometer 1 were collected until Day 154 due to its damage by construction activities. At Day 41, the observed ground movements were caused by the installation of the soldier piles of the upper wall about 30 mm. This displacement was observed in the Inclinometer 3 while the other inclinometers showed displacements with a magnitude less than 5 mm. The difference in ground movements was attributed to the location of the haul road of the project. Major excavations and ground disturbances were generated during the installation of the piles adjacent to the Inclinometer 3. According to the inclinometers, the lateral deformation of the slope was restricted to the uppermost 5 m of the profile with the maximum displacement at the surface. During the installation of the soldier piles of the lower wall and preproduction tests, between Day 41 and Day 51, slope movements showed a slight variation as seen at Day 63 around 2 mm in the inclinometers 1 and 2. However, Inclinometer 3 measured a maximum increased in the lateral deformation of 19 mm (Figure 3c). Slope movements suggested that the installation of the piles in the lower wall did not alter the movement of the slope significantly.

Installation of the steel casing for the Row D of anchors was finished around Day 84. During this activity, maximum lateral displacement was about 100 mm in the inclinometer 3. While the Inclinometer 2 showed displacements of about one-fifth of Inclinometer 3, the displacements in the Inclinometer 1 was negligible. Between Day

106 and Day 115, the drill mast was moved to install the anchors of Row B. Simultaneously to the installation of these anchors, the ground was excavated in front of the upper wall to install the Row E of anchors. During these activities, the pattern of deformation was consistent with those observed previously. Maximum deformation of the slope was registered in Inclinometer 3 as 133 mm. Although movements increased in the three inclinometers, these tended to concentrate more in the upper portion of the soil profile. The installation of the anchors and the backfilling of both walls were completed between Day 120 and Day 208. During this period, the maximum variation of the ground displacement was only 25 mm. From Figure 3, it is observed that as the construction activities progressed, the vertical extent of lateral deformation reduced from an initial value of 7 m to approximately 5 m. From the end of construction until Day 310, the ground movements developed in Inclinometer 3 with an increment of 55 mm. This variation was concentrated in the uppermost portion of the soil profile. The vertical extent of lateral deformation decreases continuously until the last day of measurement (Day 310). Inclinometer 2 did not show significant variation in the measured deformation. Based on the rate of displacement observed, both walls effectively contributed to the stability of the slope. Based on Figure 3, ground deformation was mostly limited to elevations between 211 m and 215 m approximately. This area was approximately the interface between the brown clayey silt and the gray silty clay deposits.

Figure 3. Lateral deformation of the slope; (a) Inclinometer 1; (b) Inclinometer 2 and (c) Inclinometer 3.

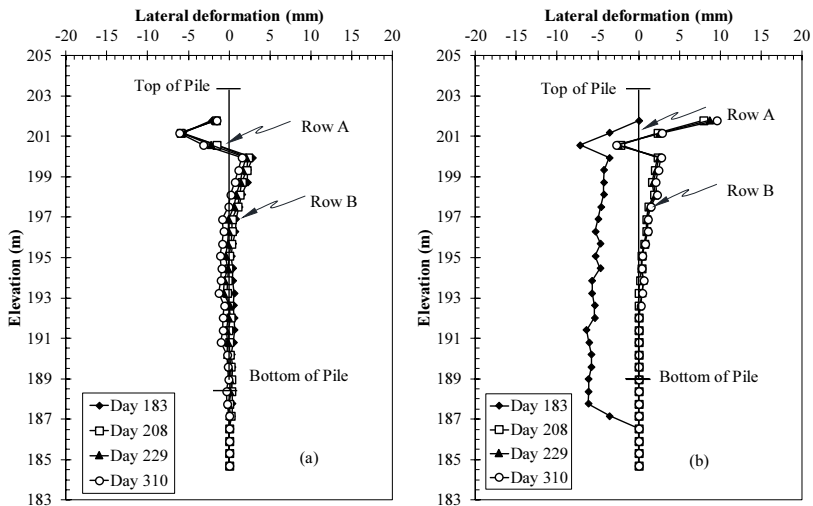
measured by the inclinometers. As seen in Figure 5, the inclinometer casing moved towards the slope approximately 6 mm. Between the ground anchors, a bulging deformation was observed with maximum lateral movement of 3 mm. This bulging deformation represents the wall response to backfilling before and after installation of the upper anchors (Row C). Soldier Pile 12 exhibited a maximum lateral deformation of 10 mm above the upper anchors. However, this value is doubtful due to the localized effect during upper anchor installation.

Figure 5. Lateral deformation measured in the lower wall; (a) Soldier Pile 11 (b) Soldier Pile 12.

At Day 208, the construction of the lower wall finished. After completion of the backfill, lateral deformation of the wall was invariant with respect to the deformations measured previously during the installation of the Row A anchors. Long-term monitoring until Day 310 revealed that further movement of the slope was restricted. Both soldier piles showed similar behavior below the upper anchors; movements concentrate approximately 7 m below the top of the wall in the backfilling area.

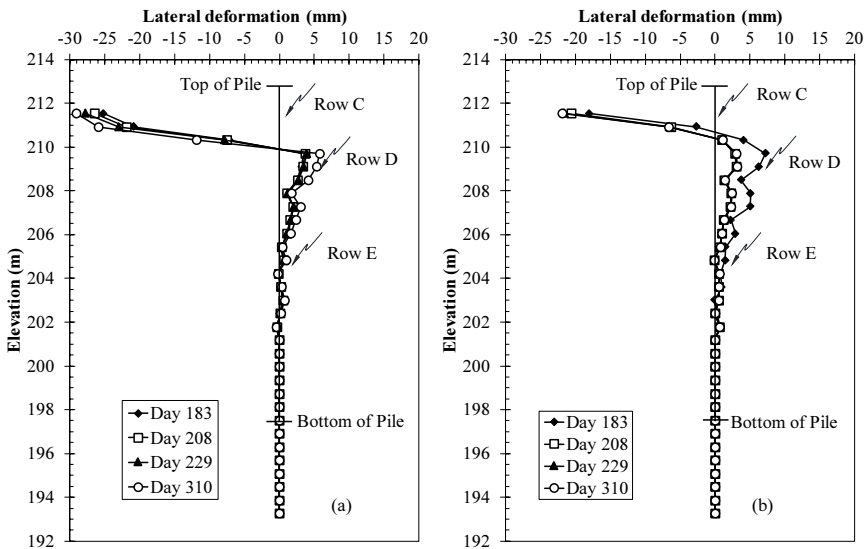
Figure 6 presents the measured response in the upper wall. Although the ground anchors were installed at Day 183, the backfill of this wall was incomplete. Below the Row C anchors, the maximum deformations were observed between the anchors in a bulging type profile. The maximum lateral deformations were 8 mm and 4 mm in the Soldier Piles 31 and 30, respectively. At Day 208 construction and backfilling of the upper wall was completed. Post grouting of anchors around this day attenuated the lateral deformation profile in the Soldier Pile 31. Measurements after construction showed an insignificant increase in the wall deformation around 2 mm by the end of the monitoring period. As in the lower wall, the upper 7 m of the upper wall exhibited lateral deformation. Consequently, the lateral deformation was concentrated only in the areas of backfill in both walls. In the excavated portion of the walls, the lateral deformation was nil because of the installation of the piles in the shale stratum. The deformation profile at Day 310 confirmed that both walls successfully improved the stability in the slope given the cease of the ground deformation.

Figure 6. Lateral deformation measured in the lower wall; (a) Soldier Pile 30 (b) Soldier Pile 31.

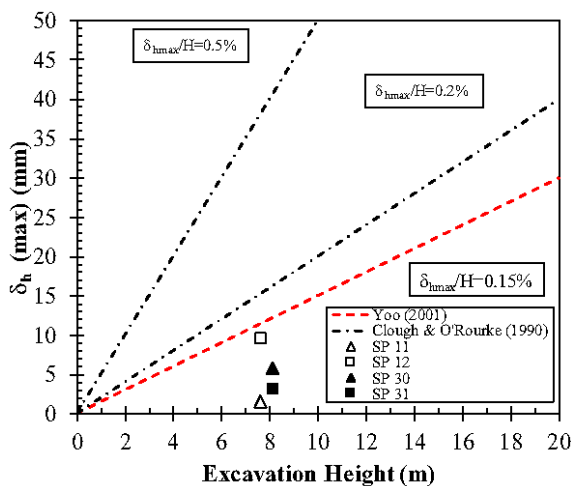
Figure 7 shows the maximum lateral deformation (Day 310) in the walls compared with typical values reported in the literature for this type of walls. In both walls, the measured movements were less than the limit values reported by Clough et al. [9] and closer to the Yoo [8] average. Normalized deformation in both walls was similar even though both walls differ in height and soldier pile separation. In the upper wall, it was 0.06 percent while in the lower it was 0.07 percent. Walls installed in soils overlying rock tend to exhibit smaller lateral movements due to the lateral restriction of the wall toe. These small values of deformation can be attributed to the embedded of the piles in the shale stratum. As reported by other researchers [8, 10, 11], the presence of bedrock may have a significant influence on wall deformations. In this project, the magnitude of the lateral displacements was somewhat limited compared to the 0.4 percent reported by Ma et al. [11] for a wall installed in a gneiss stratum.

Figure 7. Maximum lateral movement.
